**North Platte River Restoration
Project – First Street Reach**

Stream Quantification Tool (SQT)
Monitoring Report

December 20, 2022

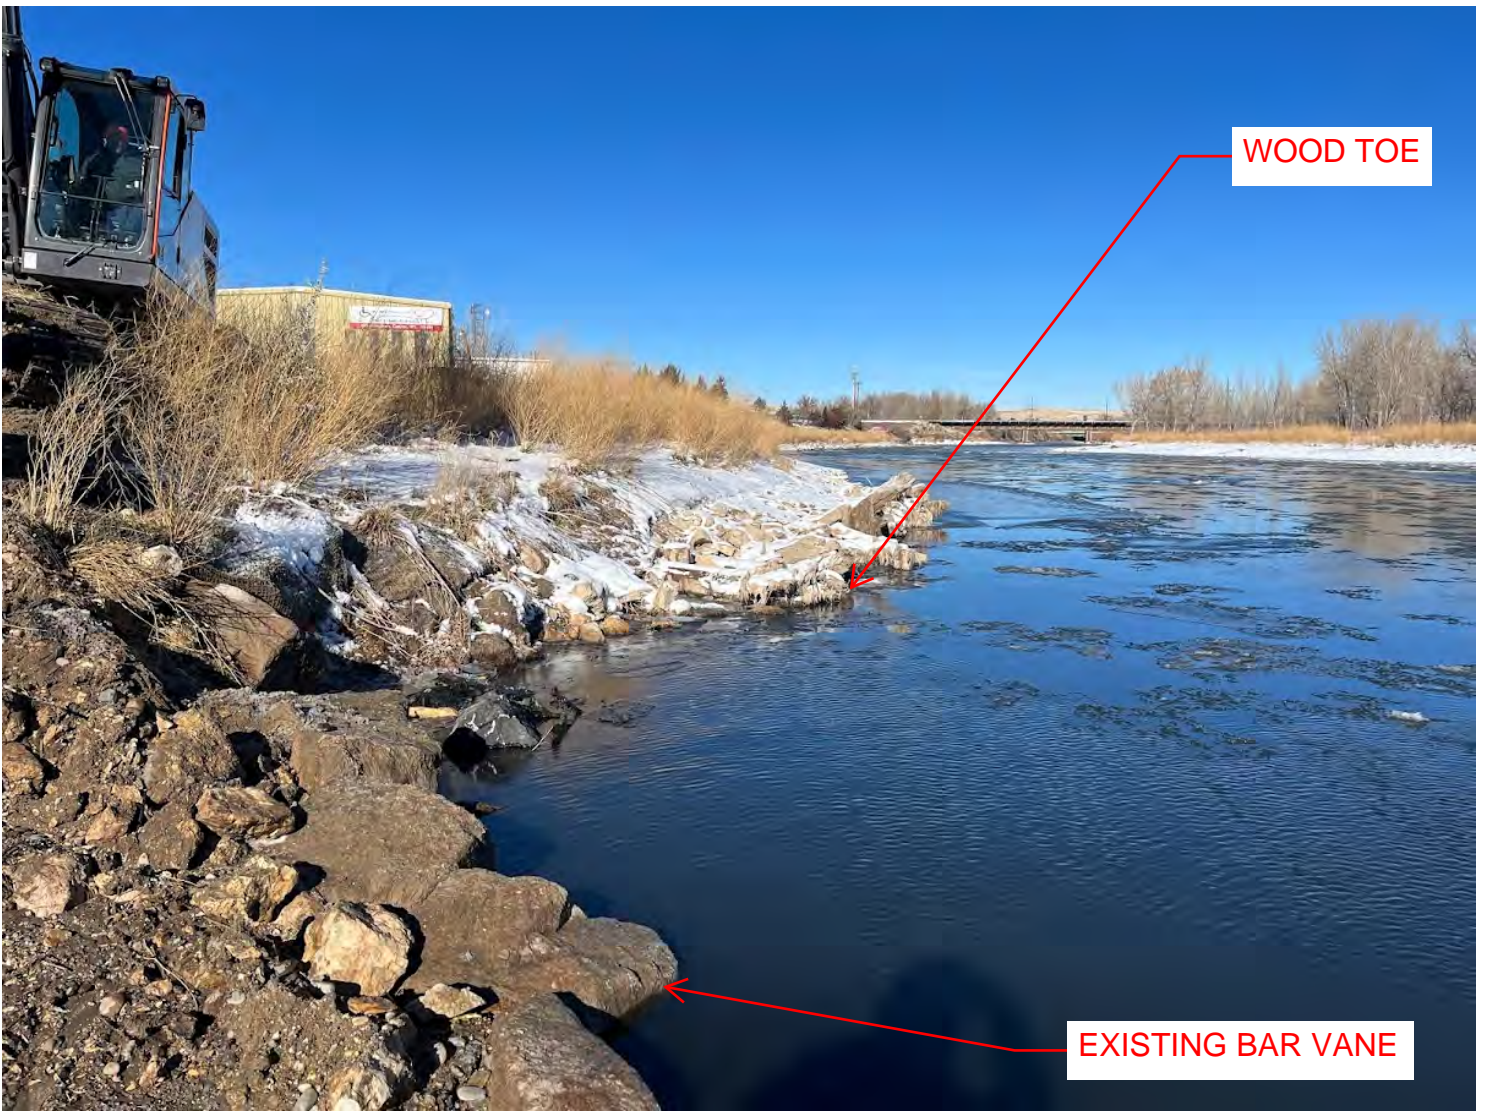
Figure 1: Prior to repair work. Image is taken on river left looking downstream. Erosion on bank can be seen between the existing bar vane and wood toe structures.

As a follow up to Stantec's site visit on April 21, 2022, warranty repair work was initiated on November 18, 2022 by Shamrock on the First Street Reach project. The purpose of this warranty work was to repair bank erosion along the left bank downstream of the First Street bridge just before the start of the wood toe previously installed during the initial construction work. This was achieved by placing approximately 20 large 2-3' diameter boulders repurposed from the nearest bar vane structure, along the toe of the bank extending upward matching the upstream bank slope. Boulder placement began at the furthest upstream log of the wood toe, extending 20 feet upstream. Larger boulders were placed at the toe and hammered into the streambed through the force of the excavator arm. Once the toe was set, smaller boulders were placed in a manner that fosters the transition from the upstream bank into the wood toe. The channel bed area impacted by boulder removal was regraded with existing channel bed material to maintain the existing channel bed grade, removing any localized depressions and material pile ups resulting from this activity. This work was observed by Stantec and documented through a series of photographs included in Appendix A. A more detailed description of the work completed is shown on the marked up As-Built Survey included in Appendix B.

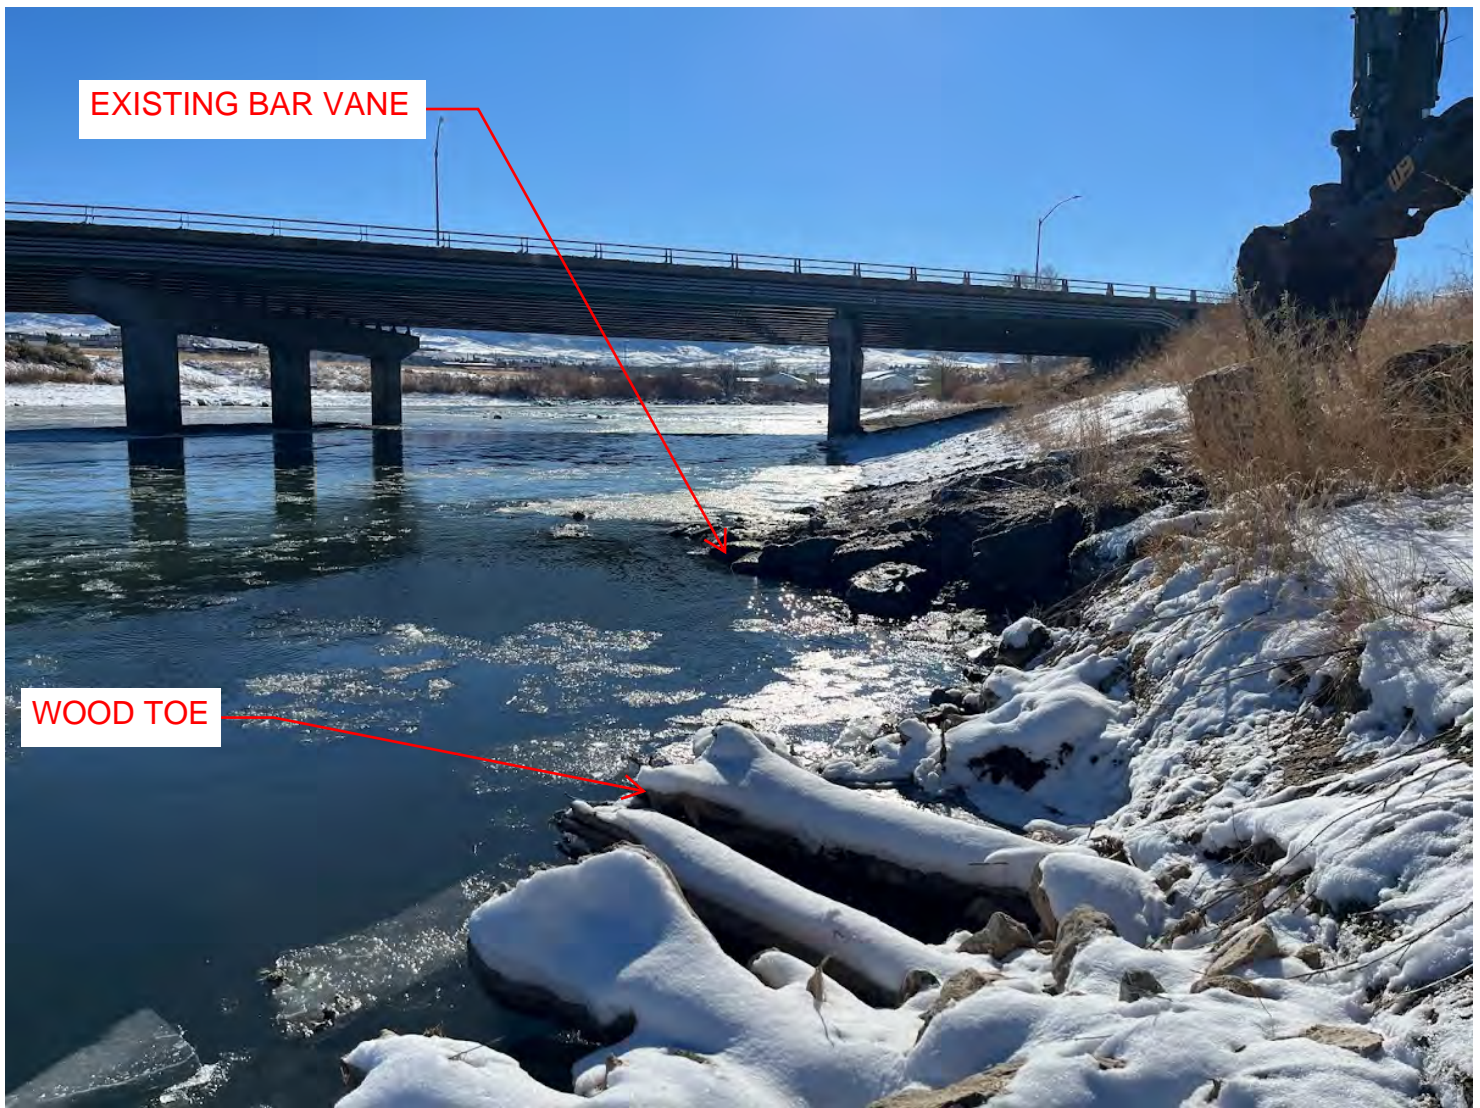
Figure 2: Prior to repair work. Image is taken on river left looking upstream. Erosion on bank can be seen between the existing bar vane and wood toe structures.

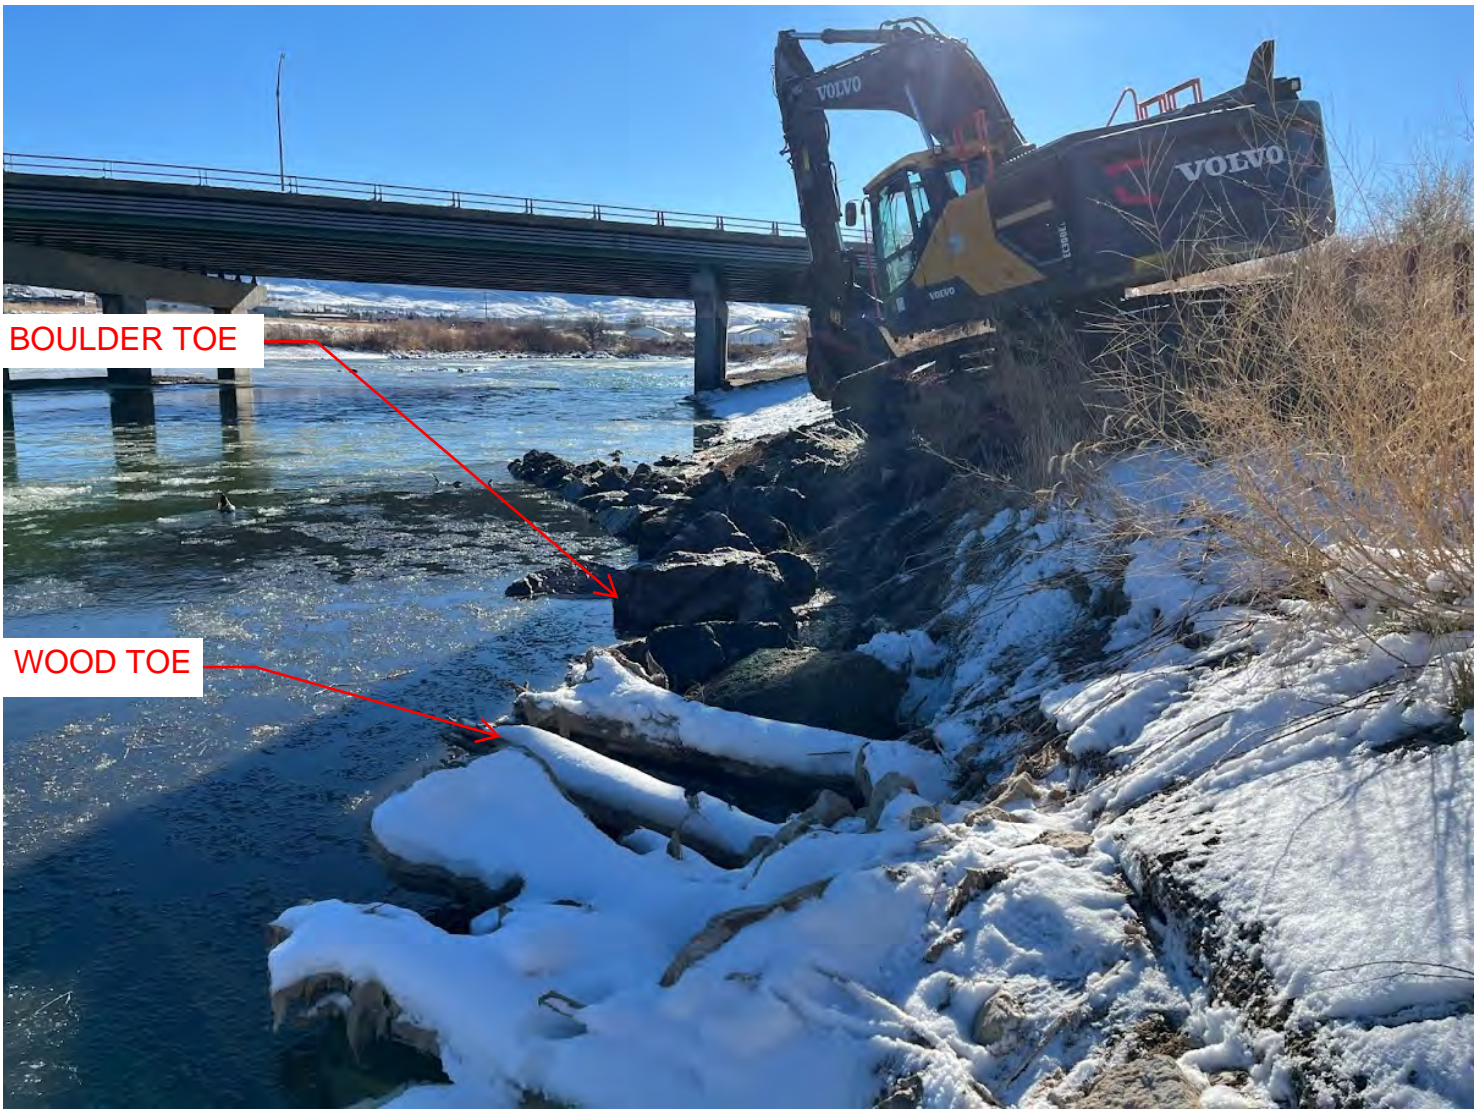
Figure 3: Image is taken on river left looking upstream. Setting boulder toe along area of bank erosion.

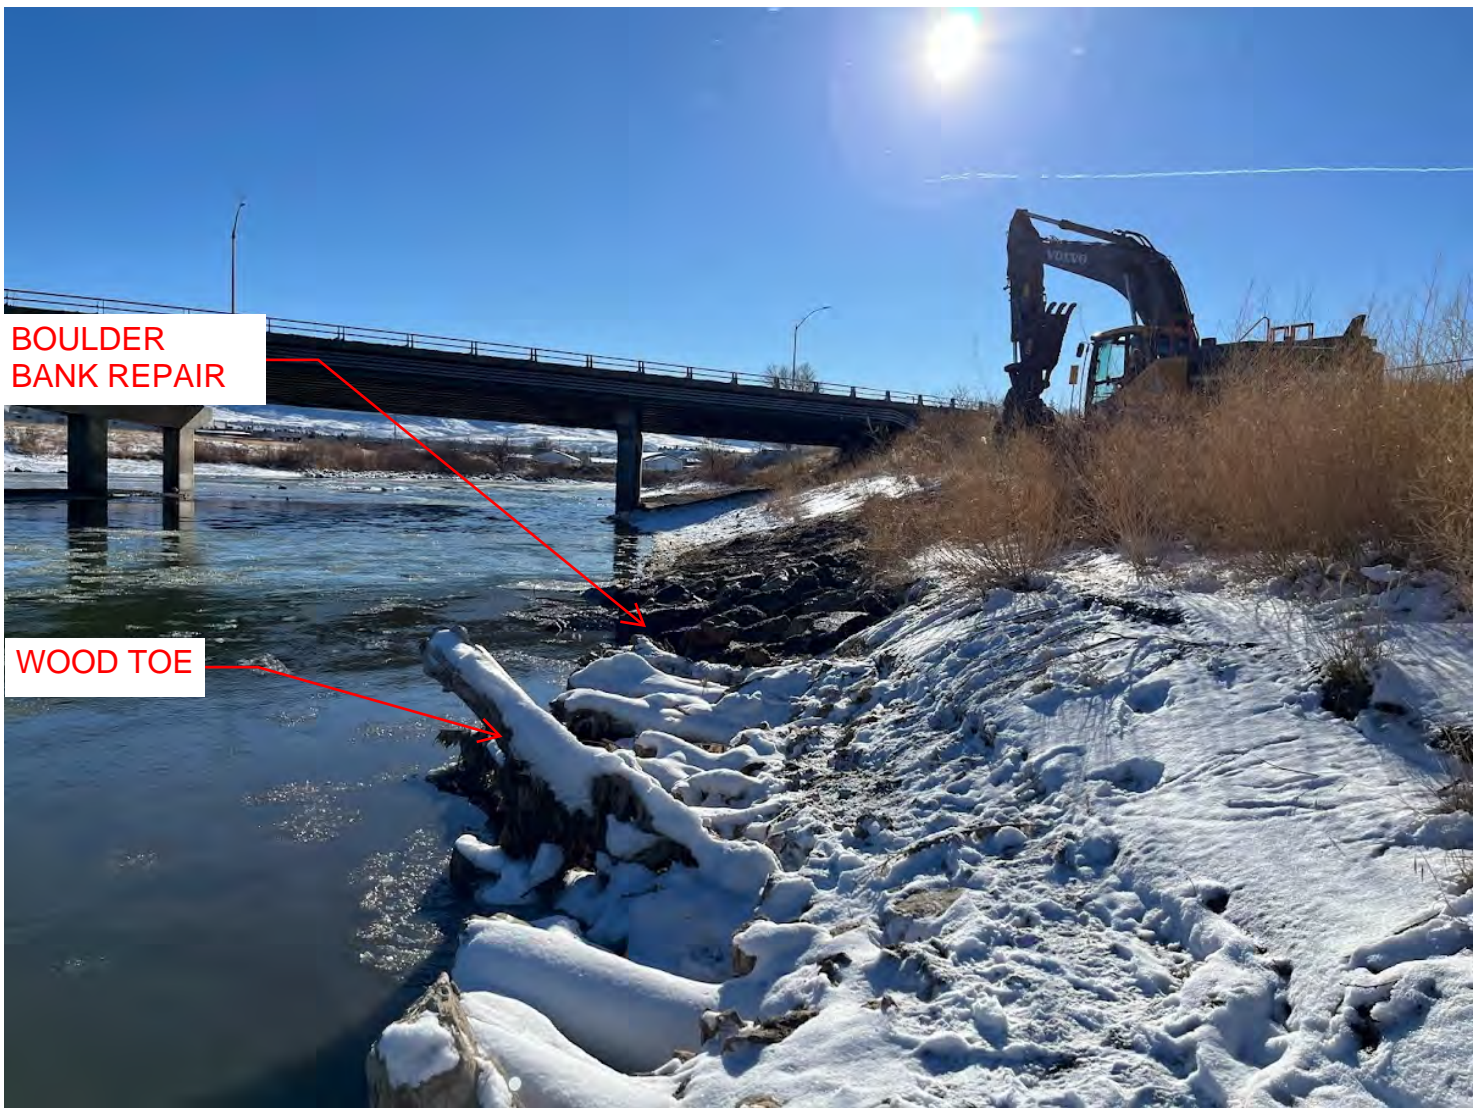
Figure 4: Image is taken on river left looking upstream. Finished product displaying the transition of the upstream bank into the wood toe.

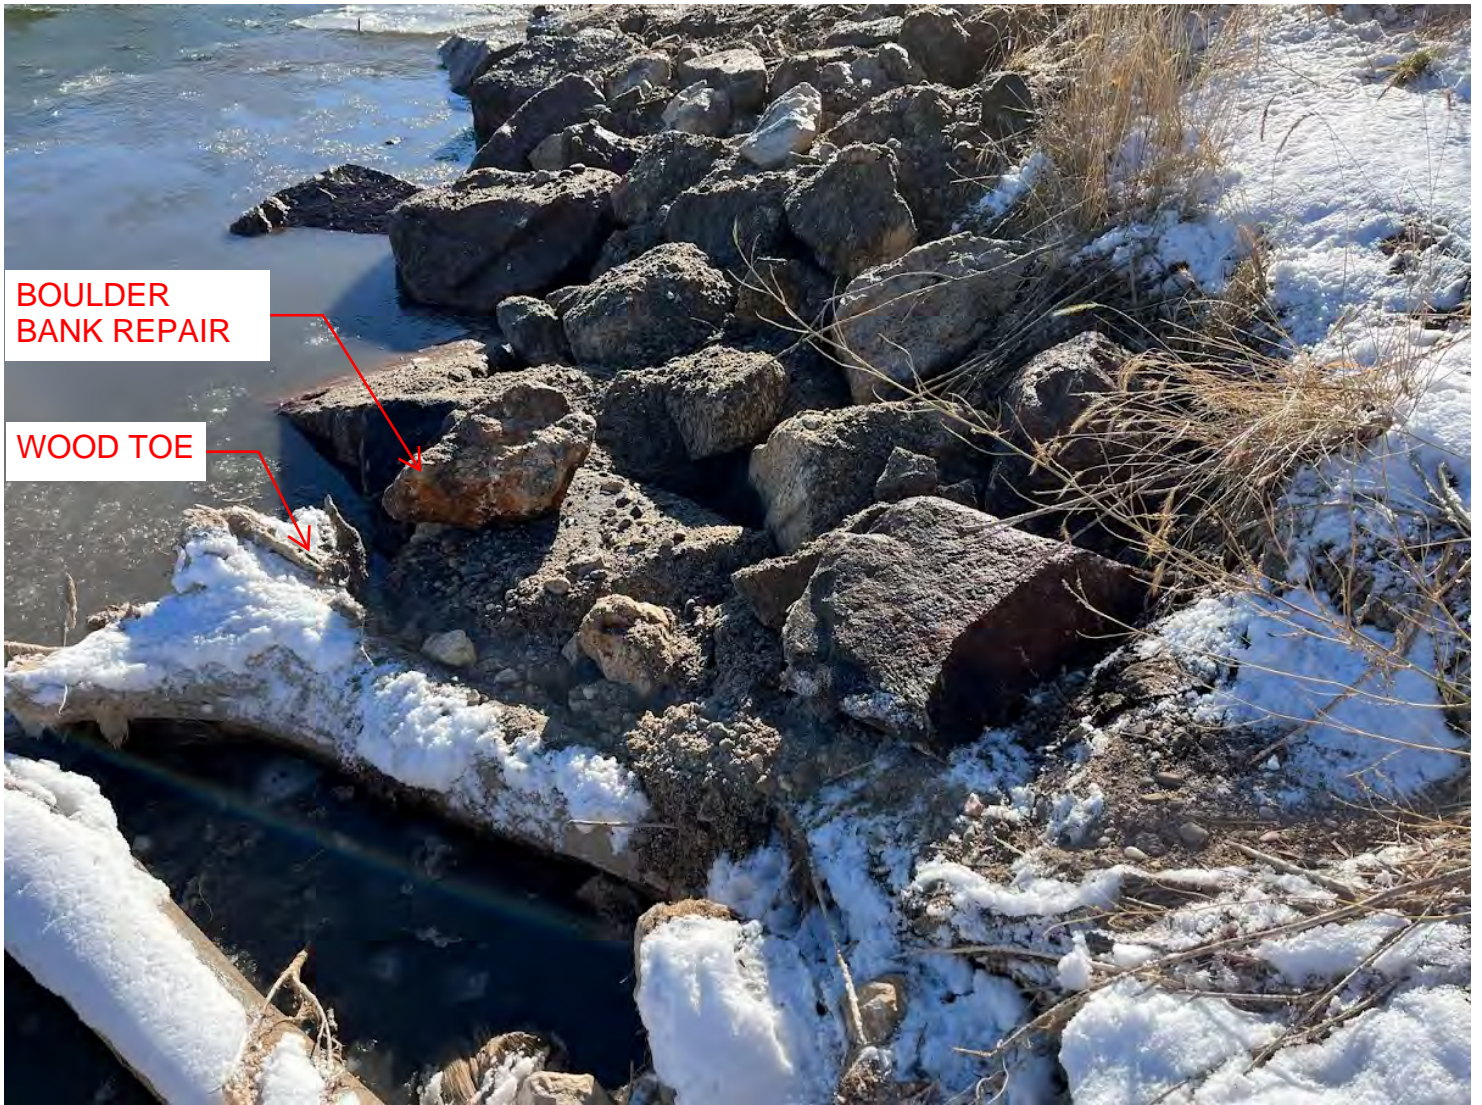
Figure 5: Boulder tie-in to wood toe structure.

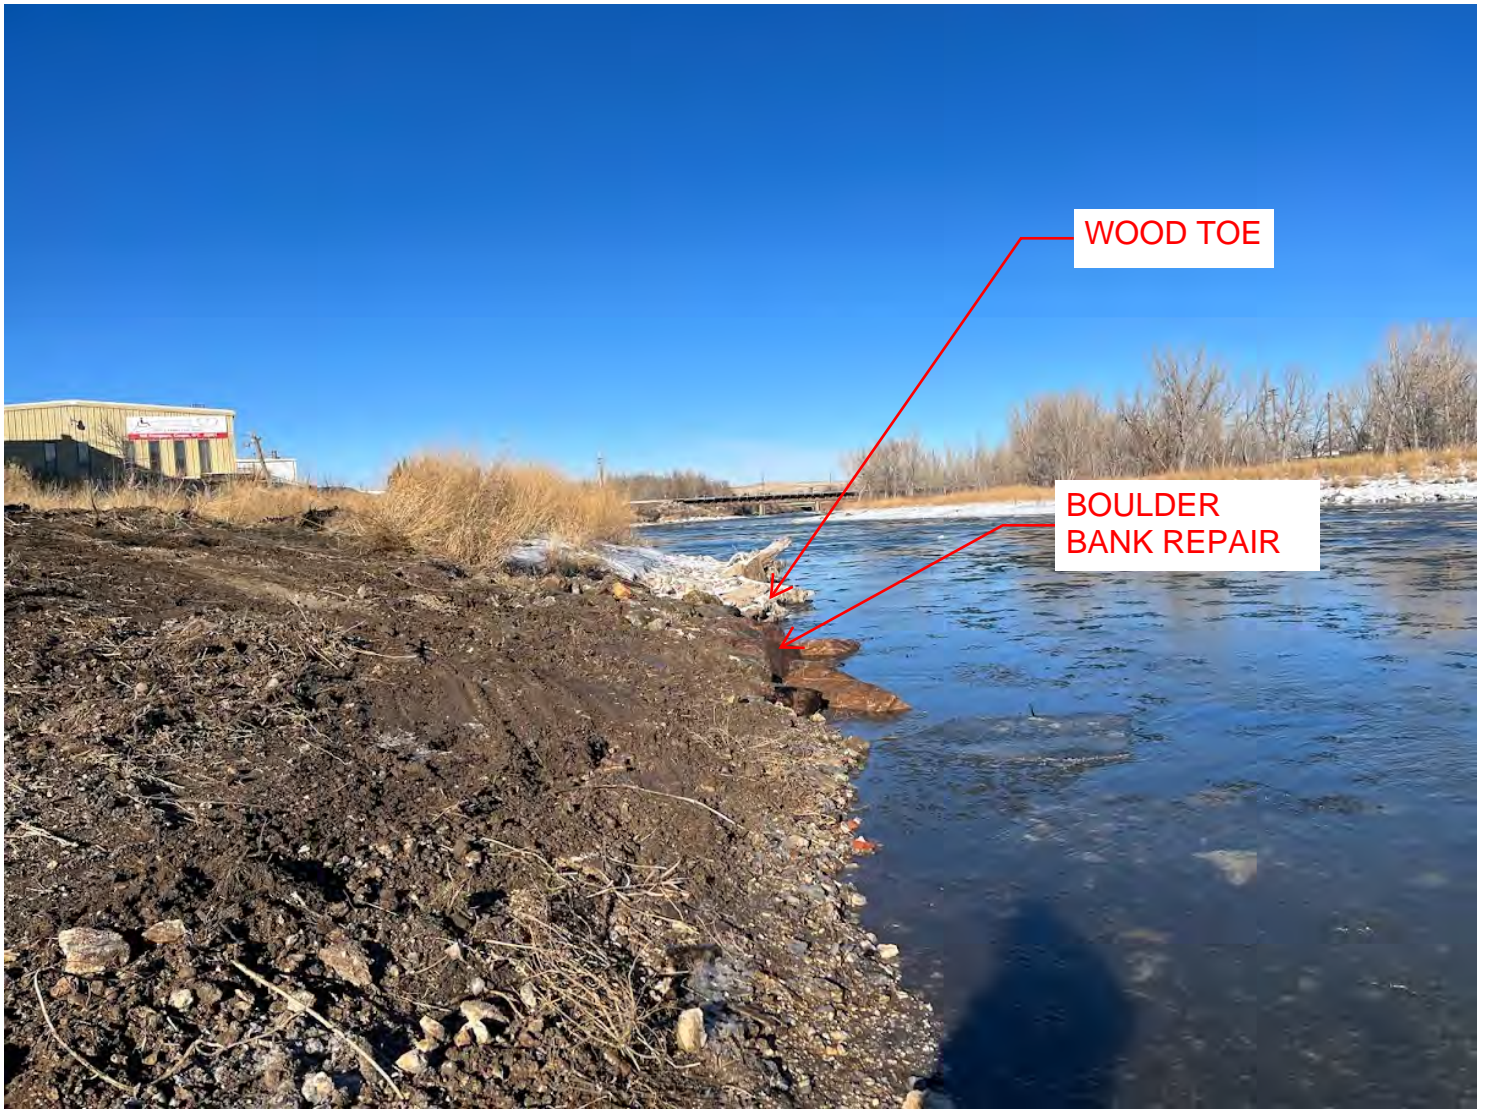
Figure 6: Image is taken on river left looking downstream. Finished product displaying the transition of the upstream bank into the wood toe.
