# Edge Engineering Group

## First Street Environmental Inspection and Report July 2022

| <b>Project:</b> First Street River Restoration | | <b>Owner:</b> City of Casper | |
| <b>Location:</b> North Platte River – Poplar Street Bridge to BNSF railroad Bridge | | | |

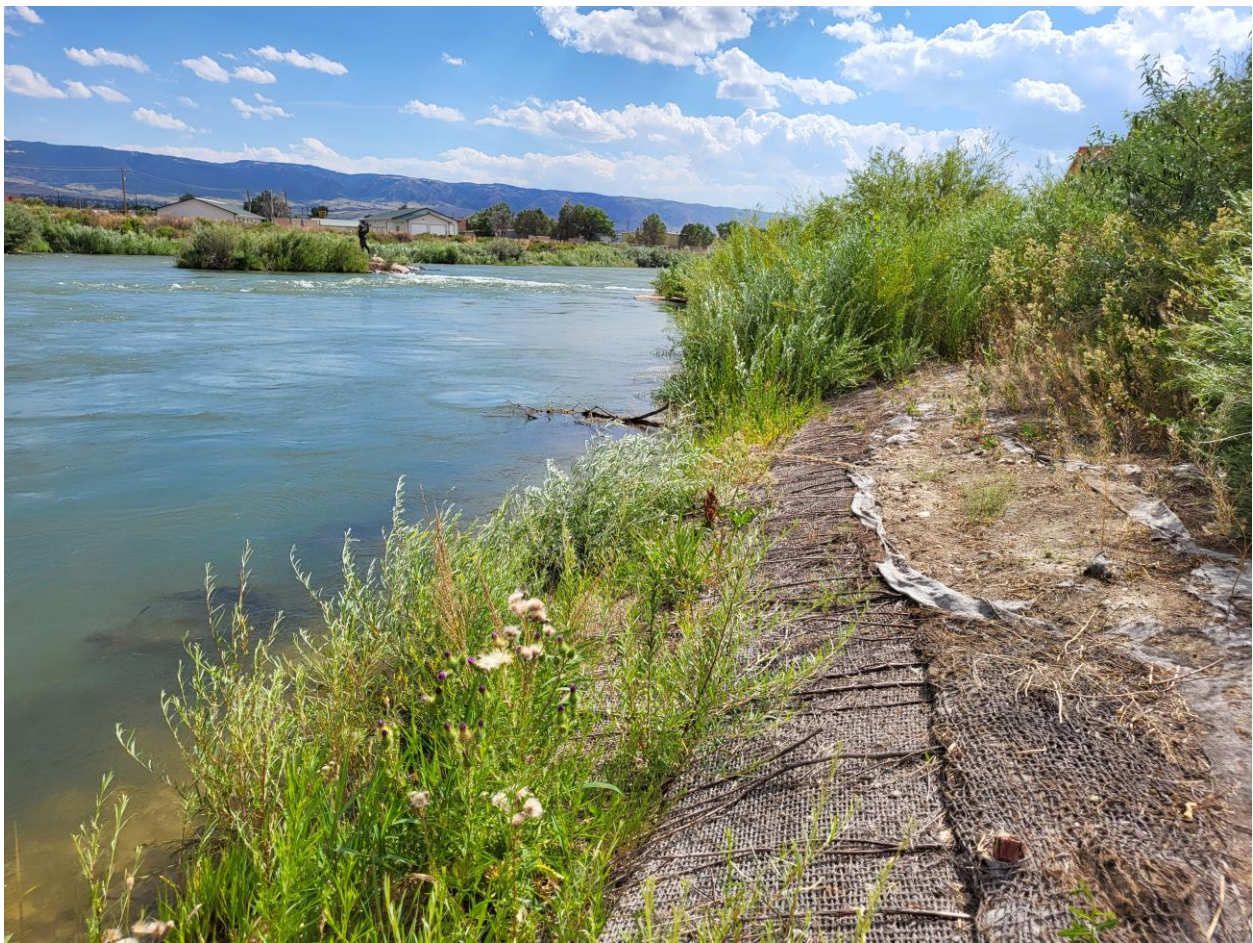
**Willow stakes in first burrito rap growing, willows in second burrito rap did not survive**

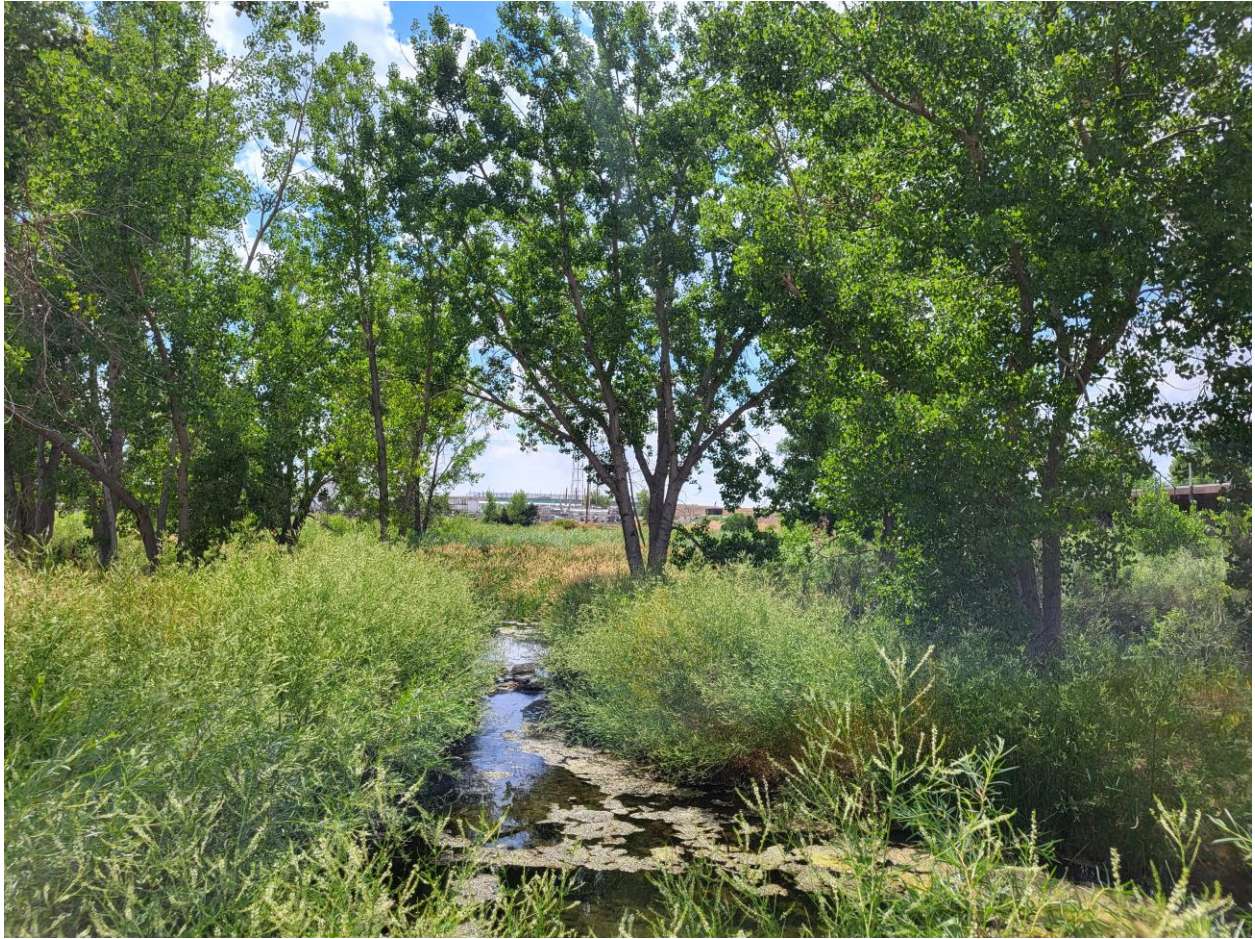
**Wetland at stormwater outlet – River right just south of BNSF Bridge**

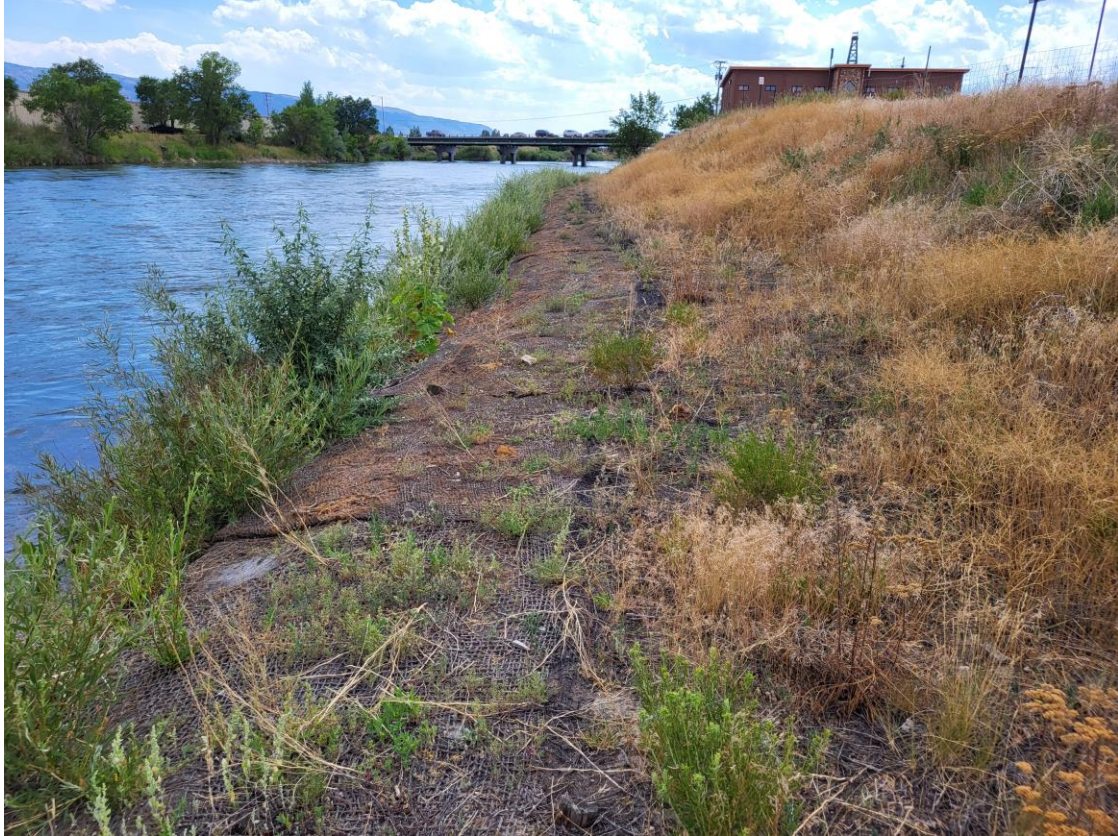
**River Left, Sta. 0+00 to 4+00. Willow stakes in first burrito established, second burrito rap willow stakes did not grow. Bench revegetation was approximately 20% coverage with the adjacent backslope at approximately 40 to 50% coverage.**

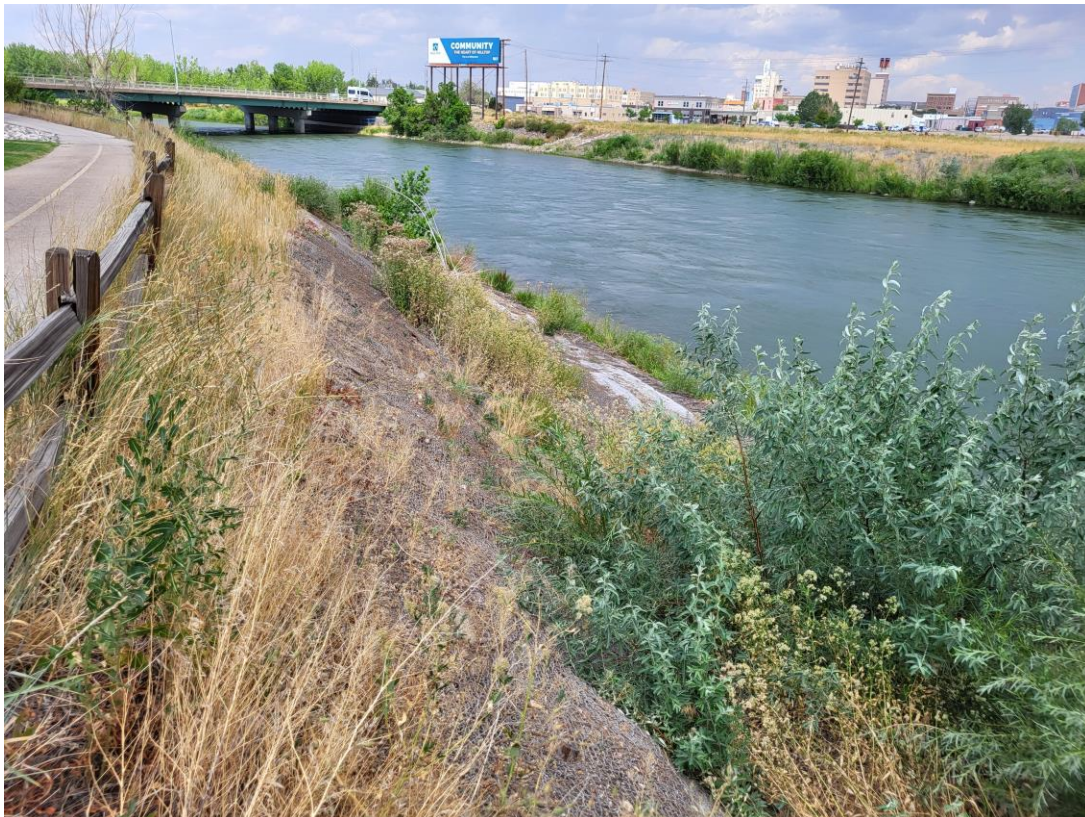
**River left sta 7+00 to first street bridge. Vegetation is approximately 30% coverage**

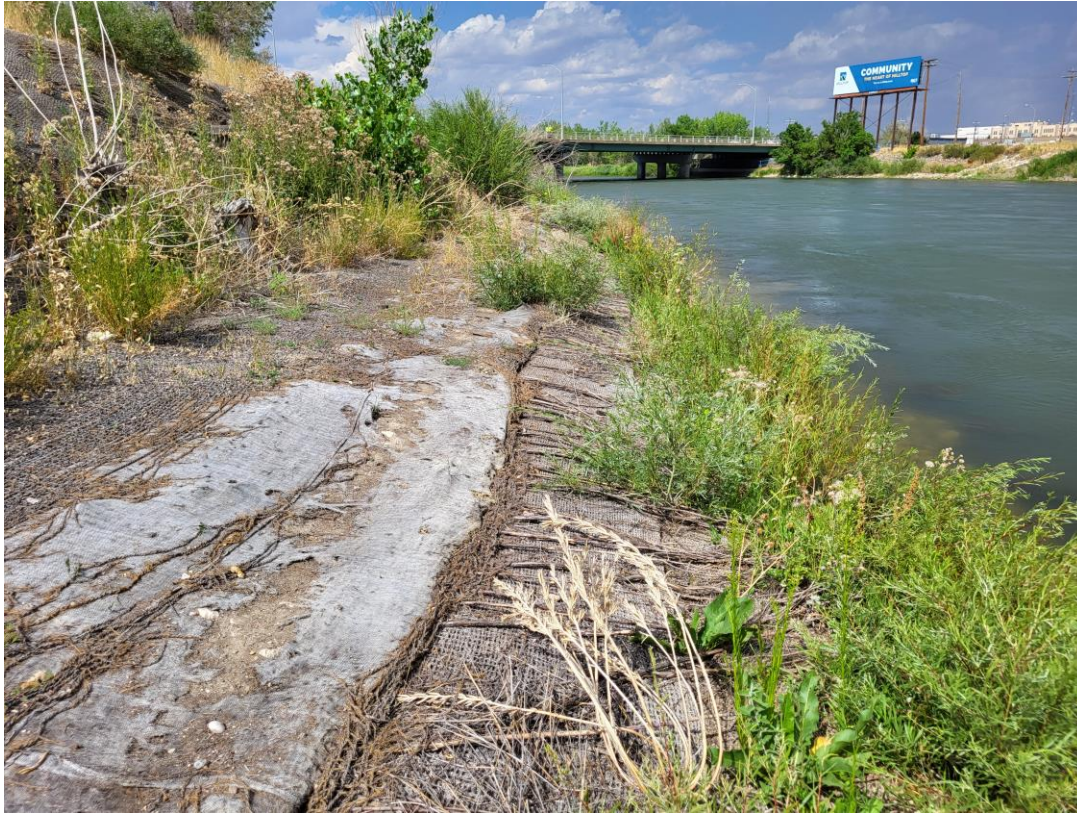
**River left sta 7+00 to first street bridge. Vegetation is approximately 30% coverage**

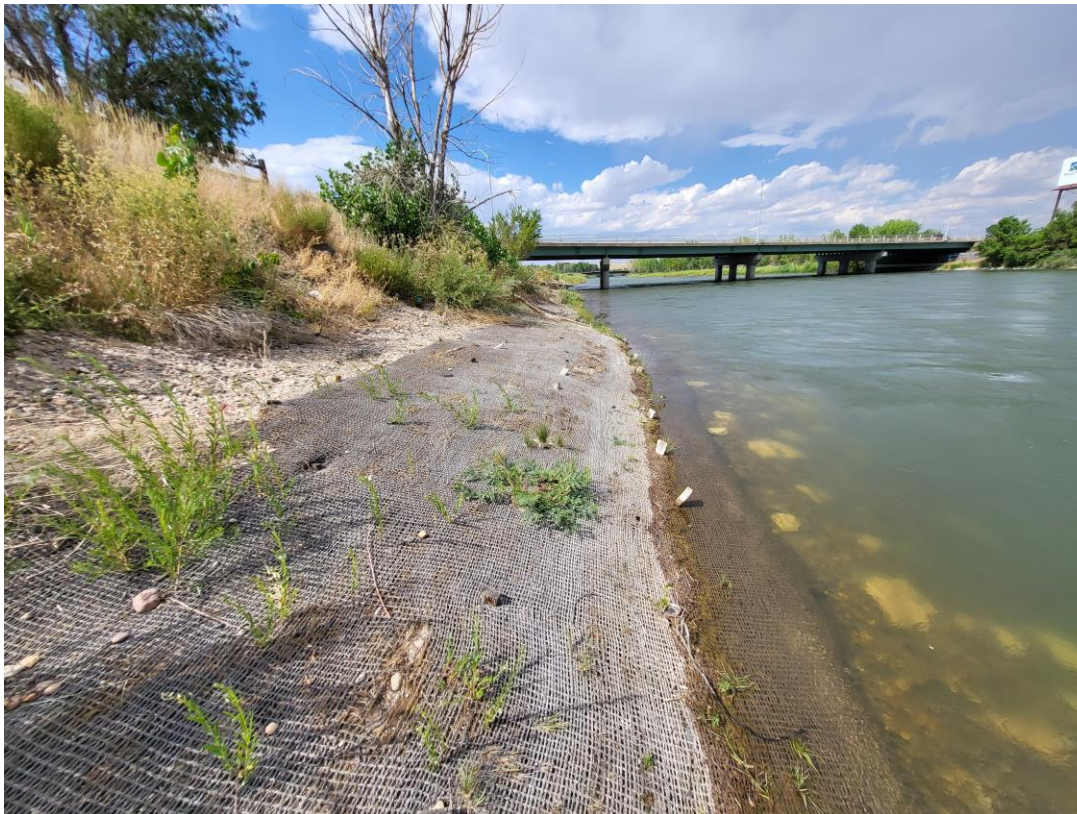
**River left sta 7+00 to first street bridge. Vegetation is approximately 30% coverage**

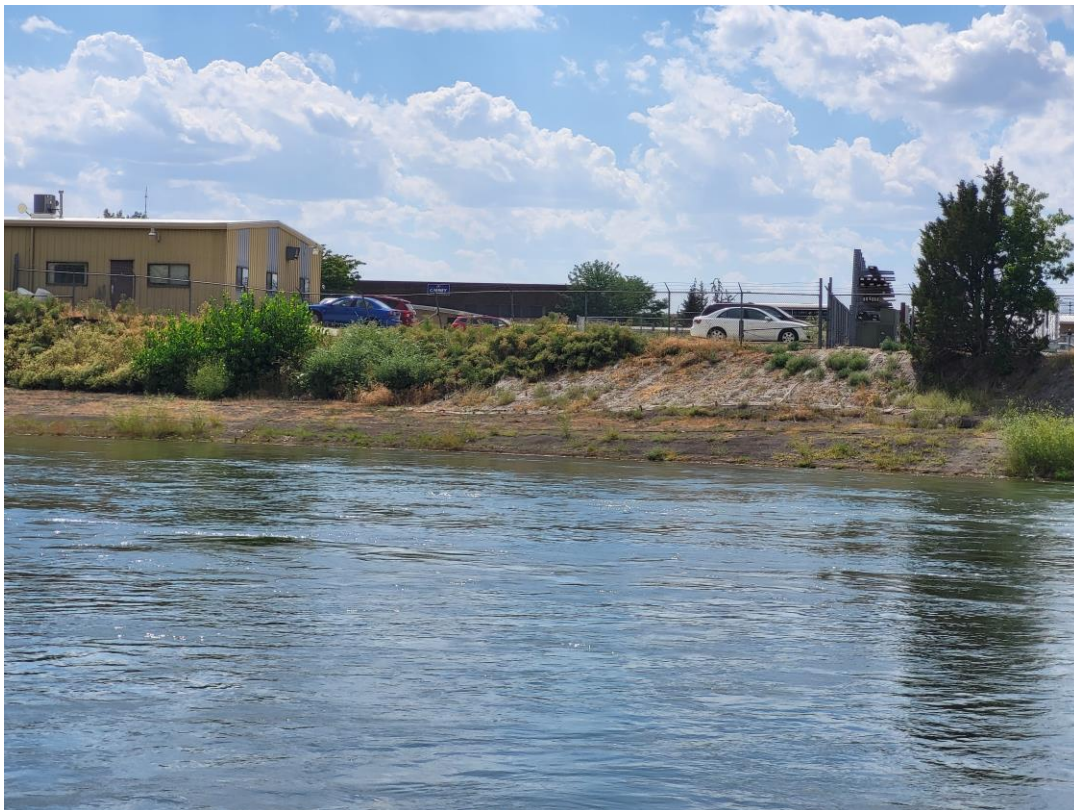
**River left from sta. 15+00 to 17+00, 10 to 20% coverage**

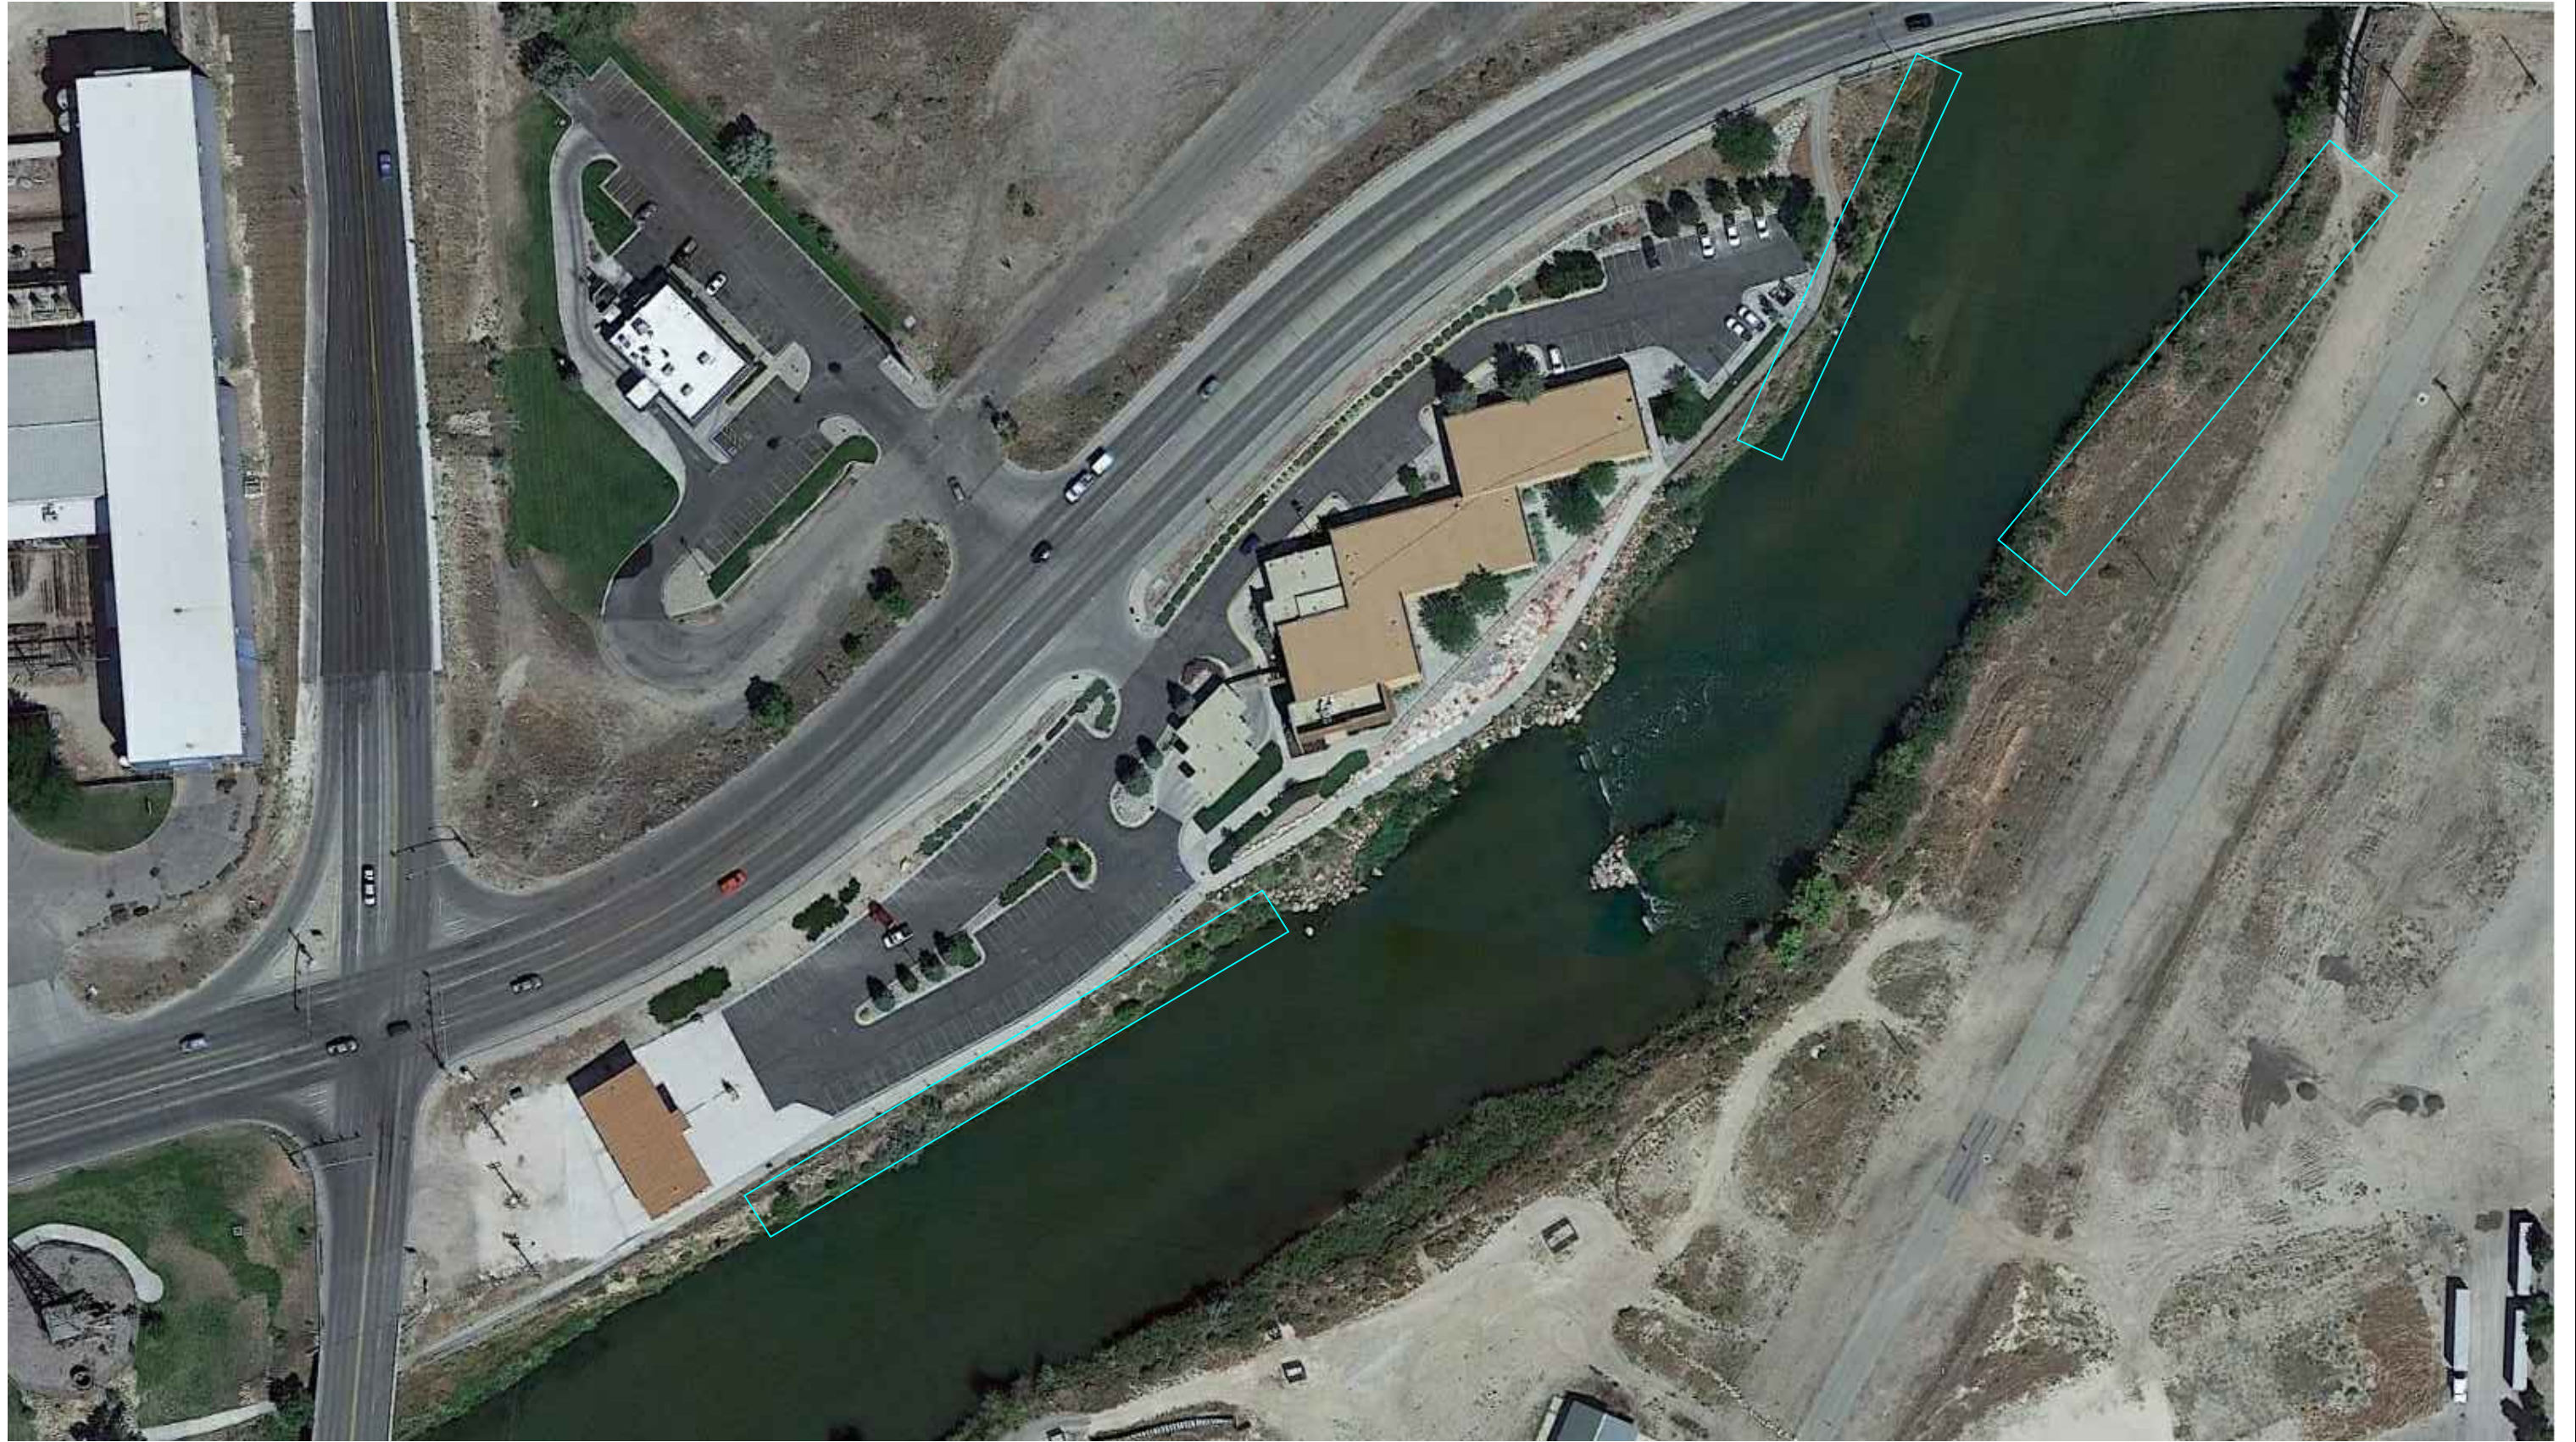
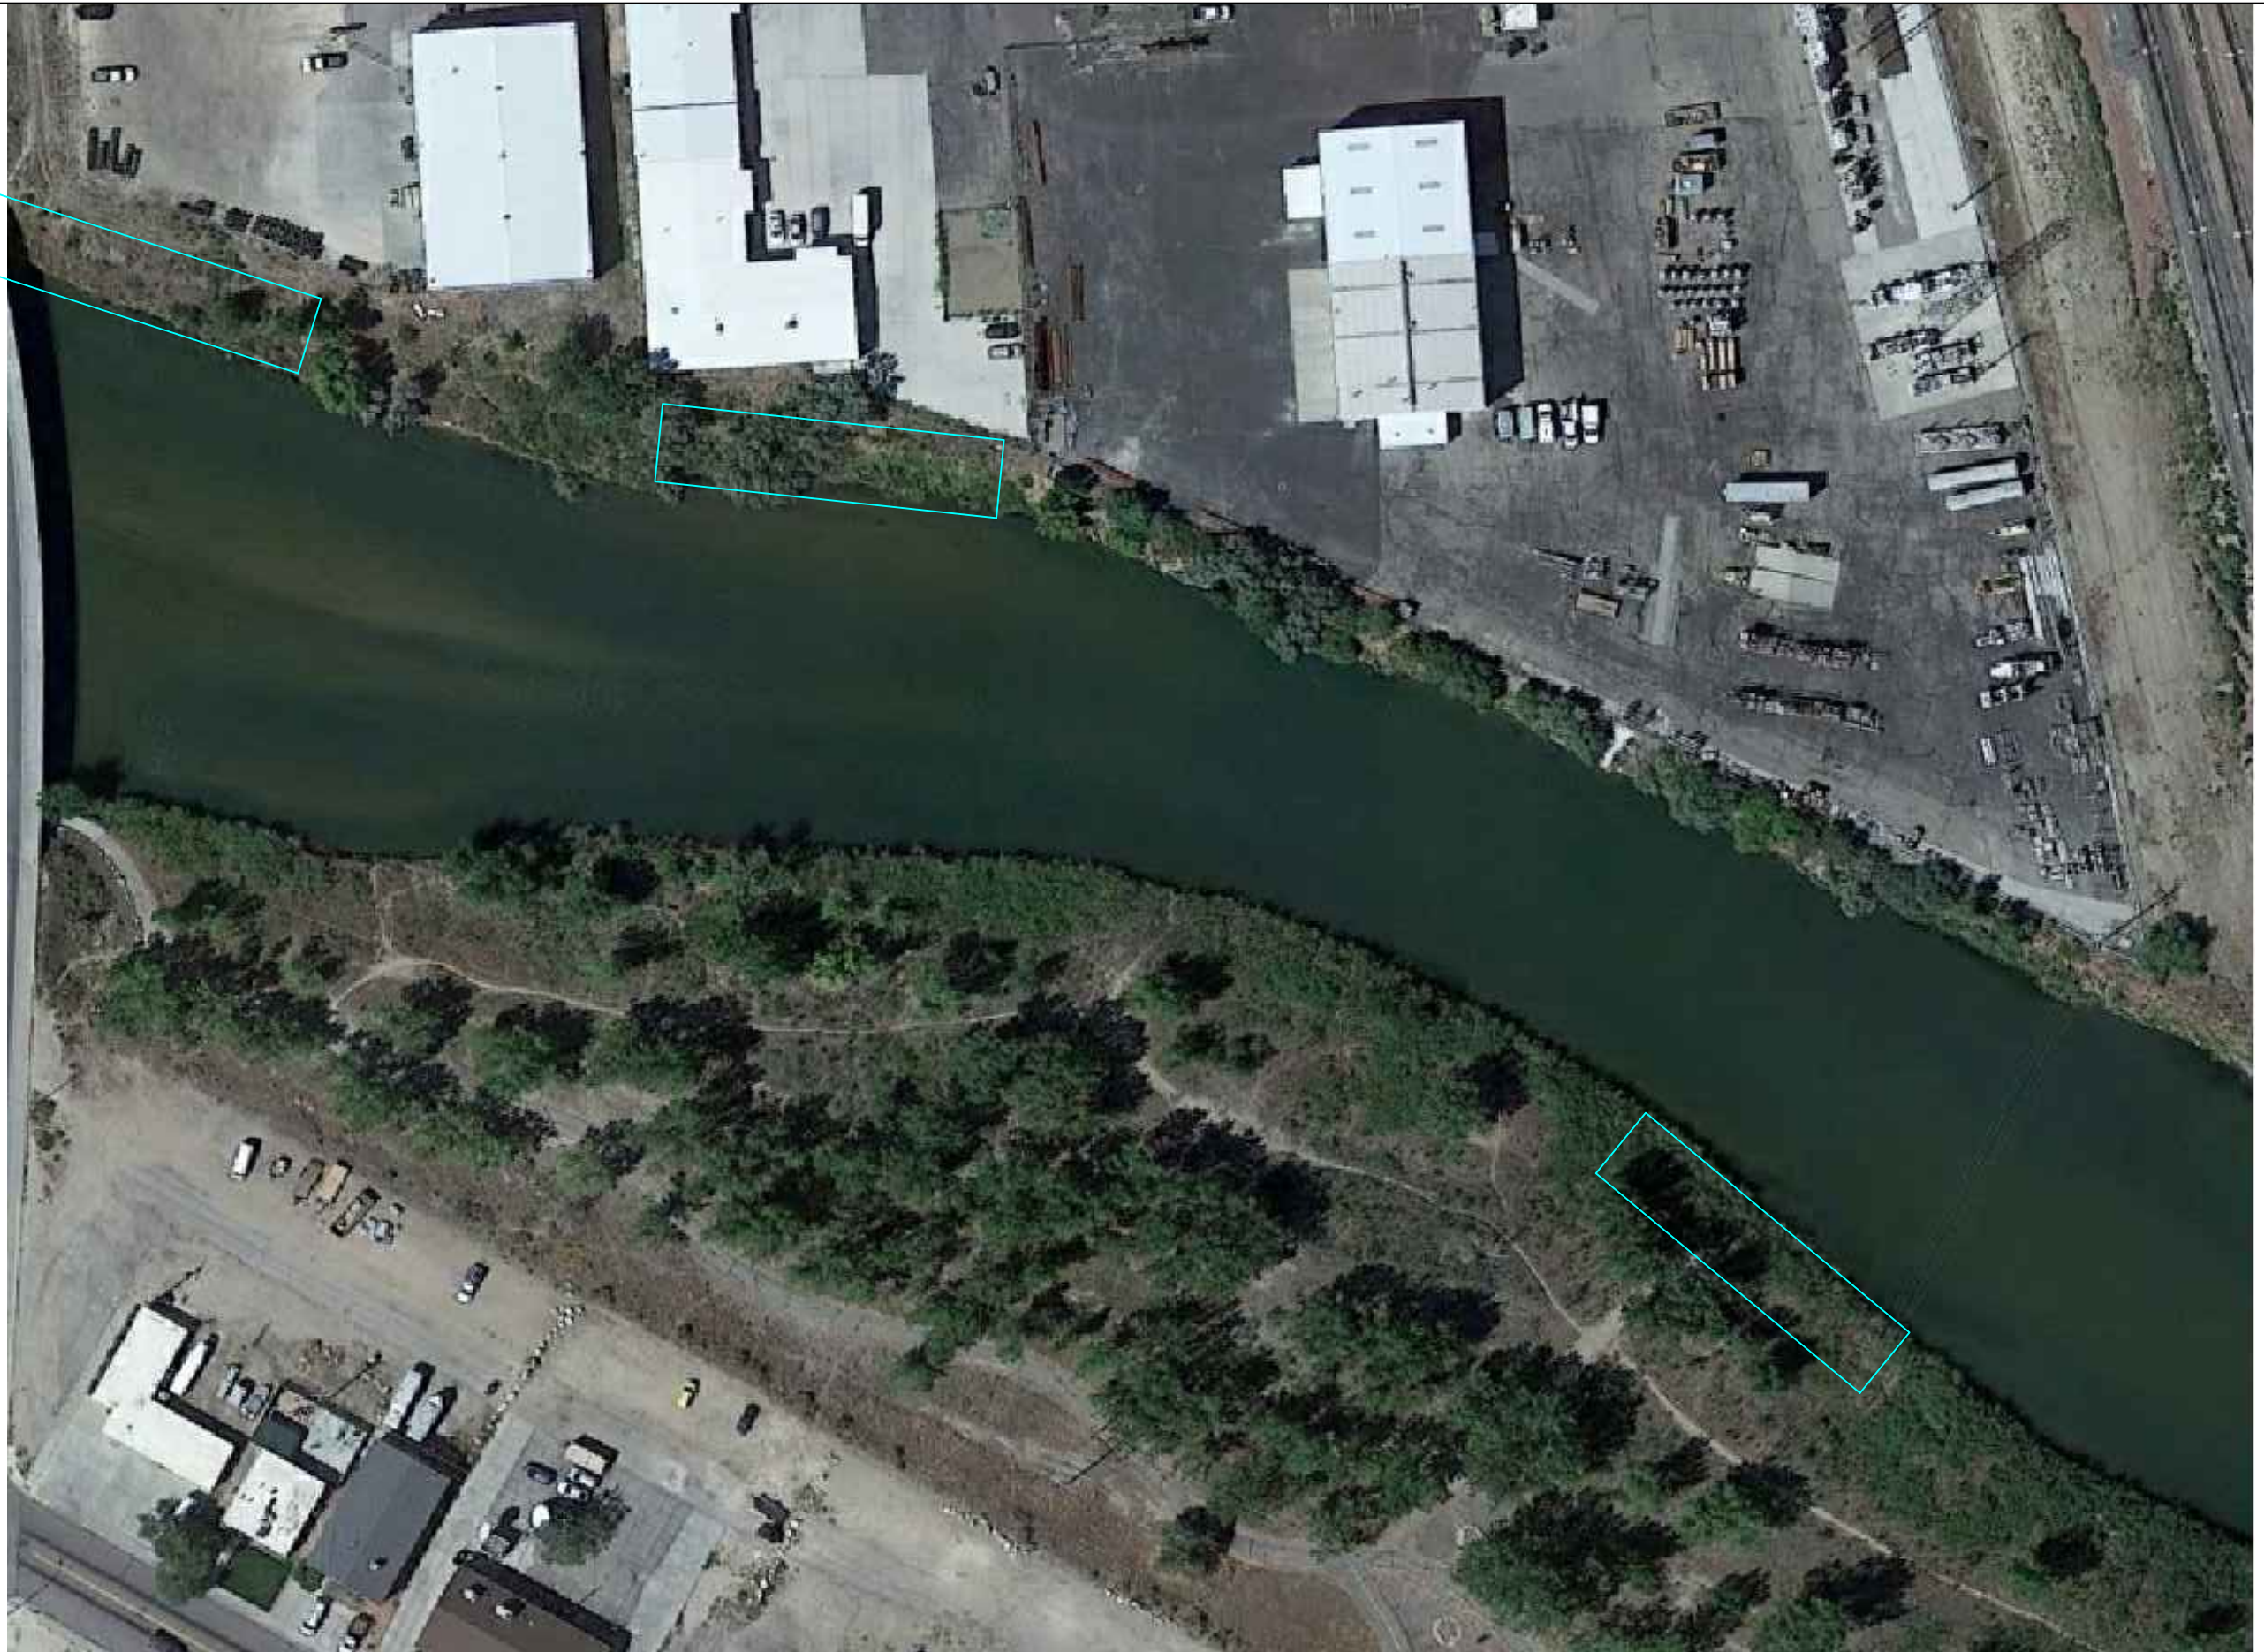
### NRRR FIRST STREET

Overall vegetation of the entire project site is approximately 50 to 60 percent coverage with large areas showing little to no growth. These areas are outlined on the attached maps. Of the areas where vegetation has occurred, the larger growth is consistent with weeds with some of the native grasses and plantings starting to grow under the canopy of the weeds.

- Reseed and replant in the areas outlined in the attached drawings.

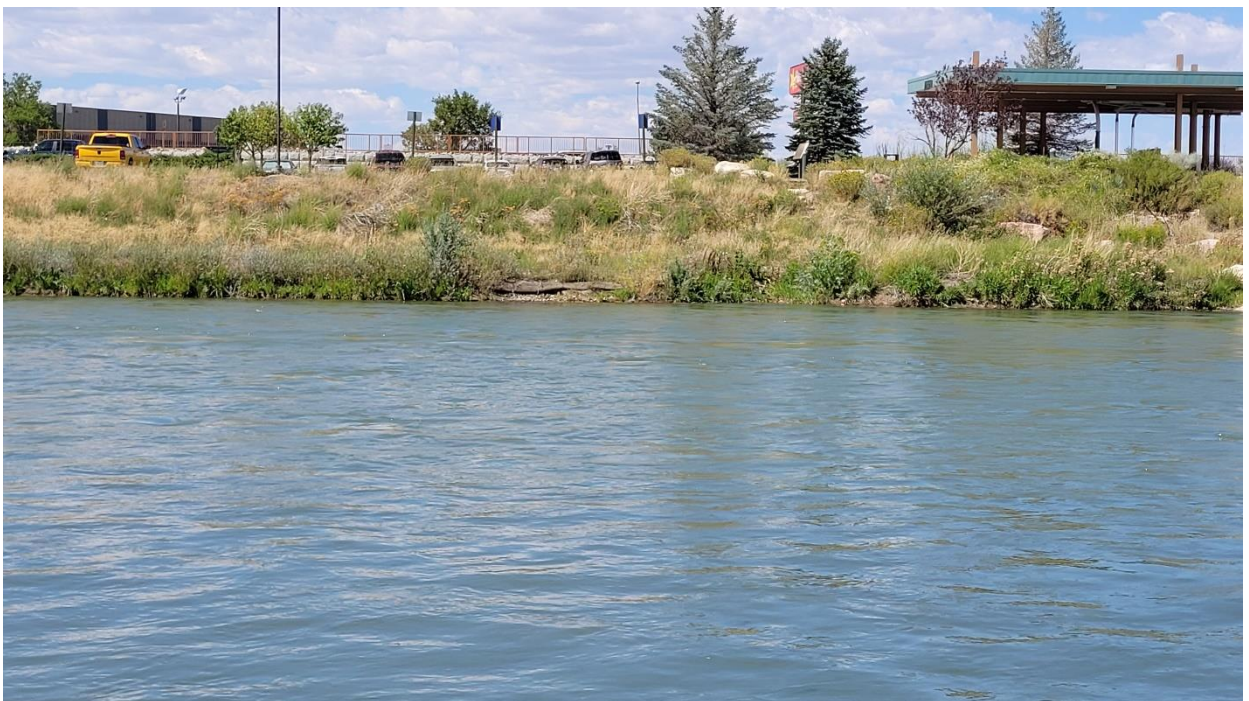
One area of potential bank erosion was noted river left, in the upper reaches of the project area, in the area of the Jonah Bank parking lot (See photo below). It was not clear if this is an artifact of vegetation regrowth, or due to bank erosion. Direct observation from the river left bank was not feasible due to good willow growth along the river edge, combined with the high river stage that did not allow for access to the area. Recommend that this area be further evaluated during future inspections at times of lower river levels.

**Photo taken river right, looking across to Jonah Bank parking lot area. Note area of potential erosion along bank, just above river level. Due to good willow regrowth adjacent to river and lack of access due to river stage, closer observation was not possible. River level will be much lower next month for a closer inspection.**

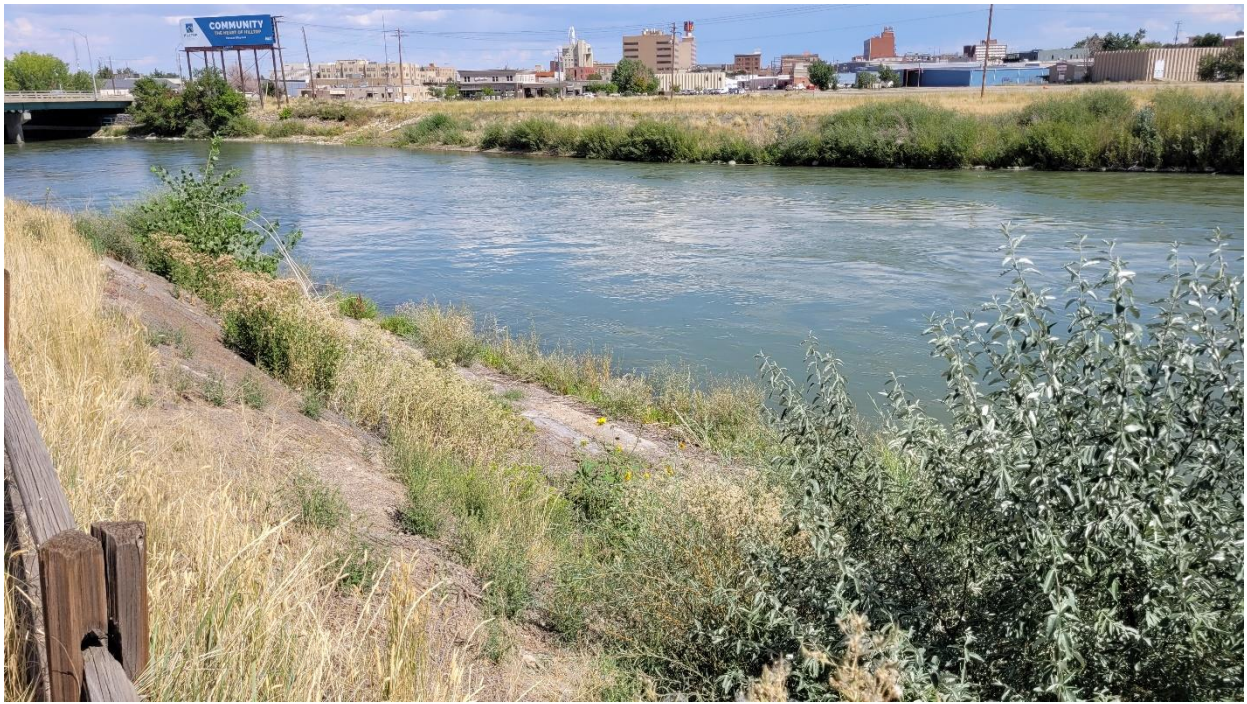
**Willow stakes in first burrito rap growing, willows in second burrito rap did not survive. View looking generally downstream, 1<sup>st</sup> Street Bridge in upper left of photo.**

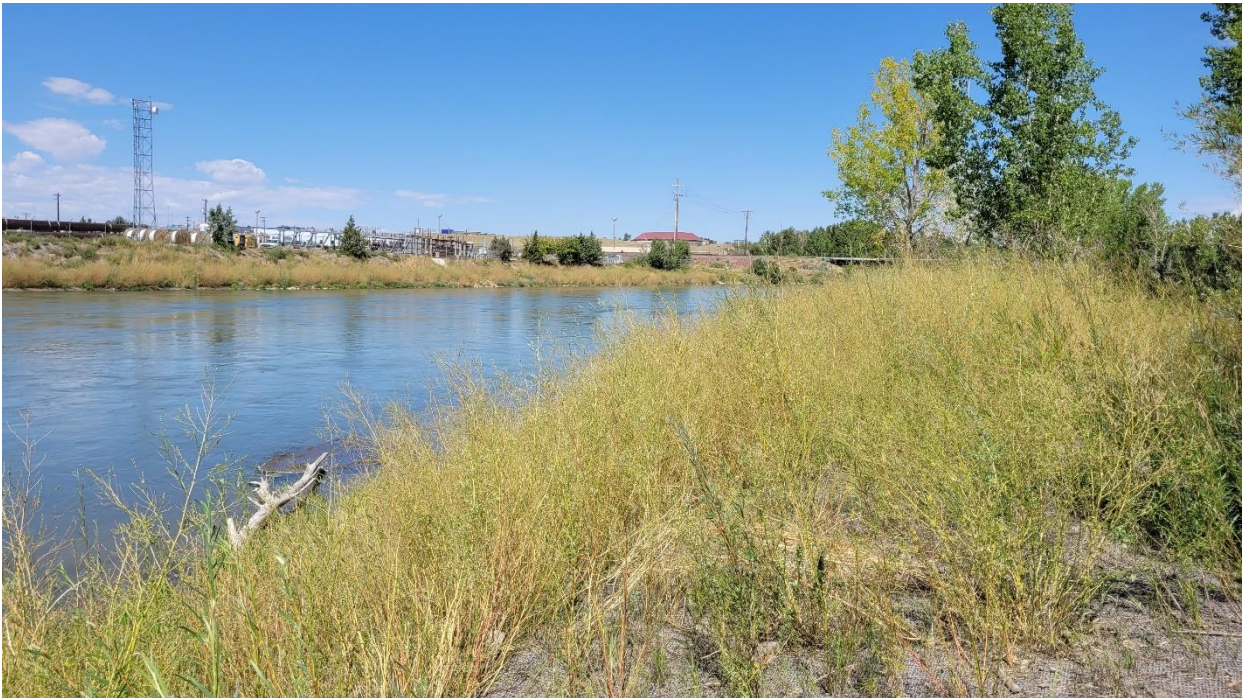
**Photo taken from river right looking generally downstream. Note BNSF bridge just visible in center right of photo. Note generally weedy appearance of much of the vegetation at this location.**

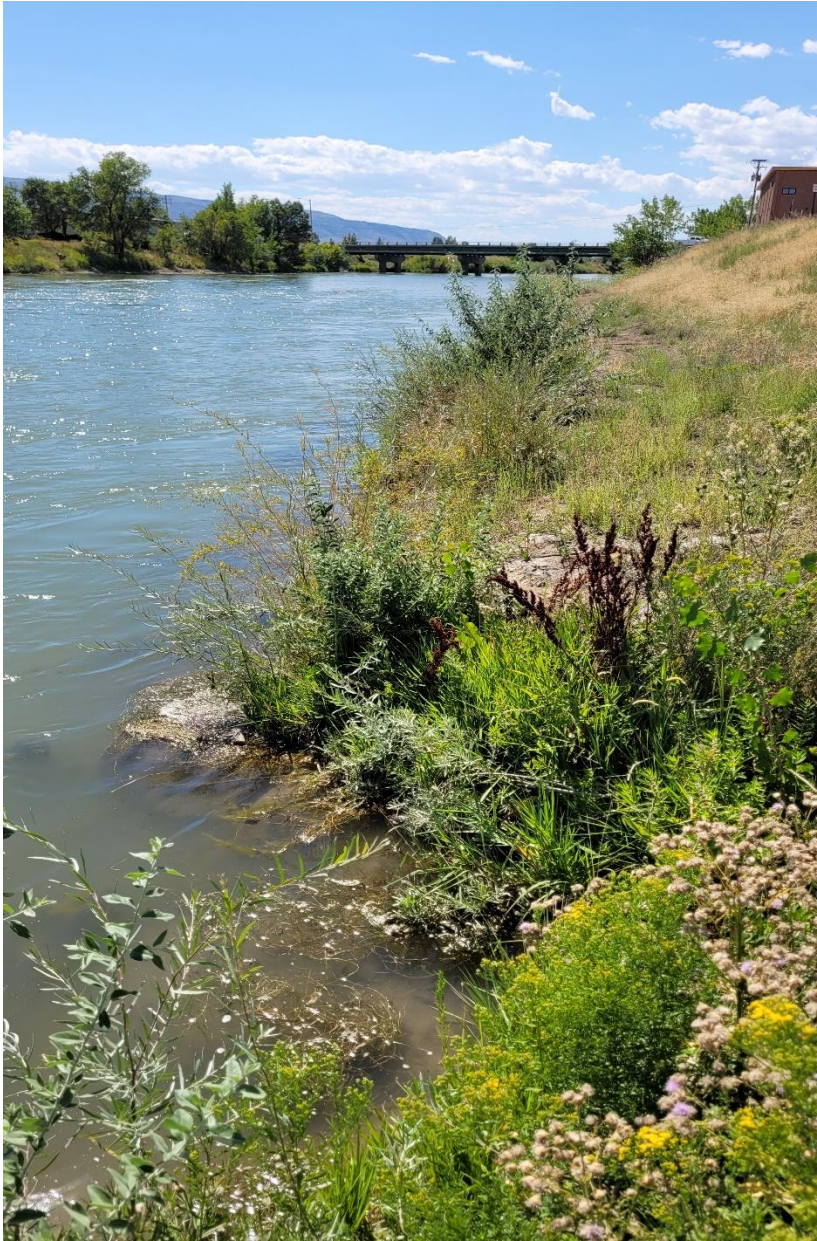
**River Left, looking upstream, 1<sup>st</sup> Street bridge in upper center of photo. Willow stakes in first burrito established, second burrito rap willow stakes did not grow.**

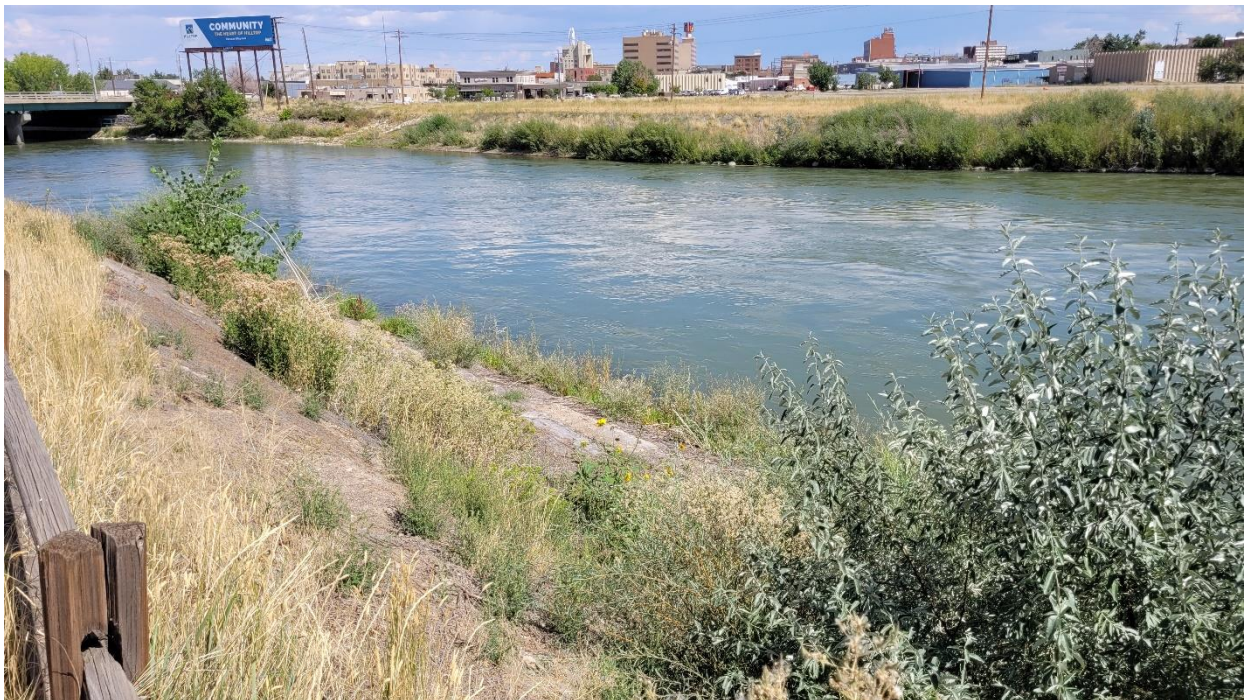
**River left, approximately sta 7+00, looking toward 1<sup>st</sup> Street bridge in upper left of photo. Vegetation is approximately 30% coverage.**

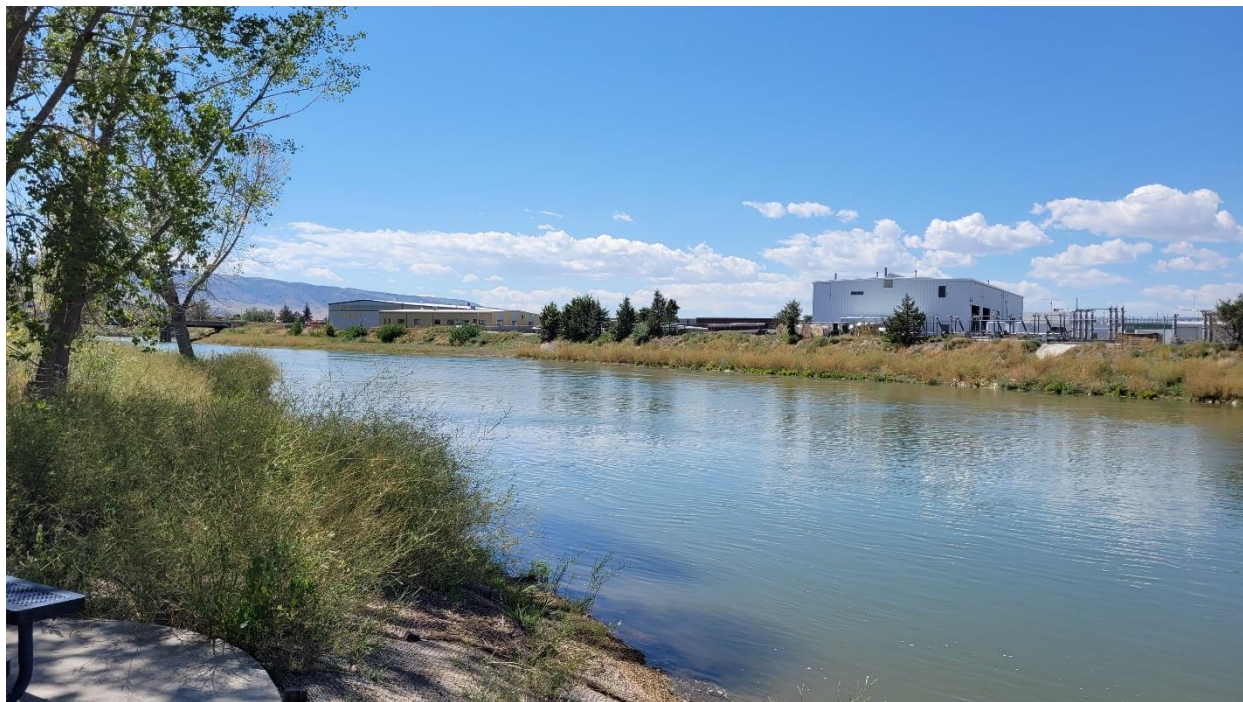
**River left from picnic table. Note decrease in vegetation in area of Goodyear building, left center of photo.**

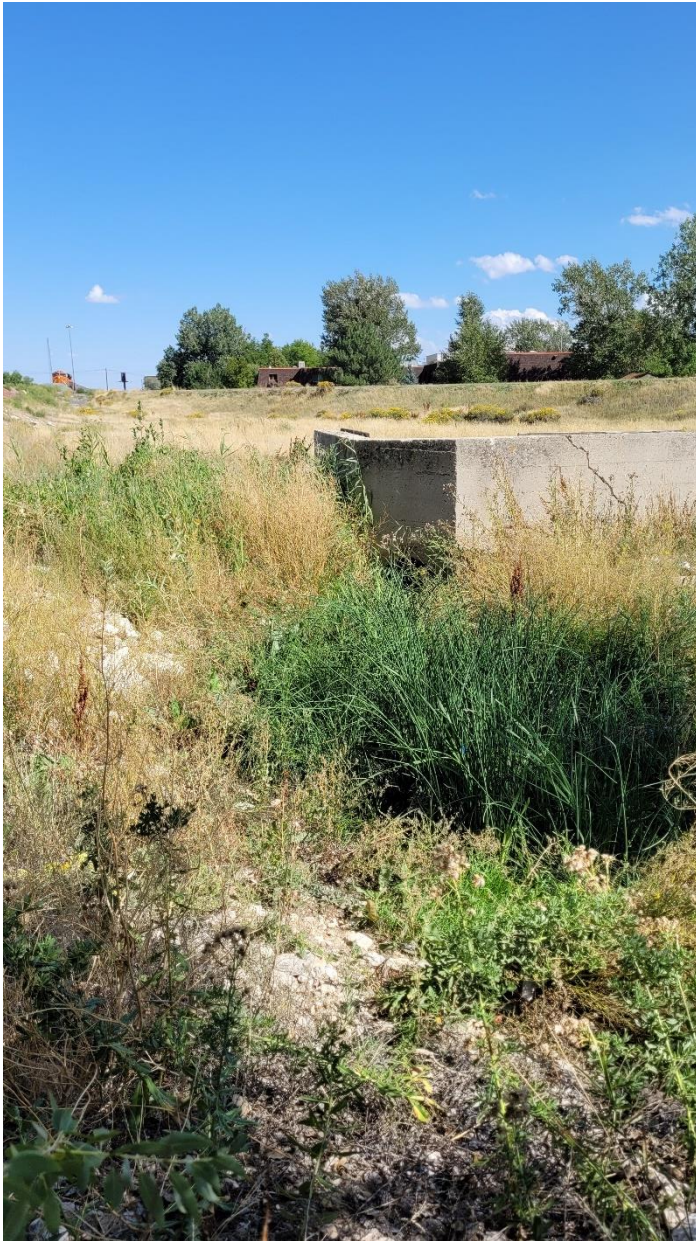
**Photo of drainage leading toward wetland from culvert. Culvert is in concrete face top right of photo.**

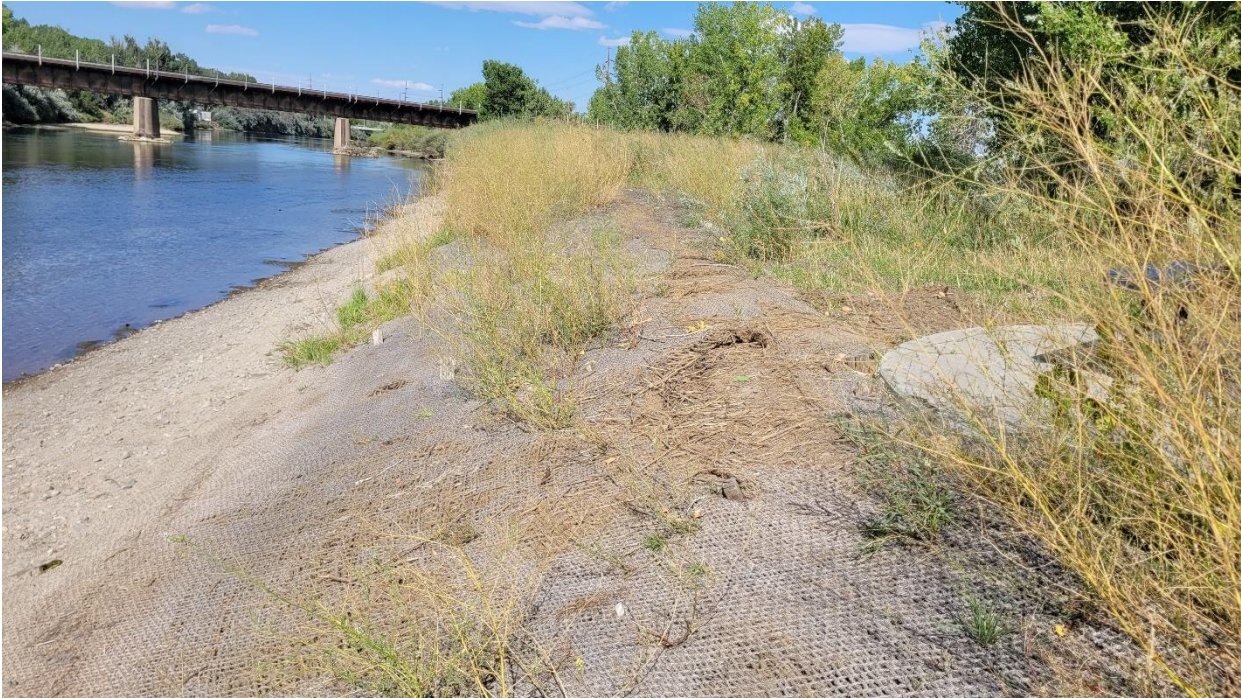
**Photo taken from river right looking generally downstream. Note BNSF bridge visible in upper left of photo, and picnic table in center right of photo behind vegetation. Note exposed stream bank due to low flow condition. Note generally weedy appearance of much of the vegetation at this location, and sparse coverage of vegetation in some areas.**

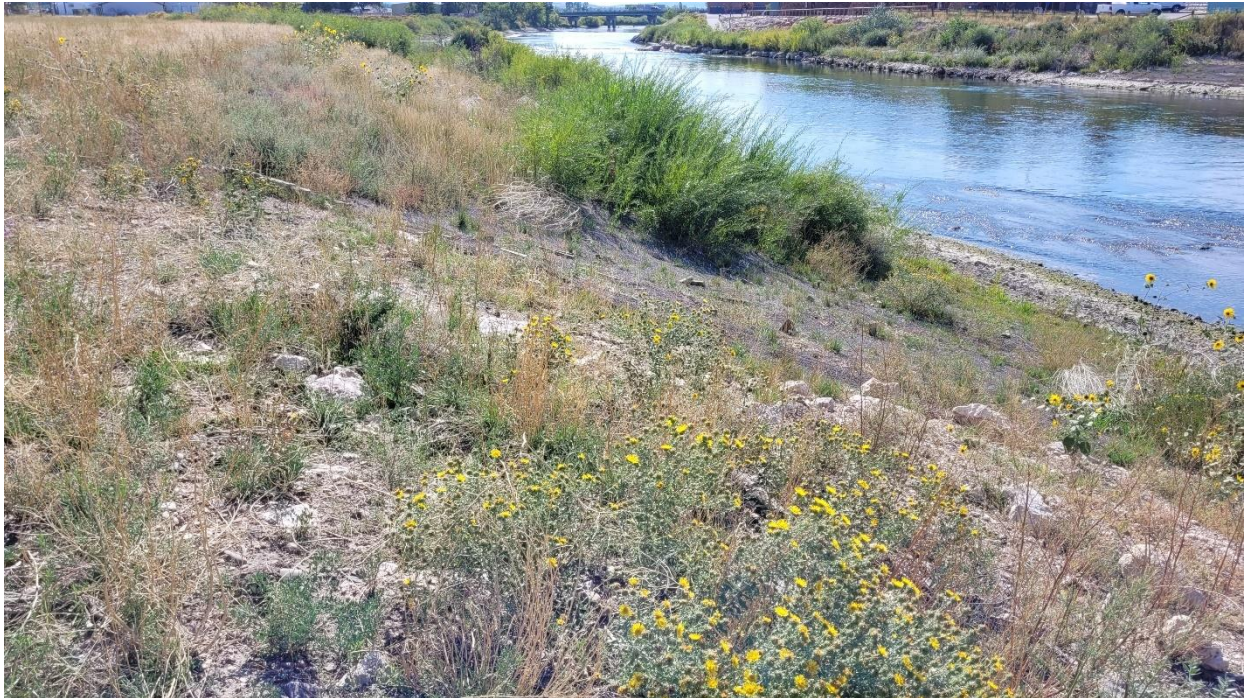
**Vegetation on construction access ramp is still sparse compared to area immediately upstream, adjacent to river. Note decrease in vegetation away from river upstream of construction access. View looking upstream from river right, Jonah Bank just visible in upper right of photo.**
