# Edge Engineering Group

## First Street Environmental Inspection and Report July 2022

| <b>Project:</b> First Street River Restoration | | <b>Owner:</b> City of Casper | |
| <b>Location:</b> North Platte River – Poplar Street Bridge to BNSF railroad Bridge | | | |

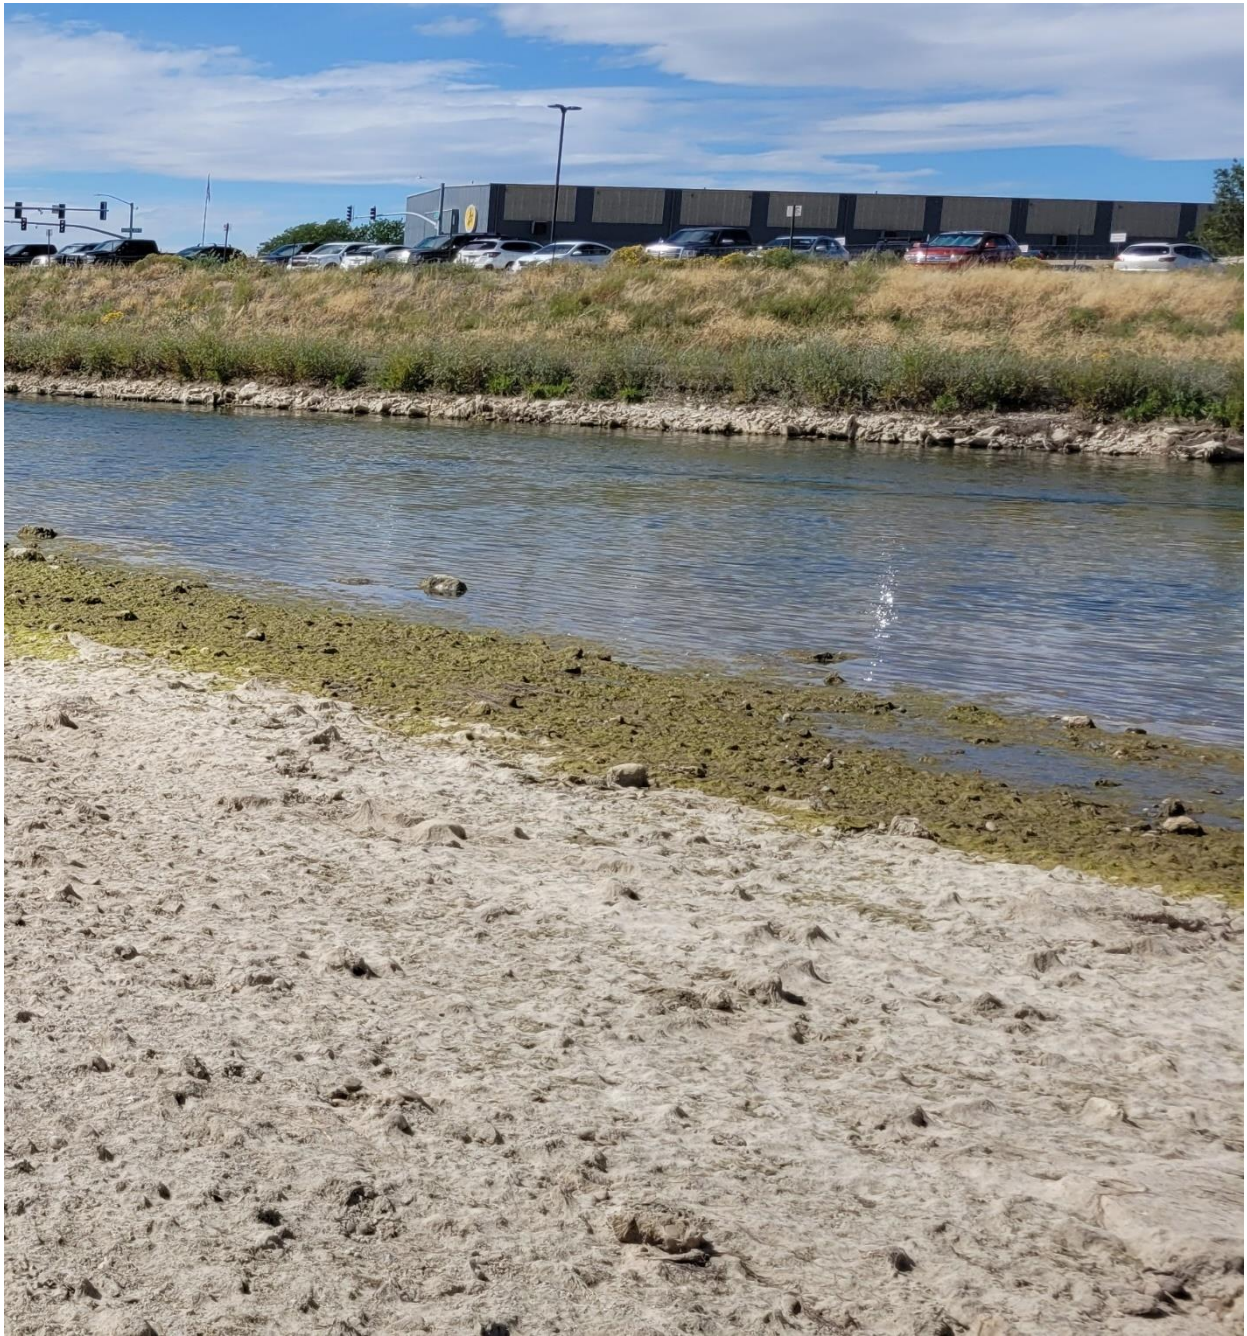
**View of river left upper portion of the Jonah Bank area. Note apparent ledge approximately one foot high immediately above the woody toe and cobbles that are exposed due to lower river level.**

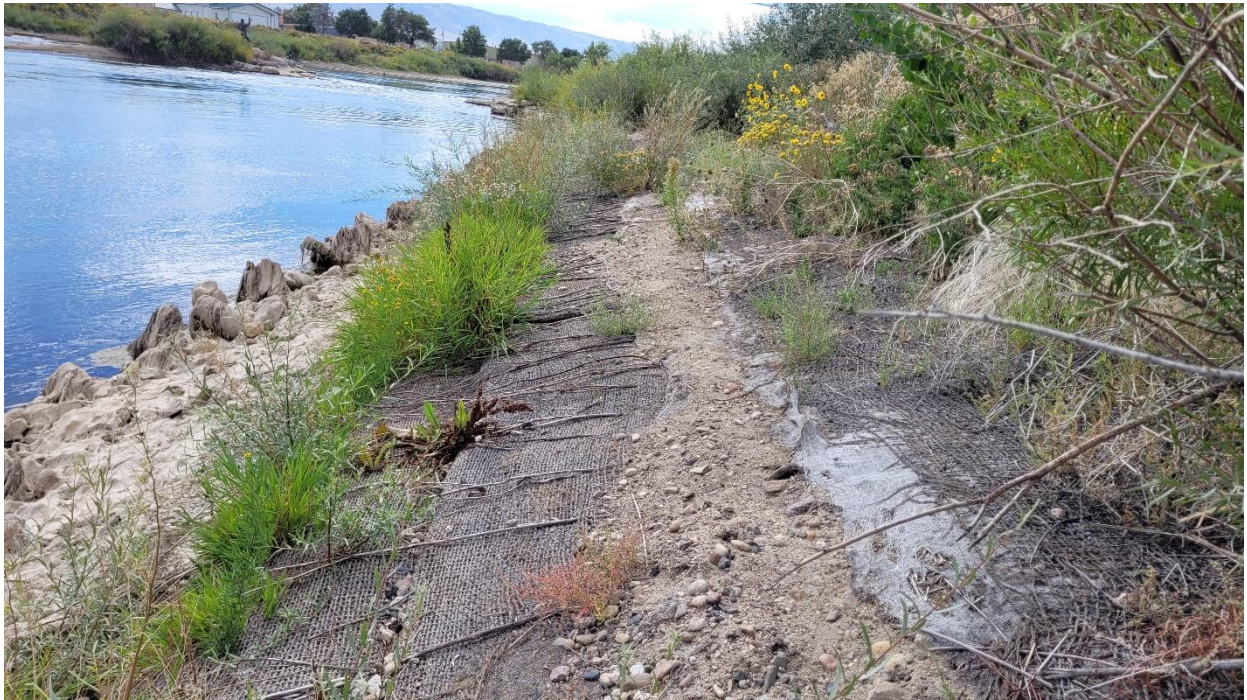
**View of river left bank just below fisherman statute, visible in upper left of photo. Note some grasses and willows establishing along high water level, general absence of vegetation just above that level.**

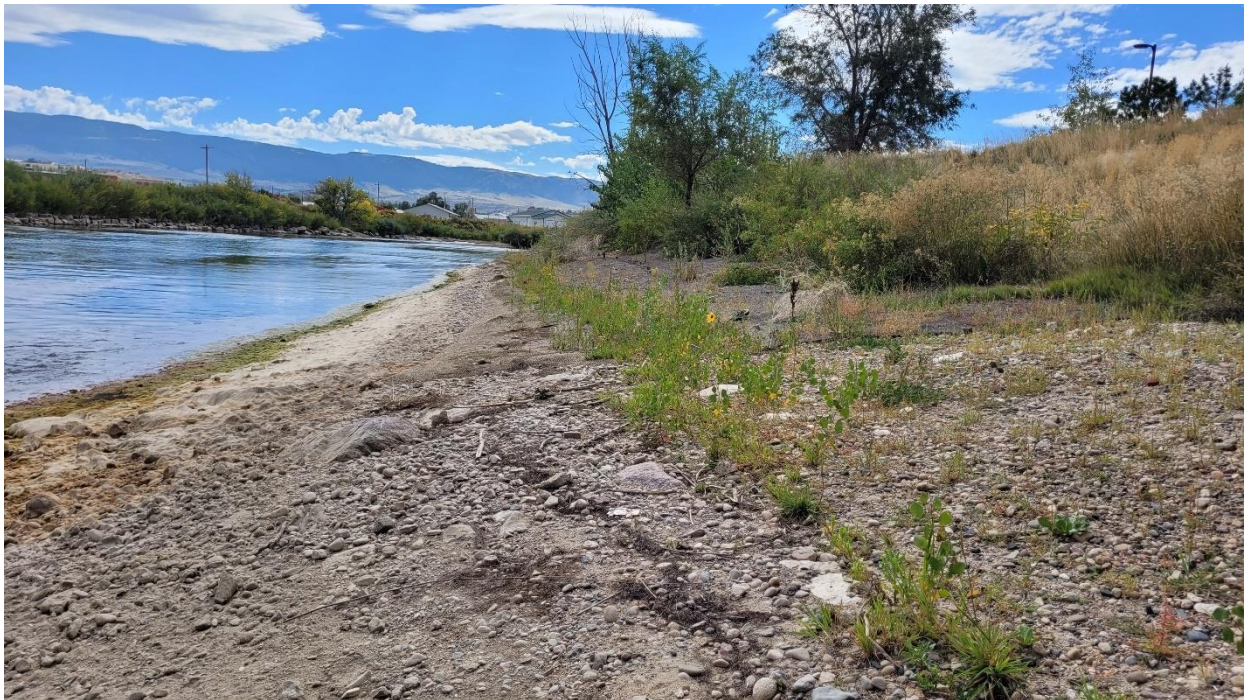
**View river left, looking upstream from 1<sup>st</sup> Street bridge. Note line of vegetation establishing along high water line, but sparse vegetation otherwise in construction area.**

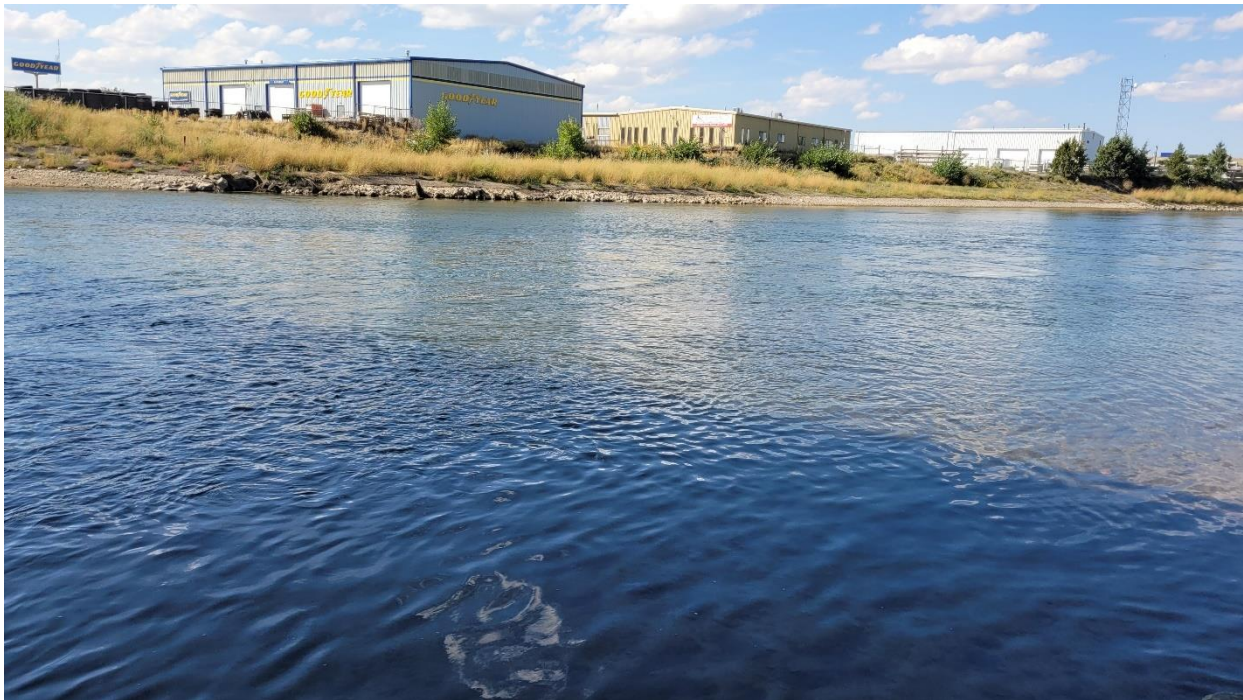
Also, on river left downstream of the 1<sup>st</sup> Street bridge, there is some erosion occurring that appears to be related to water runoff from a power company yard, eroding the higher portions of the riverbank. Rock has been dumped in the eroded area in an apparent attempt to address this problem. This issue does not appear to be related to river construction work; as noted above, it appears to be related to runoff from a power company yard (see photos).

**View of river left, in the vicinity of the Goodyear building, showing apparent erosion area noted in previous photo. Eroded area is just right of smooth stream bank visible in far left of photo. Monitoring wells just visible in grass above the area. Note that this area had eroded significantly prior to construction – the bank was eroded back to the monitoring wells. Also note general absence of vegetation along bank to right of photo.**

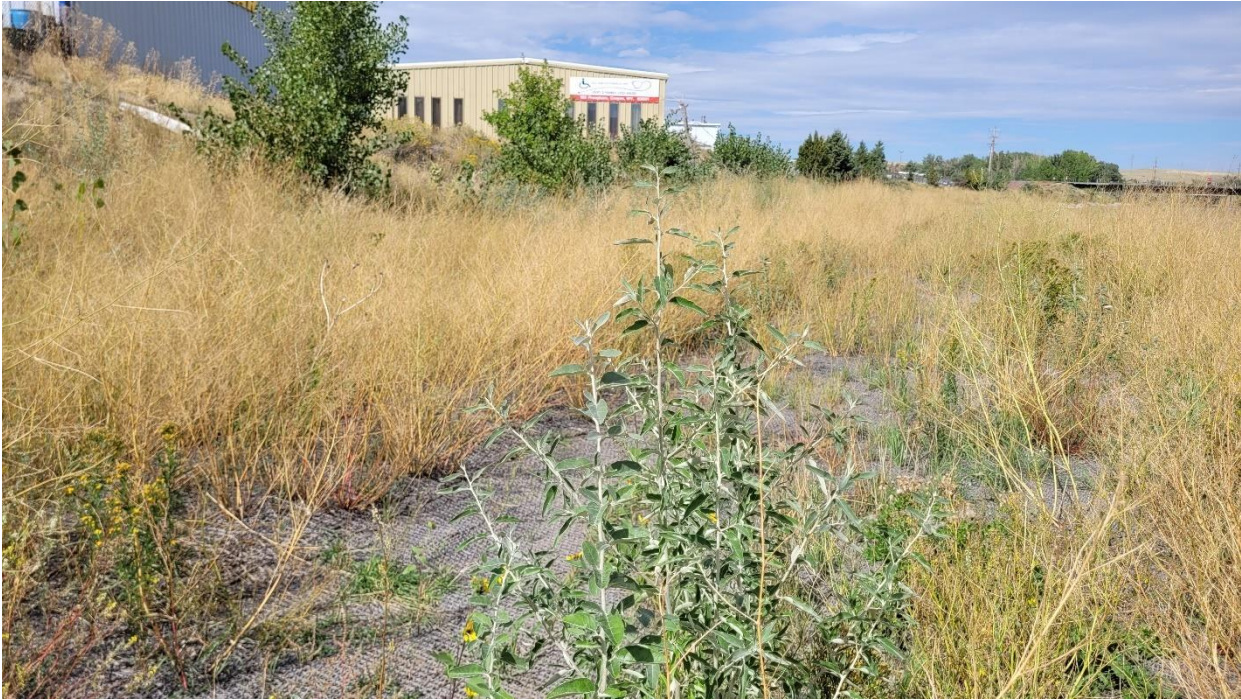
**River left, looking downstream, Goodyear building visible in upper left of photo. Note weedy nature of vegetation, and Russian olive regrowth in foreground, and just to left of foreground Russian olives in the distance. Vegetation looks thicker than it is, most is weeds, actual coverage by grasses etc. is limited.**

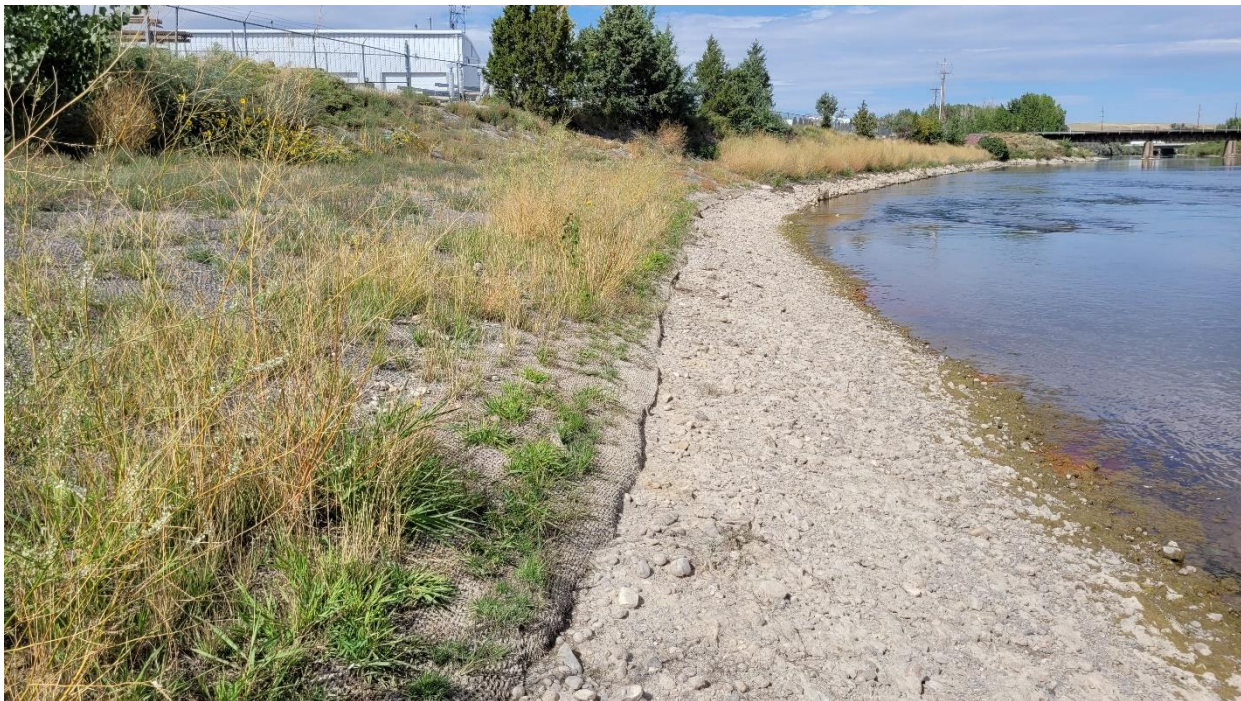
**River left, looking downstream, railroad bridge visible in upper right of photo. Note sparse grass and willow regrowth, Vegetation generally the same as July and August 2022 inspections.**

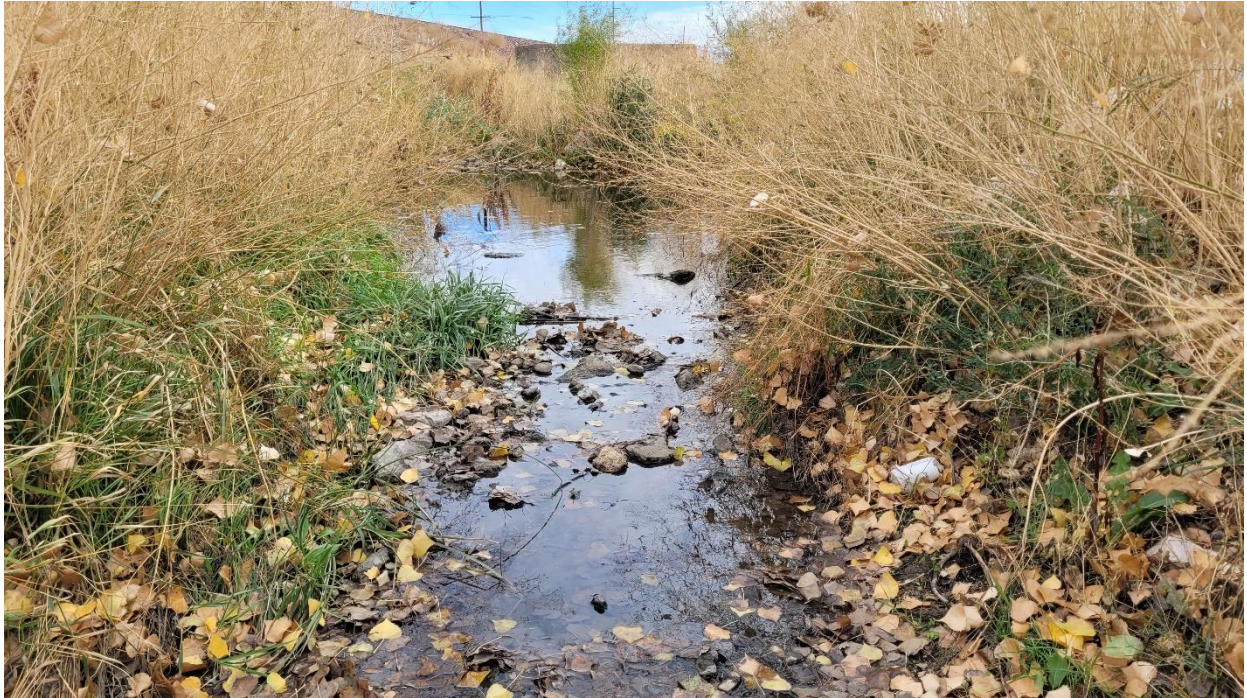
**Photo of drainage leading toward wetland from culvert. Culvert is in concrete face just visible at top center of photo.**

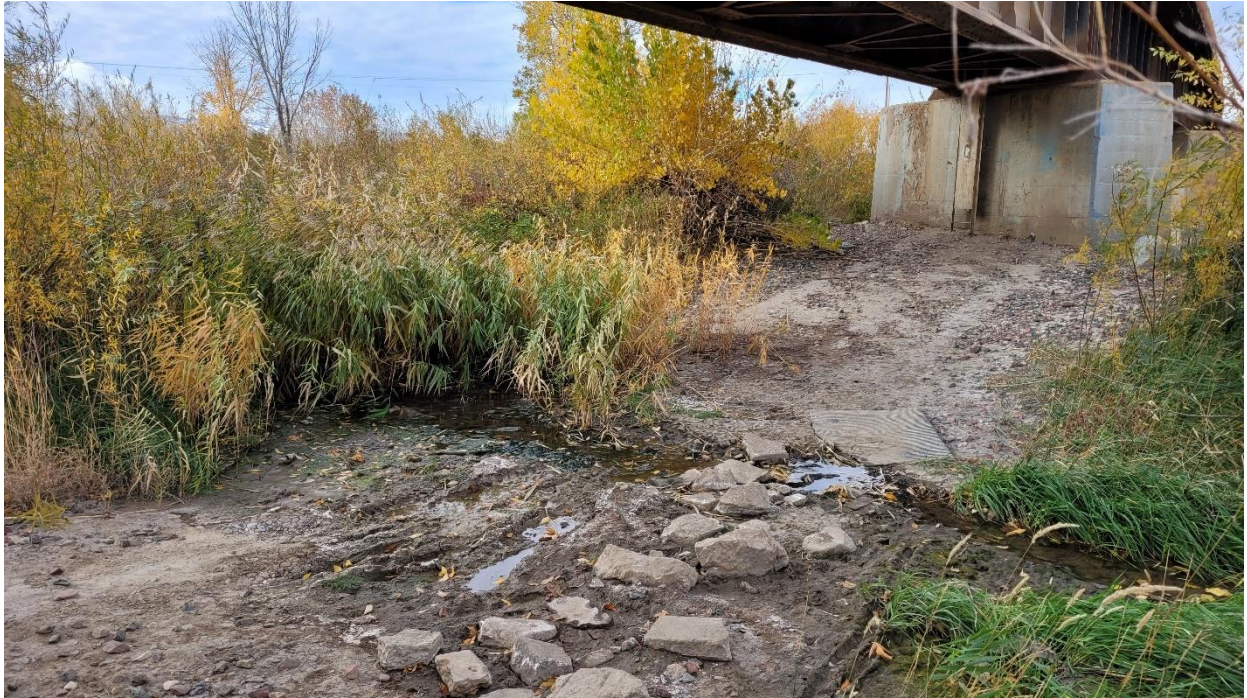
**Photo of small flow of water from wetland area toward North Platte River, beneath the BNSF railroad bridge.**

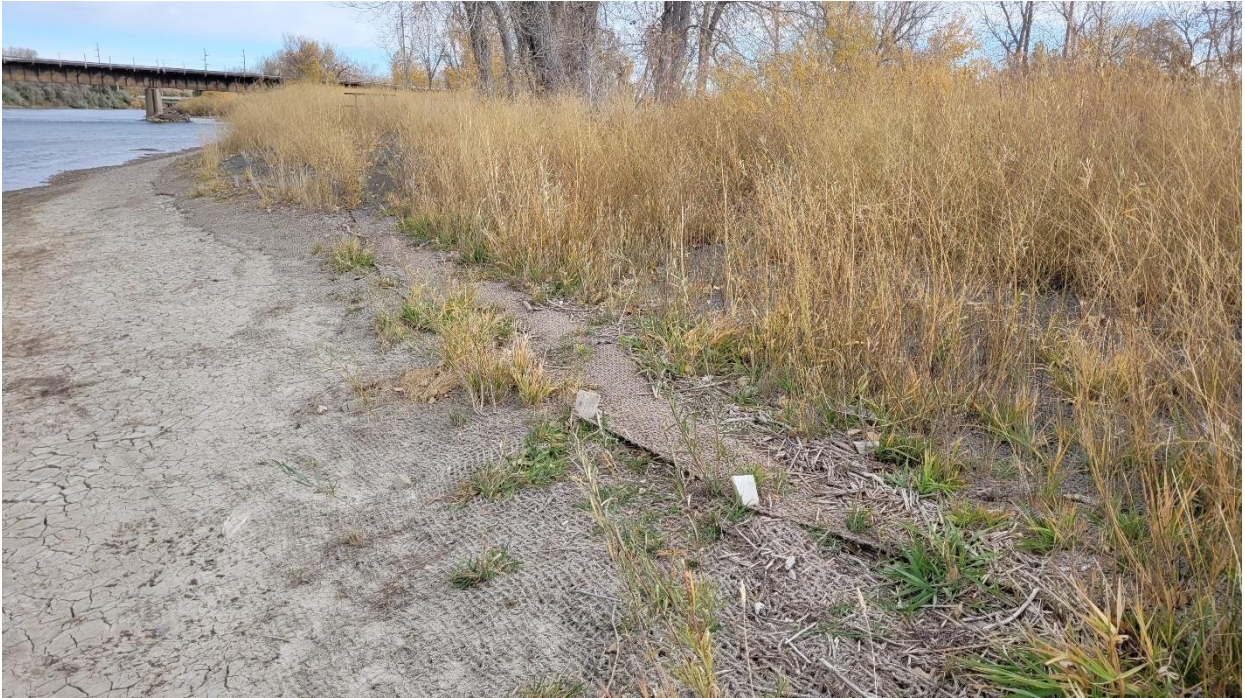
**Photo taken from river right, just upstream of Tate Picnic Area looking generally downstream. Note BNSF bridge visible in upper left of photo, picnic table barely visible at top of photo behind vegetation. Note exposed stream bank due to low flow condition. Note generally weedy appearance of much of the vegetation at this location, and sparse coverage of vegetation in some areas.**

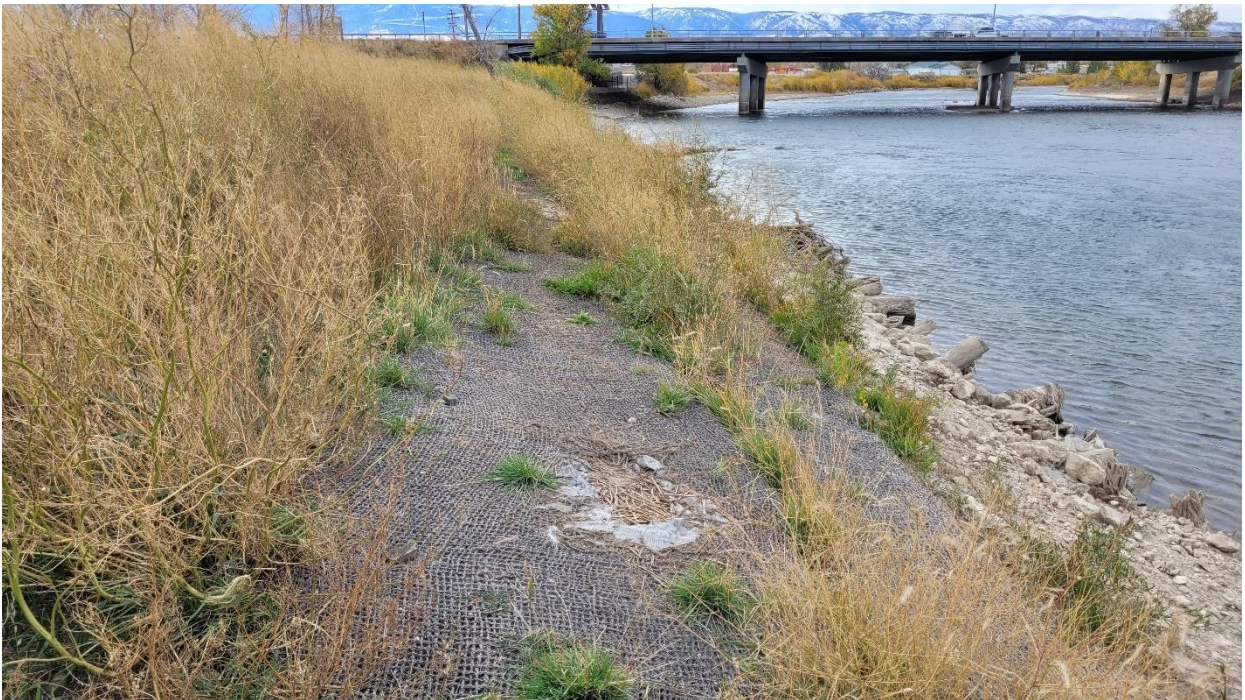
**View looking upstream, river right. 1<sup>st</sup> Street Bridge visible at upper right of photo. Note locally bare areas in vegetation.**

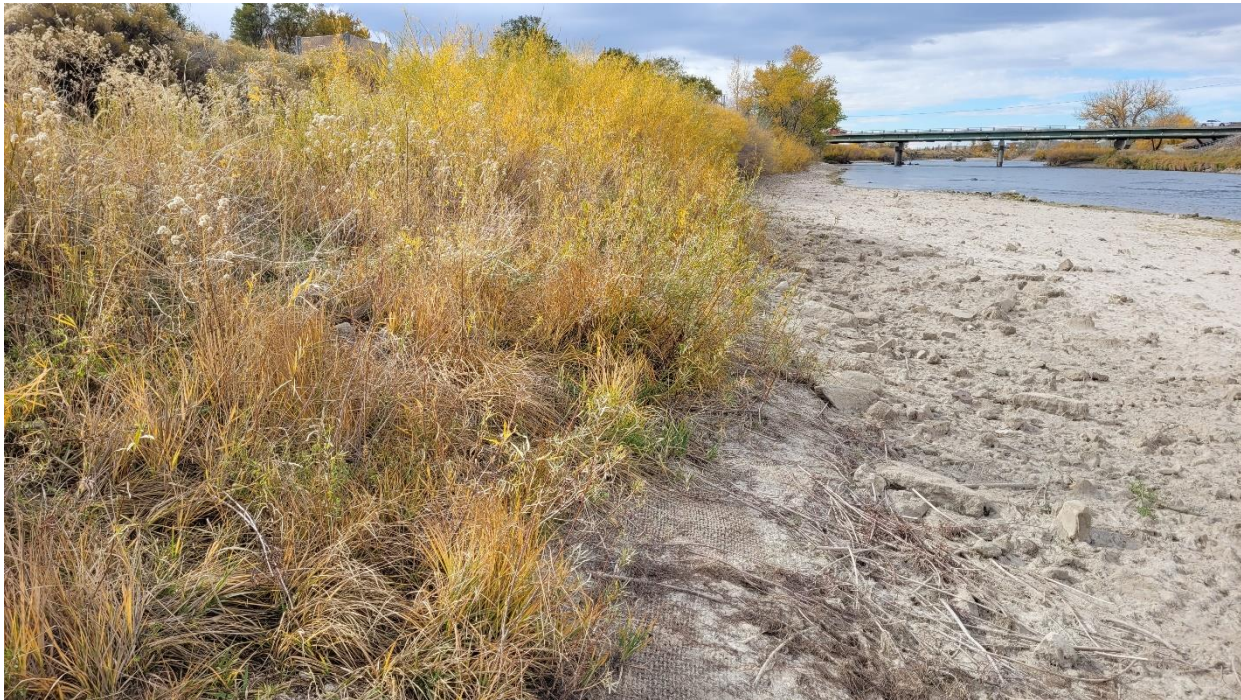
**View looking upstream river right, just above fisherman statue, Poplar Street bridge visible top center of photo. Note good vegetation growth.**

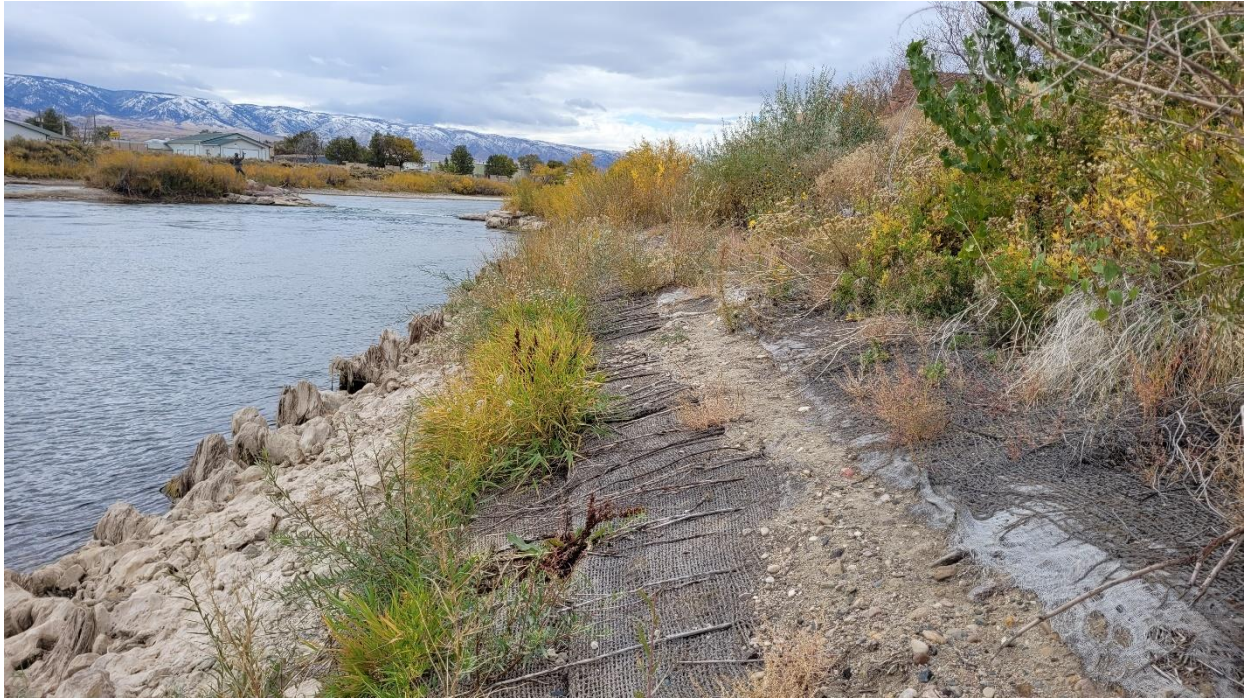
**View of river left bank just below fisherman statute, visible in upper left of photo. Note some grasses and willows establishing along high water level in approximate center of photo, general absence of vegetation just above that level.**

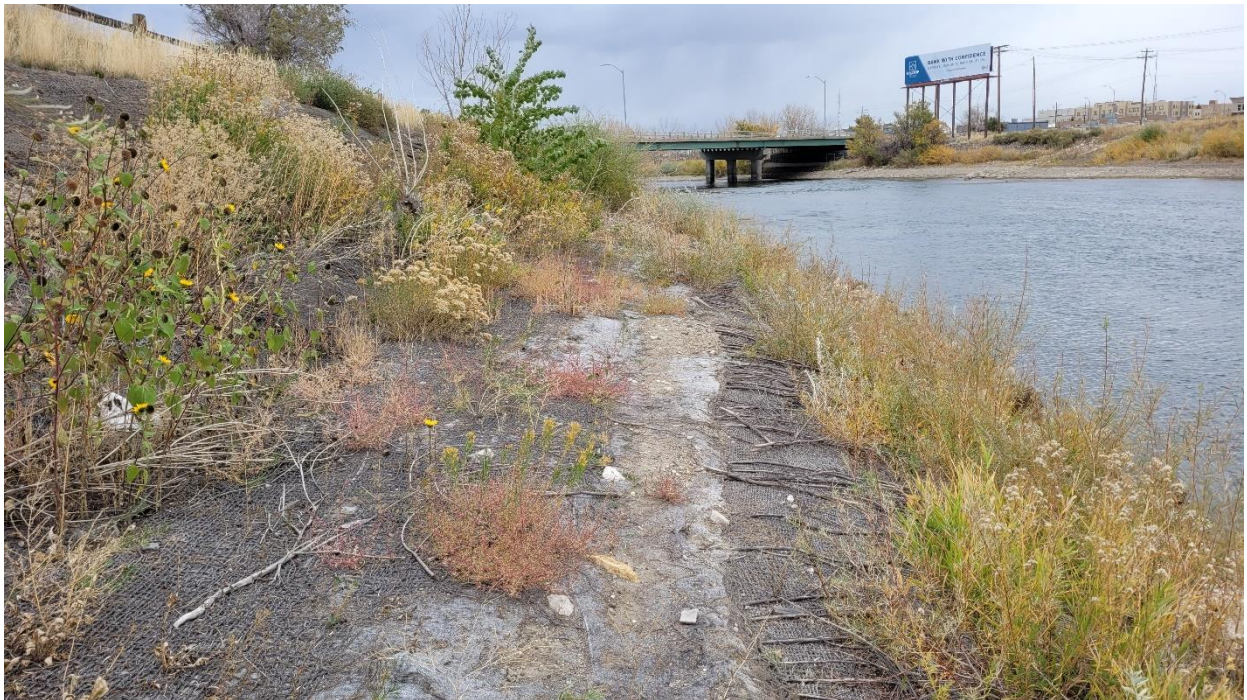
**View river left, looking downstream adjacent to Jonah Bank building with 1<sup>st</sup> Street bridge visible at top center of photo. Note line of vegetation establishing along high water line to right of photo, but somewhat sparse vegetation otherwise at this location.**

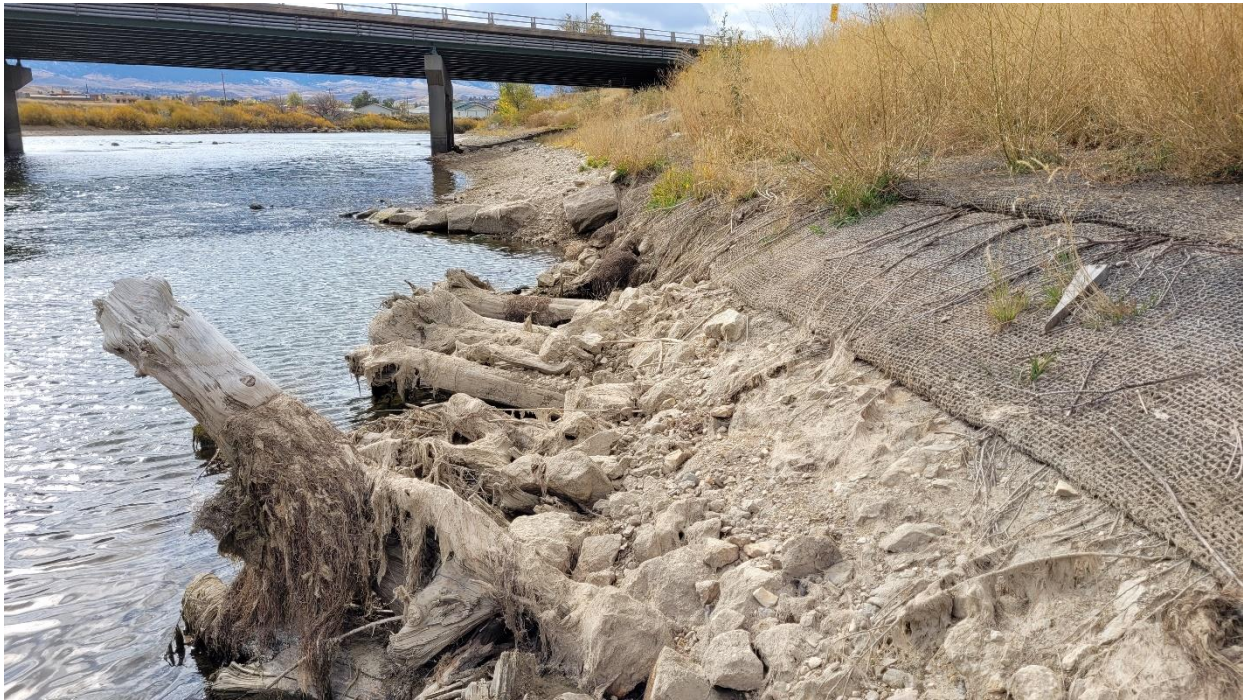
**Downstream of 1<sup>st</sup> Street Bridge, looking upstream, river left. Note slight indent just downstream (below) of boulders extending into river, with bank steeping due to local bank erosion. Monitoring well cluster is just out of sight in upper right of photo.**

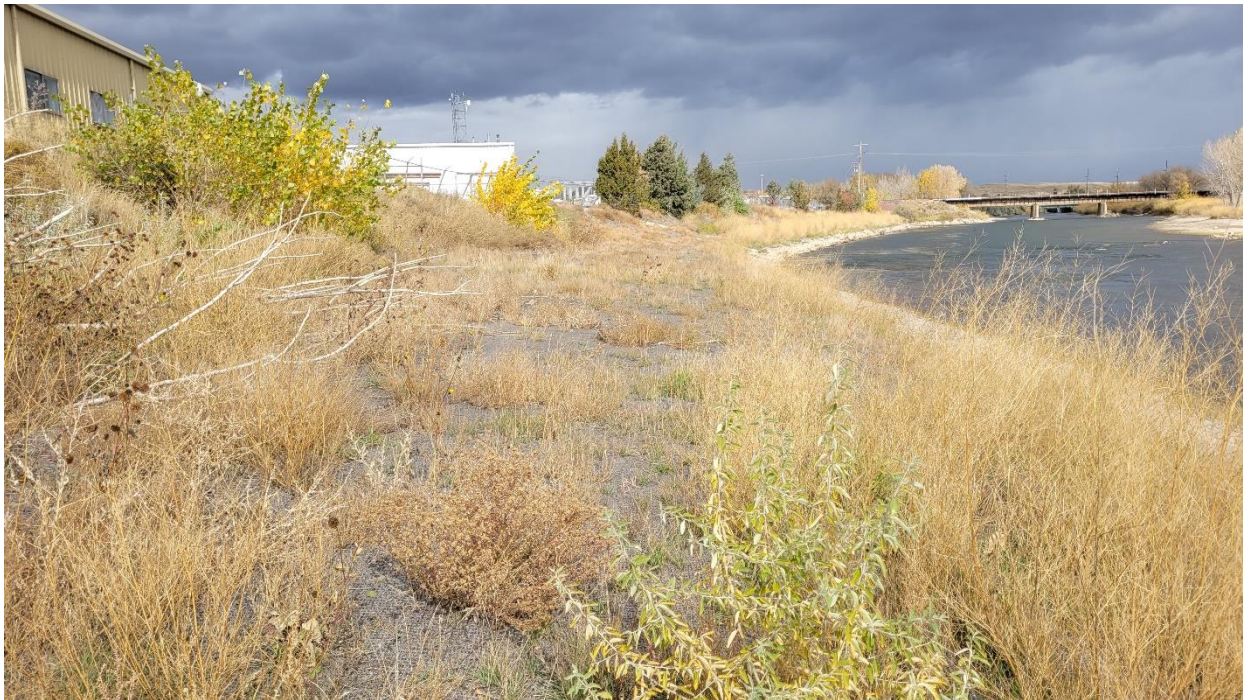
**River left, looking downstream, All About Family Inc. building visible in upper left of photo. Note weedy nature of vegetation, and Russian olive regrowth in foreground. Vegetation is predominantly weeds, actual coverage by grasses and willows, etc. is limited.**

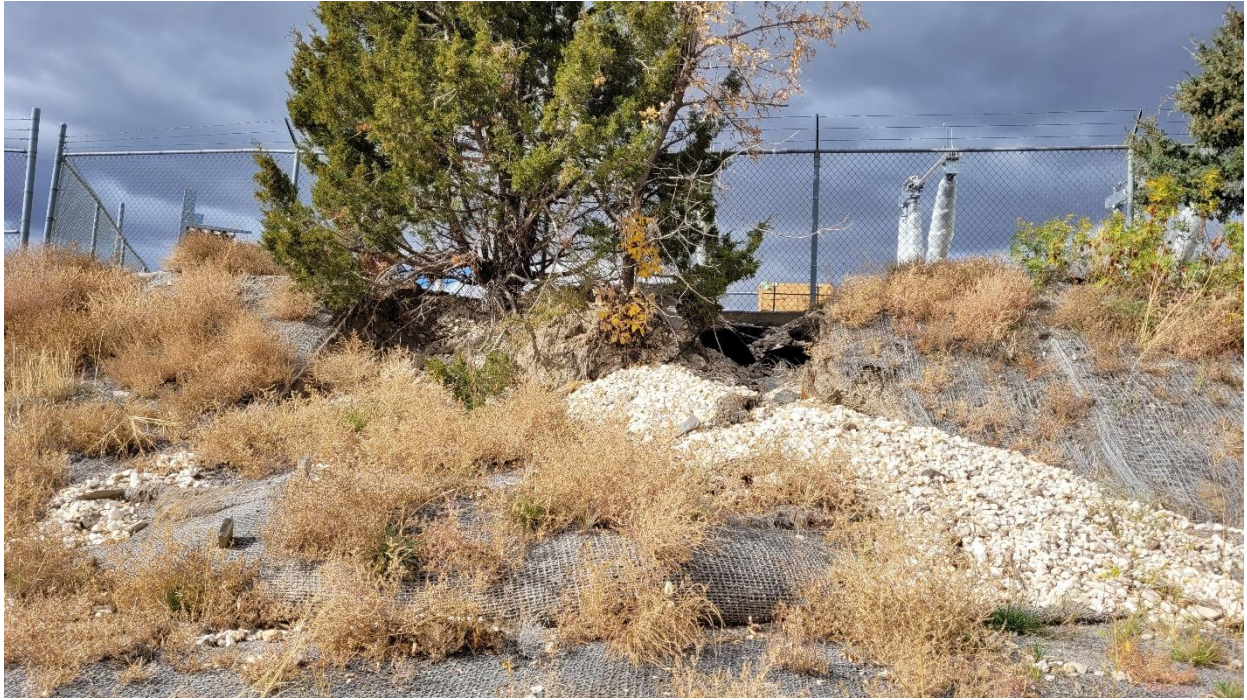
Also, on river left downstream of the 1<sup>st</sup> Street bridge, there is some erosion occurring that appears to be related to water runoff from a power company yard, eroding the higher portions of the riverbank. Rock has been dumped in the eroded area in an apparent attempt to address this problem. This issue does not appear to be related to river construction work (see photo). This area does not appear to have changed significantly since the September 2022 inspection.

**Bank erosion noted in previous inspection, in area of power company yard. Note relatively sparse vegetation, less than 70% coverage overall.**

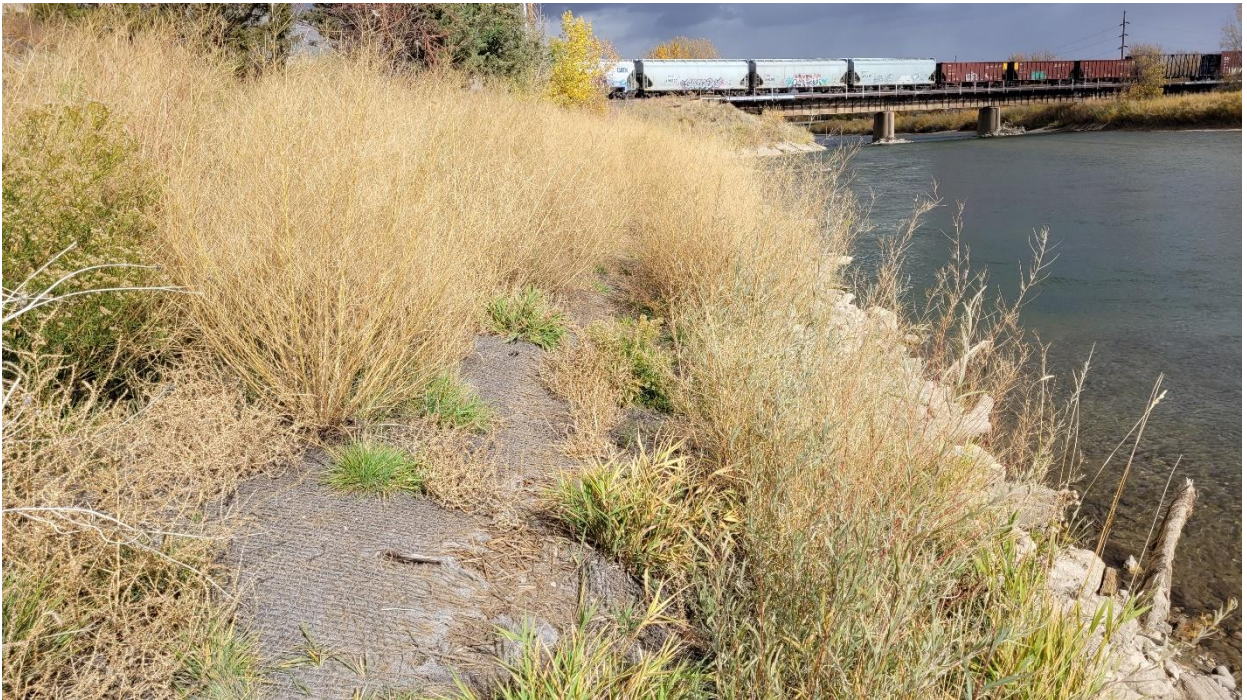
**View looking downstream from river left, note BNSF railroad bridge in upper right of photo. Note grasses and willows along water line to right, with barren areas in next burrito wrap away from riverbank. Much of vegetation present is weedy in nature.**

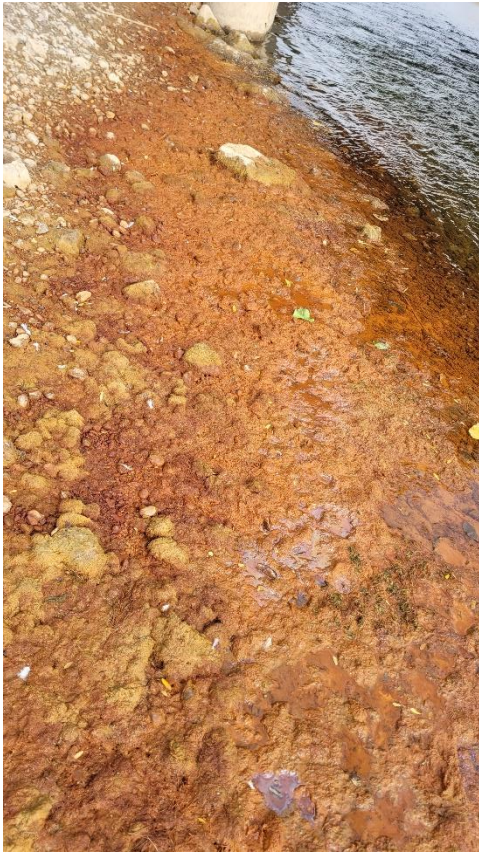
**Red surface staining observed at the end of October**

The red/orange color in the picture is created by a dye agent. The dye was heavy in nature which allowed it to settle quickly in the flowing current. It is a surface staining; the rocks are clean on the bottom side embedded in the river bed.

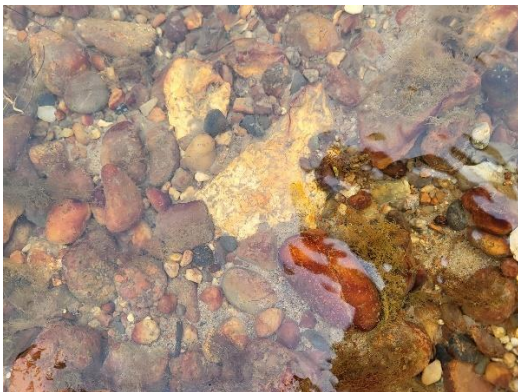
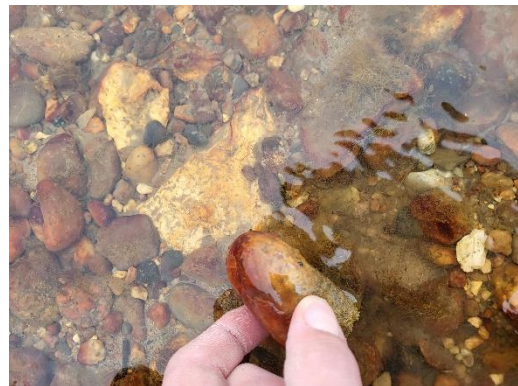
**Red Stained rock, top and bottom**

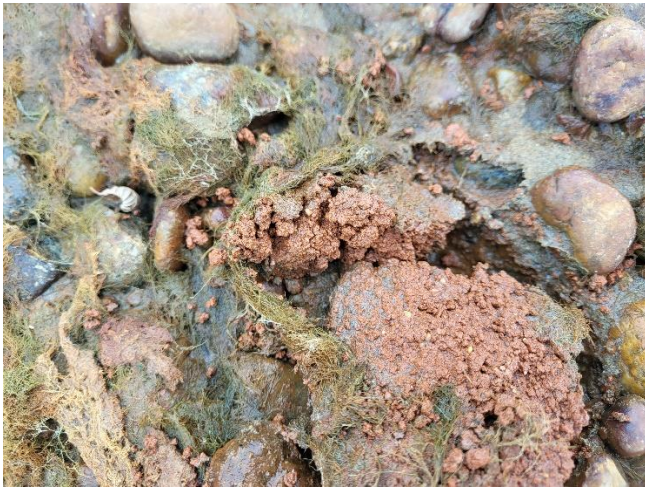
At the first location south of First Street bridge river left, a small pile of semi harden concrete grout; consistency of what someone would buy from Home Depot with a red dye added. This small pile was found in the water close the shore line. This is a high probability of illegal dumping as someone washed out a bucket of dyed concrete.

**Small pile of harden concrete dyed red**

It is assumed that all four areas were most likely stained by the same individual, washing out concrete tools at the river's edge.

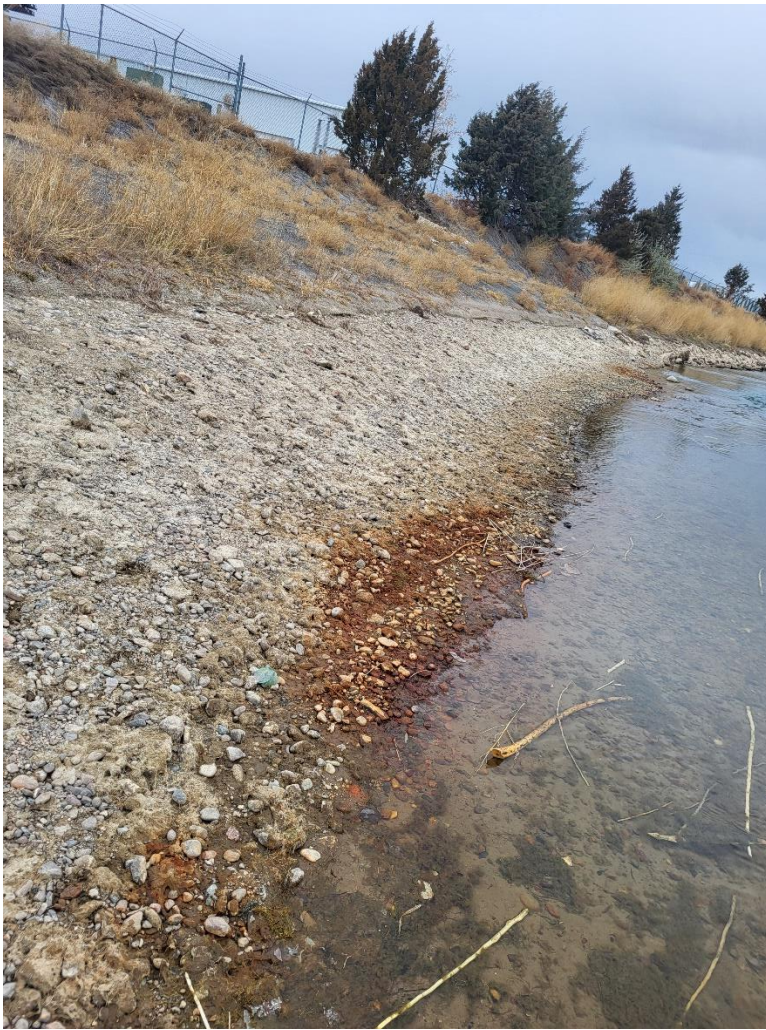
There are three additional areas where the rivers edge surface is stained in a similar color, north of First Street bridge on river left. These three areas are much smaller in size and are not stained as bright of a red color.

**You can see two of the small areas north of First Street bridge**

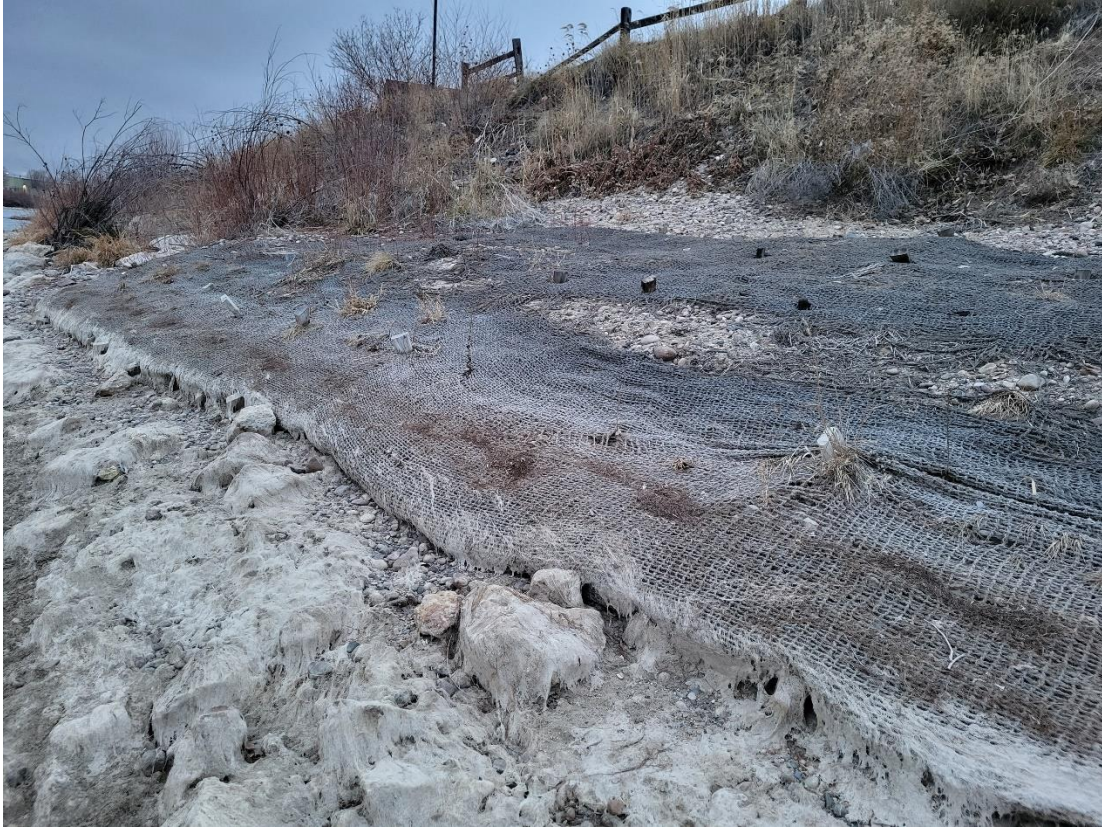
**Sparse vegetation river, left just upstream from 1<sup>st</sup> Street Bridge**

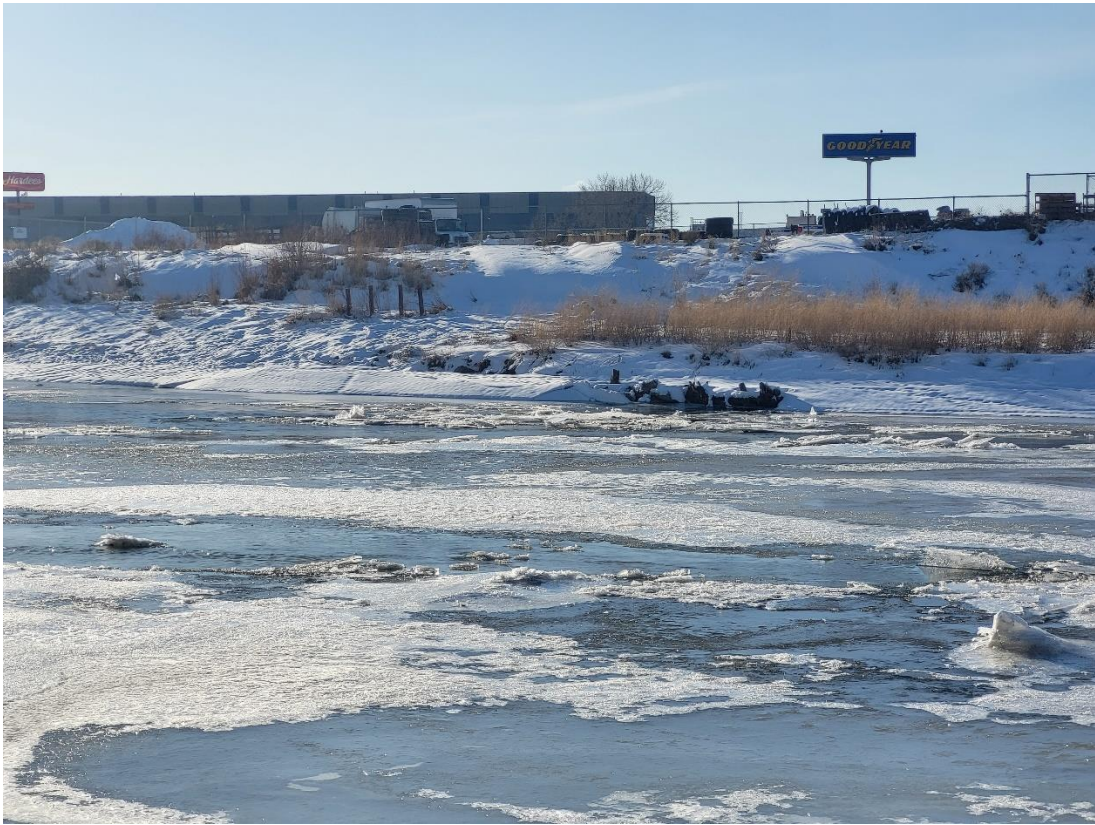
**Repaired erosion area, river left**

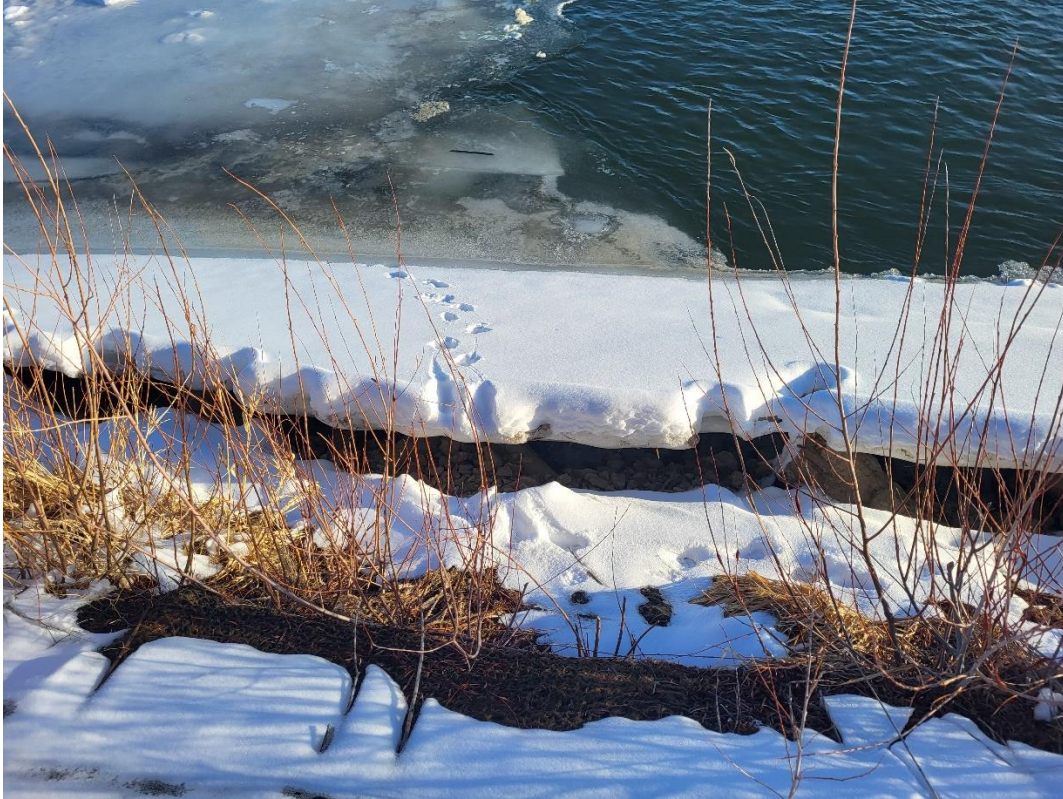
**Ice slab pushing over wood toe, no damage viewed at this time**

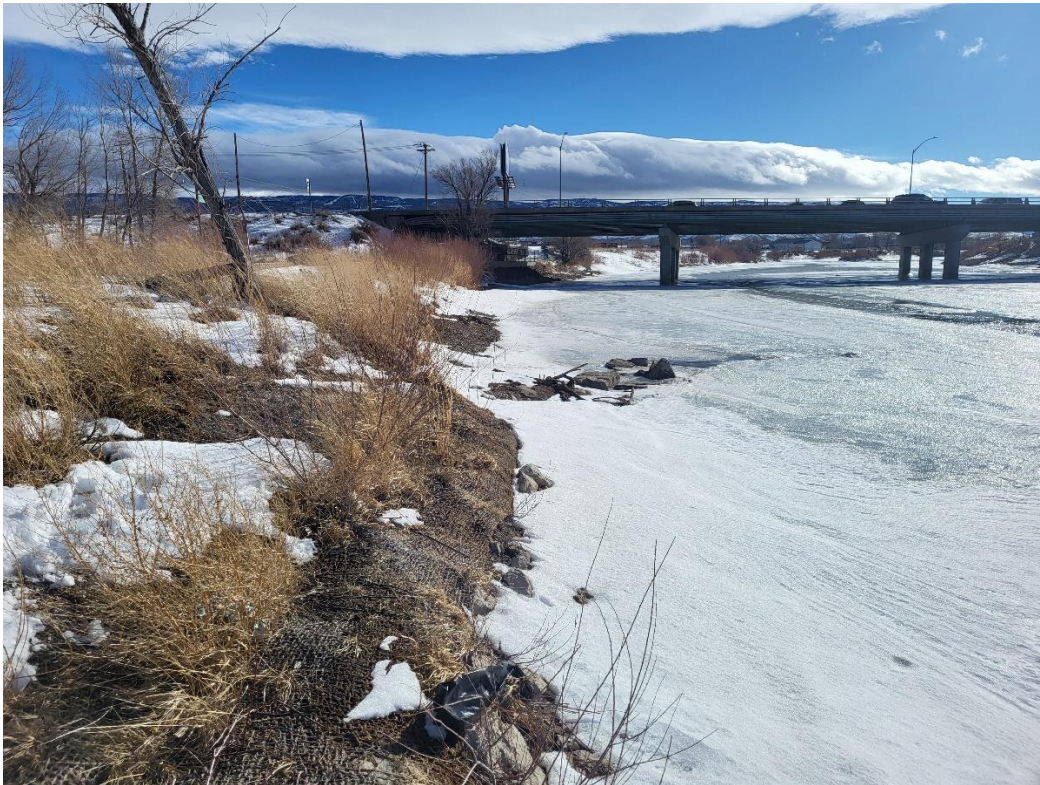
**J-Hook structure starting to become visible through the snow and ice river right sta. 16+00**
