# Edge Engineering Group

## First Street Environmental Inspection and Report July 2022

| <b>Project:</b> First Street River Restoration | | <b>Owner:</b> City of Casper | |
| <b>Location:</b> North Platte River – Poplar Street Bridge to BNSF railroad Bridge | | | |

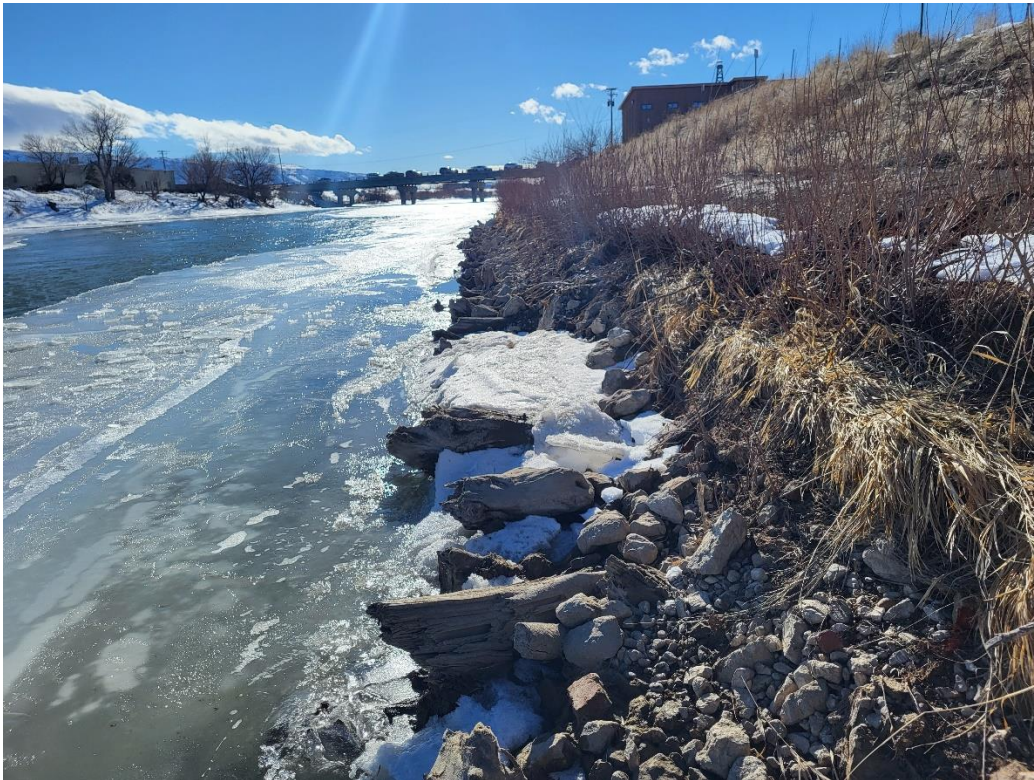
Small erosion area river left sta. 4+25

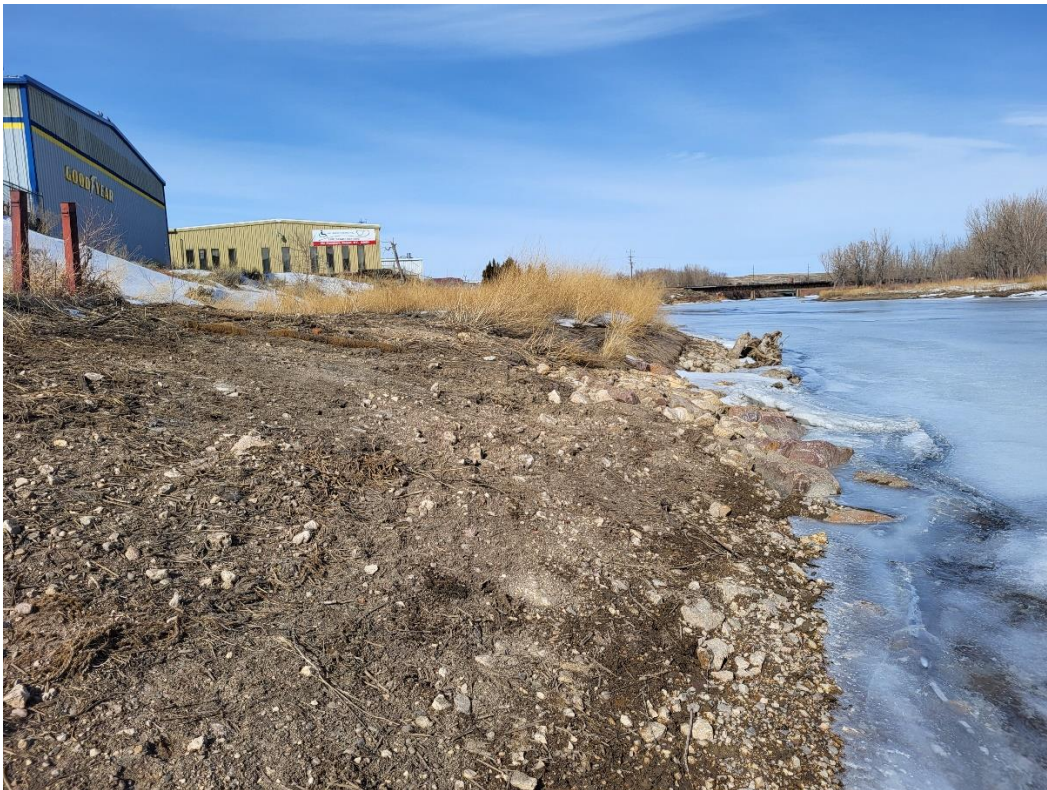
**Recently repaired erosion area river left just down stream from First Street Bridge**

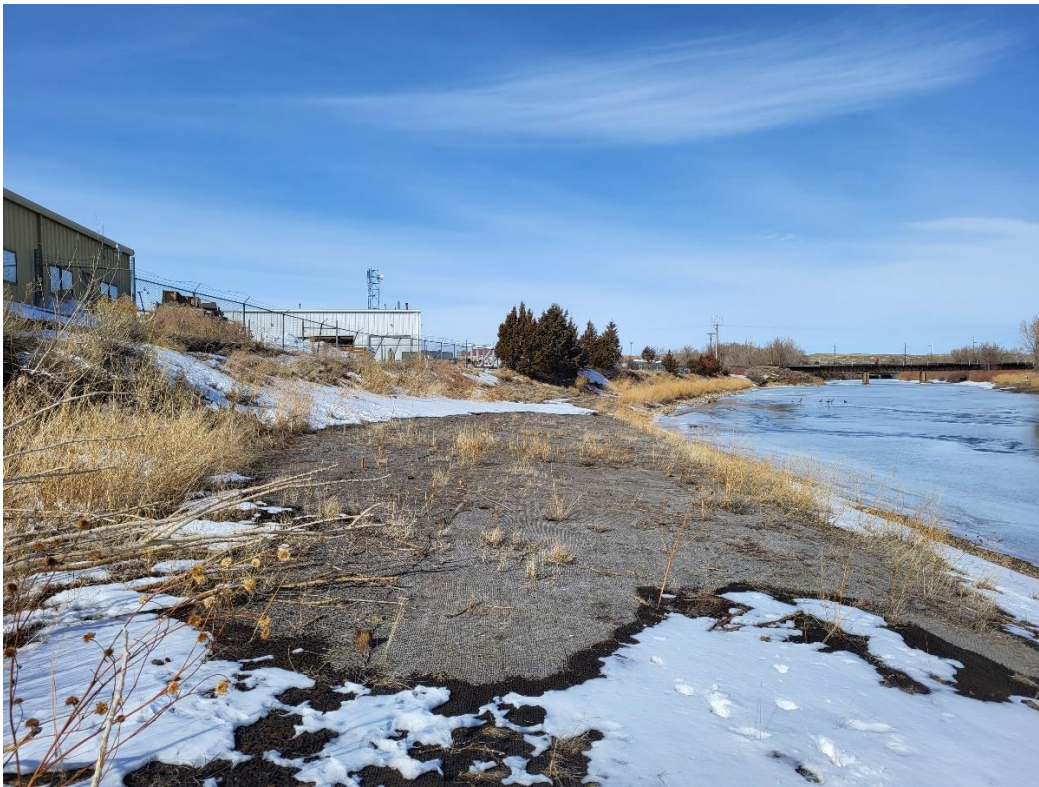
**Sparse vegetation river left sta. 19+00**
