Project/File: North Platte River Restoration Projects Date: June 1, 2022

Reference: Field Observations on the North Platte River Between Bryan Stock Trail and Knife River Property

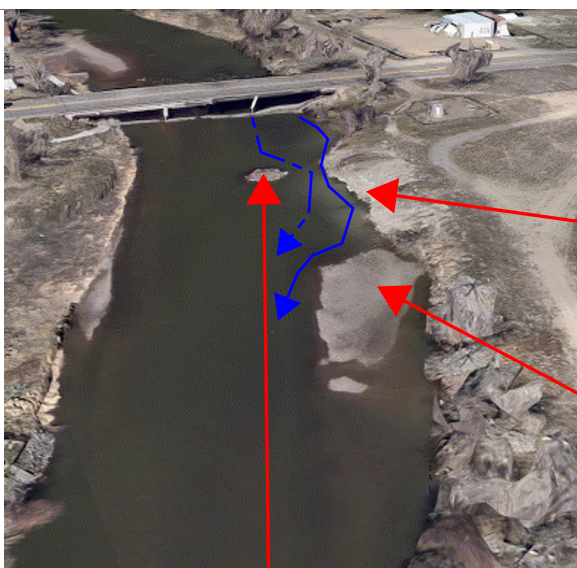
Problem area 1 located on the left descending bank just downstream of the Bryan Stock Trail Bridge. This approximately 210' long section has served as a dumping ground for waste concrete poured along the bank. In addition, a large pile of concrete slabs in the channel about 30' from the bank, constricts flow and has formed a scour pool. This is contributing to the undermining of the bank and development of a sediment aggradation bar immediately downstream. Without removal of concrete, failure of the bank toe and additional sediment deposition is expected to continue increasing localized stress on the bed and bank, leading to further erosion upstream and downstream of this area.

Photo 1: Layers of poured concrete visible along left bank being undercut by scour pool at least 8-10' deep.

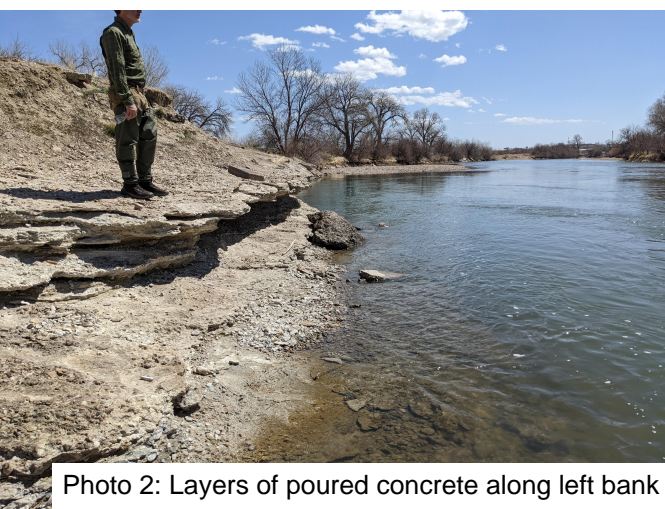
Photo 2: Layers of poured concrete along left bank

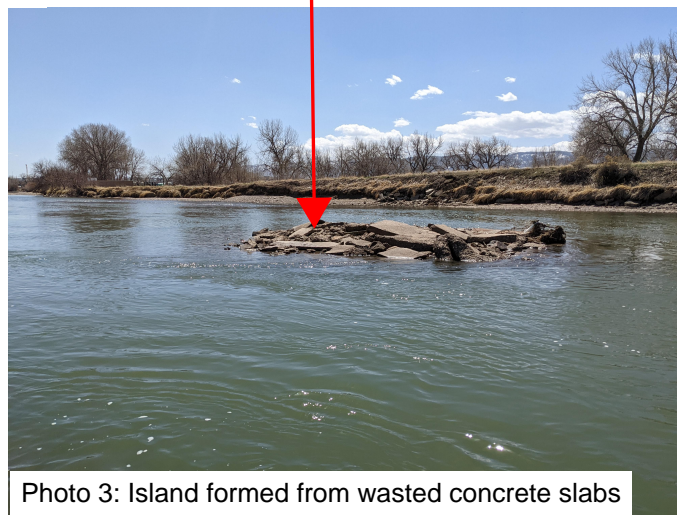
Photo 3: Island formed from wasted concrete slabs

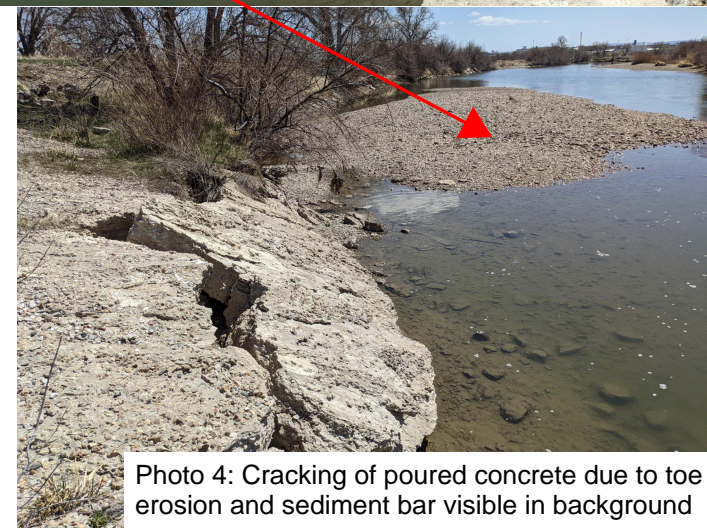
Photo 4: Cracking of poured concrete due to toe erosion and sediment bar visible in background

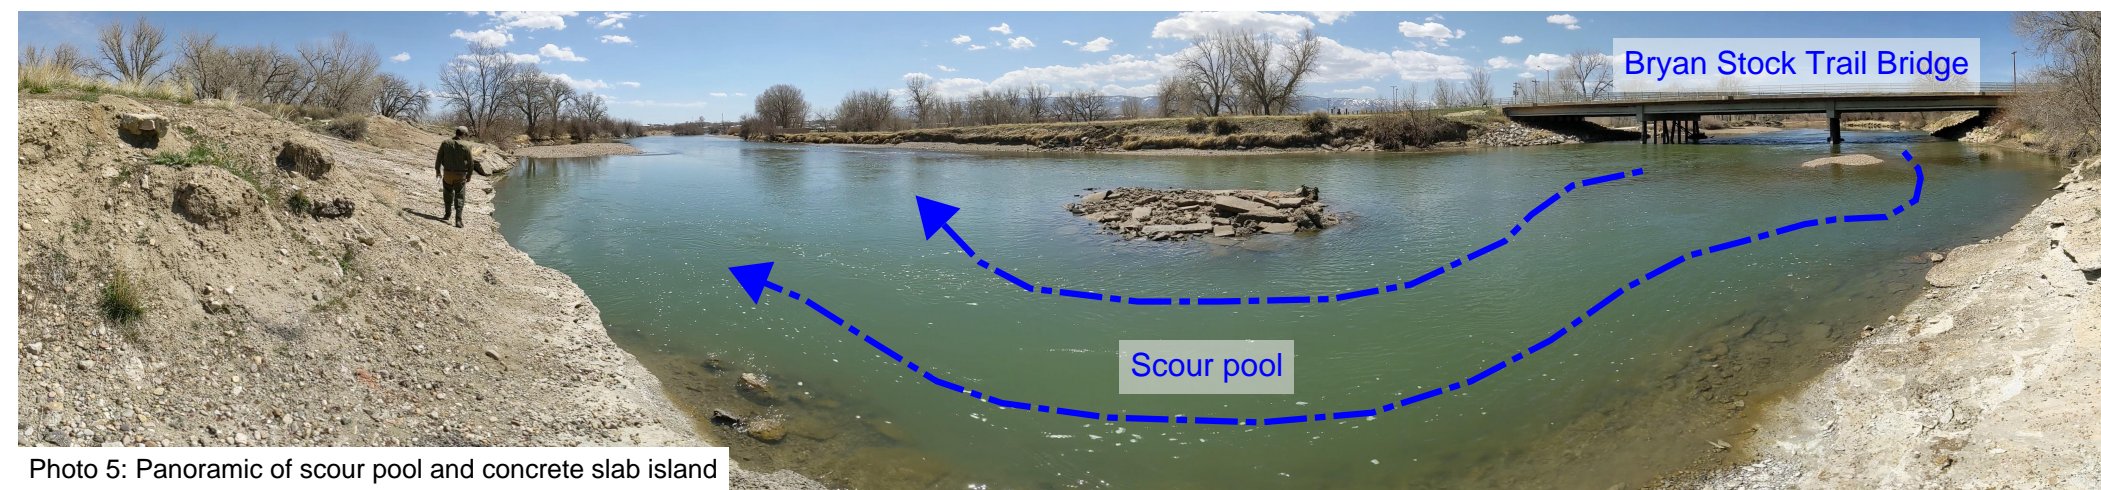
Photo 5: Panoramic of scour pool and concrete slab island

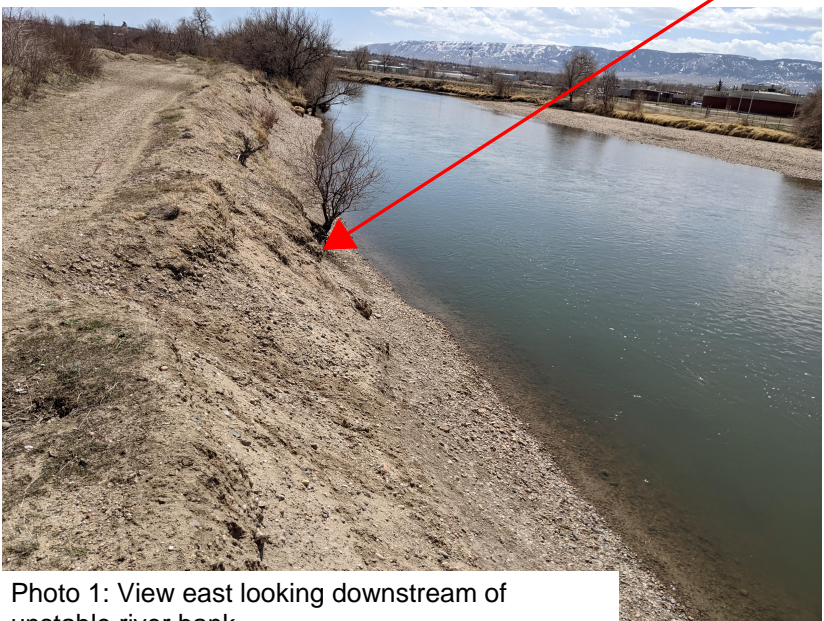
The bank angle is near vertical through much of this section with sparsely vegetated banks and is experiencing toe erosion and bank sloughing. The river is separated from a relic gravel pond by a narrow (12-15') strip of bermed bank for approximately 200 linear feet. This 200' section of bank, consisting primarily of unconsolidated small cobble/gravel/sand bank material, has lost all vegetation and exhibits signs lateral migration toward the pond. The pond side of the berm is also nearly vertical, sparsely vegetated with woody plants, and does not appear to be very robust. If the lateral retreat of this bank toward the pond is allowed to continue or if a large overtopping flow event were to occur, risk of a major channel avulsion through the gravel pond is likely. In this event, the river would likely abandon it's current course and flow through the gravel pond to the North-East, before returning back into the existing river channel (As shown in the Overview Map).

Photo 1: View east looking downstream of unstable river bank

The liability of this potential river avulsion needs to be a key consideration in any negotiations involving purchase of this land. The potential restoration of this area will require addressing this avulsion risk and also reworking the southern portion of the large gravel pond. As such, coordination with JTL Group, additional land acquisition, and/or securing of an easement will be critical to appropriately restore the river corridor and to mitigate potential risk of avulsion.

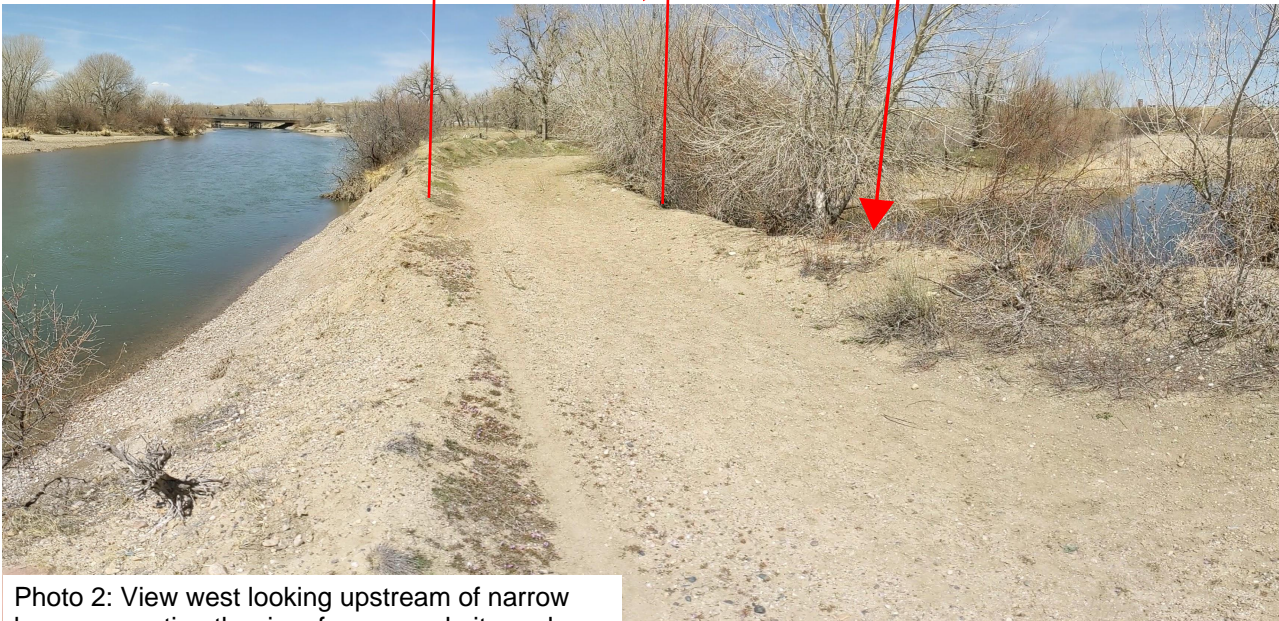
Photo 2: View west looking upstream of narrow berm separating the river from gravel pit pond

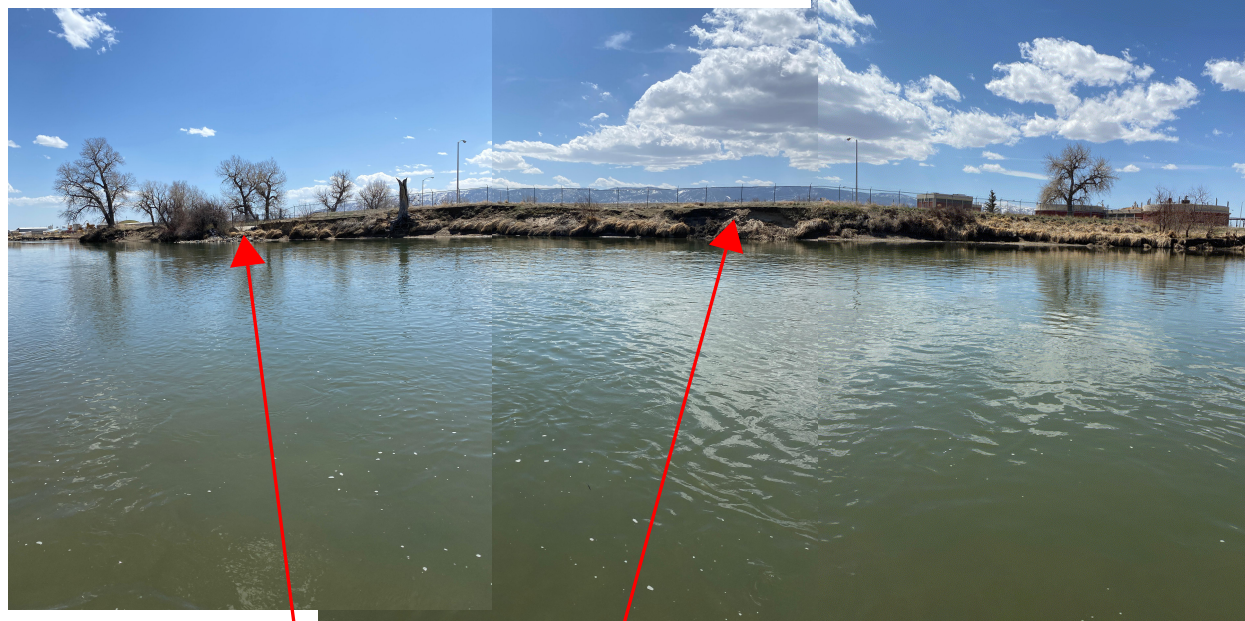
Problem Area 3 is located on the right descending bank, adjacent to the Sam H. Hobbs Regional Wastewater Facility, approximately 1,500 ft. downstream from the Bryan Stock Trail Bridge. The river thalweg shifts from the left to right side of the river along this reach and the wetted width reduces from approximately 200 ft. to approximately 160 ft. The reduction in width was created by the channelization and berming of the left bank for gravel mining operations. This constriction and high near bank stress along the right toe is causing toe erosion and mass wasting of the bank immediately adjacent to the Wastewater Facilities sludge settling pits.

There has been noticeable erosion and retreat of the bank apparent in the aerial imagery from the last 10-15 years, and it is currently threatening to undermine the facilities perimeter fence, which is only 30-40 from the edge of the sludge settling pit. Without intervention, incremental lateral retreat of this bank towards the wastewater facility is likely to continue. Additionally, a large flow event has the potential to cause major bank scouring and could threaten the integrity of the sludge pit, resulting in contamination to the river. Release of concentrated wastewater sludge into the river would result in detrimental affects to water quality, aquatic species, and impact downstream drinking water sources.

Photo 1: View south looking across the river at the unstable river bank adjacent to the Sam H. Hobbs Regional Wastewater Facility

While temporary stabilization of this bank would help to reduce the short-term erosion risk to the wastewater facility, addressing the root cause of the instability is recommended to provide long term risk mitigation. Addressing the root cause would require shifting the river away from the facility towards the north by modifying the gravel pit pond and improving floodplain connectivity.

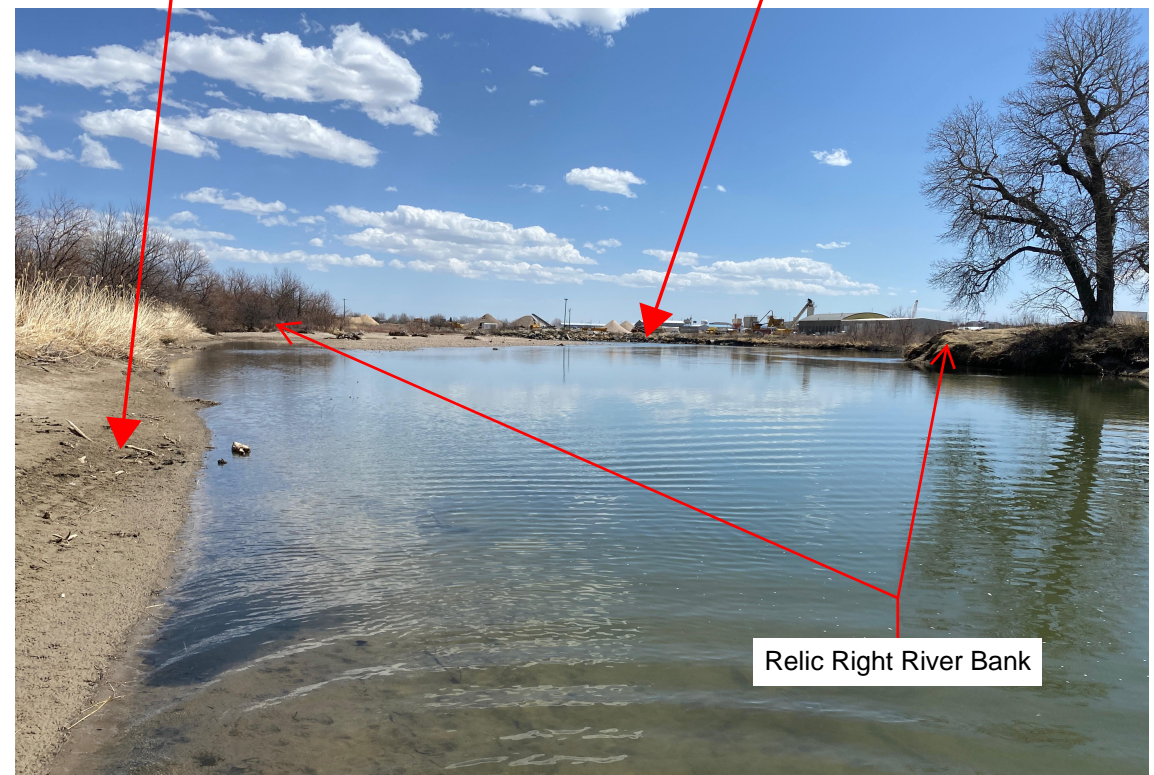
Problem Area 4 is located immediately downstream of Problem Area 3. The river was bermed and surrounded on both sides by large gravel pits as part of the "Casper Sand and Gravel Operation" owned by JTL Group, Inc. According to the WDEQ reclamation plan (Permit No. PT215), a high water event in 1984 led to a breach of the eastern berm separating the river and gravel pit resulting in a channel avulsion into the mining area (known as a "pit capture"). The avulsion led to the river abandoning its original channel, and the new river channel corridor was created by backfilling along the new eastern bank with unmarketable sand and gravel generated during on-site mining operations, uncontaminated cut-material imported from various JTL Group, Inc. construction projects, and wasted concrete slabs. Because a majority of the Casper Sand and Gravel Operation was disturbed prior to the enactment of the WEQA, the permit holder has limited reclamation obligations in this area and the permit application claims that the "area has stabilized and extensive vegetation has become established." As such, the "area is classified as not available for reclamation and is excluded from any future reclamation or revegetation requirements." However, the "extensive vegetation" is almost exclusively composed of invasive Russian Olive trees which chokes out and prevents re-establishment of native plants.

Contrary to the claim in the permit, this river reach is very unstable and exhibits both large areas of sediment deposition and bed/bank erosion, as shown in the historic aerial images shown on next page. The extreme expansion and over-widened river cross section drastically reduces the river's ability to transport sediment, leading to the formation of large sediment bars consisting of fine-grained material. Overwide channels have very poor aquatic habitat and shallow water is prone to temperature increases due to solar radiation. In addition, the tight, dogleg turn to the north has experienced bank erosion, requiring extensive bank armoring, which currently consists of wasted concrete slabs. This problematic bank erosion has been observed and documented along the right descending bank, potentially threatening the JTL Group, Inc. property and Shop. The entirety of the right bank through this reach has been armored with wasted concrete slabs in an attempt to stabilize the bank but provide little/no potential for vegetation establishment.

Photo 1: View east looking downstream at the overwide river channel at point of 1984 avulsion.

Due to the extensive volume of river alluvium mined from the current North Platte River Channel and a history of river avulsion, successful restoration and mitigation of further avulsion risk in this area will require a holistic approach in order to be successful. This will involve the reworking of the north river bank and southern portion of the adjacent gravel pit pond, in order to improve floodplain access, reduce erosion risk to the wastewater treatment facility, and creation of a robust outer right bank with a reduced radius of curvature required to relocate the river back to the relic channel. The current river channel can be converted into a series of oxbow lakes and wetland systems designed to treat stormwater from south of the site. Because so much of this corridor has been mined, imported alluvium will likely be required to properly reestablish channel banks and floodplains. Locations and configuration of the oxbow lakes will have to be optimized to account for net fill needed to balance the site.
