## **2018 Annual Monitoring Report for the North Platte River Restoration Project**

Joanna Harter, Aquatic Habitat Project Biologist

Wyoming Game and Fish Department, 5400 Bishop Blvd, Cheyenne, WY 82006

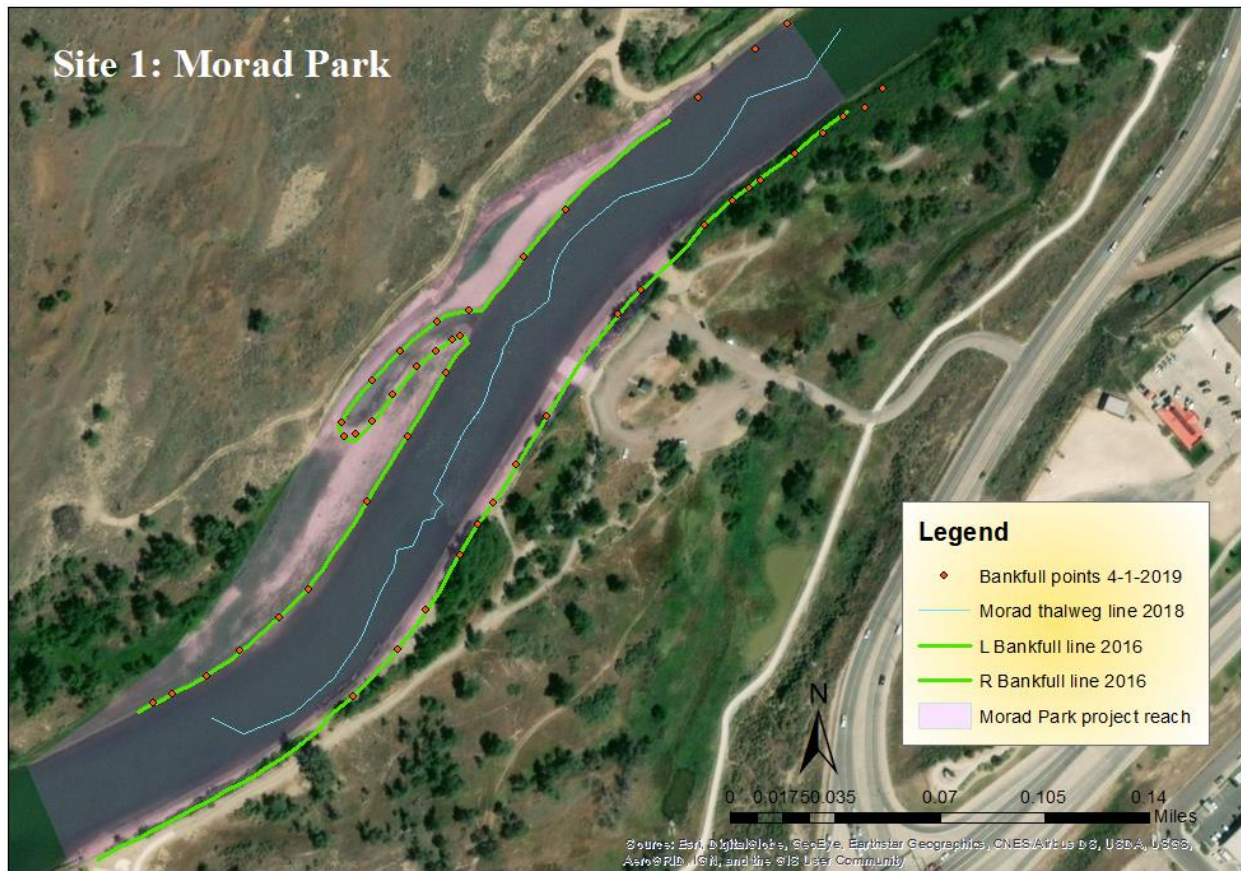
Figure 5. – Map of bankfull elevations along both banks of the Morad Park restored reach in 2016 and 2018.

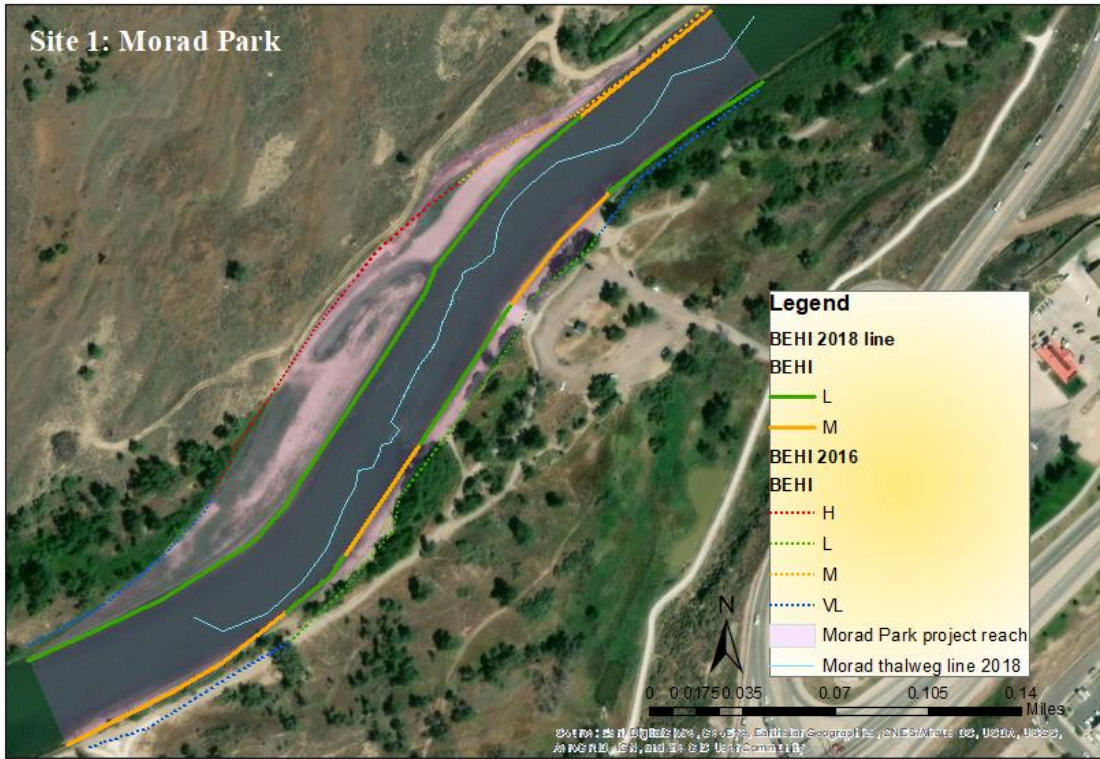
**Geomorphology Goal 3 – Stabilize Streambanks.** Visual assessment of the stream banks revealed no areas of active erosion. Geotextile fabric continues to stabilize many of the banks. The only location of concern was downstream of rock vane 3, where an eddy had formed that may increase near-bank stress on the left bank where the bank slope is steep. Bankfull elevation was surveyed on both banks along the entire project length to compare with the bankfull line surveyed in 2016 (Figure 5). No significant changes in the bankfull locations were observed. BEHI (Figure 6) and NBS (Figure 7) data were mapped and summarized in Table 5. The goal was for BEHI and NBS to be moderate or lower on all banks within the project reach. BEHI was moderate on 36.3% of the bank lengths and low on 63.7%. No banks received a BEHI rating greater than moderate in 2018. NBS was low on 61.8% of the bank length, which is much greater than the 15.8% pre-project value. NBS was high on 12.4% of the banks, which is not desirable but is a reduction from 21% of banks rated high before the project.

Figure 6. - Bank Erosion Hazard Index (BEHI) ratings for the banks in the Morad Park restored reach before restoration (dotted lines) and three years post-restoration in 2018 (solid lines).

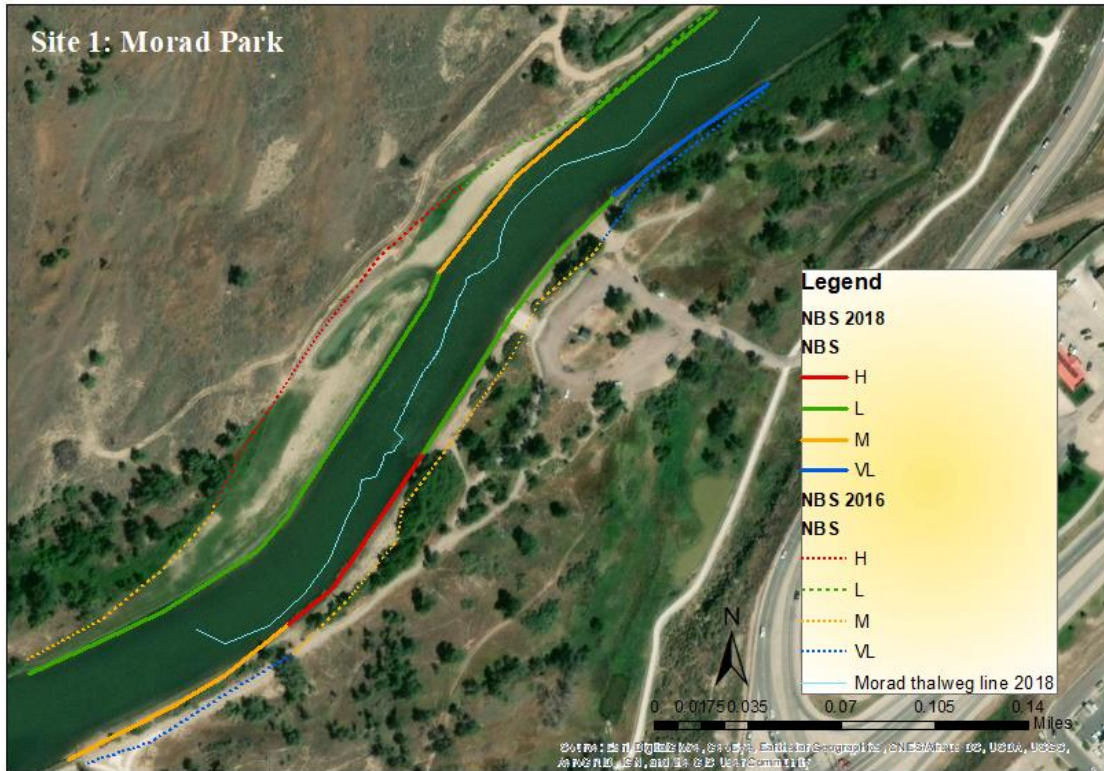
Figure 7. Near-bank Stress (NBS) ratings for the banks in the Morad Park project reach before restoration (dotted lines) and three years post-restoration in 2018 (solid lines).

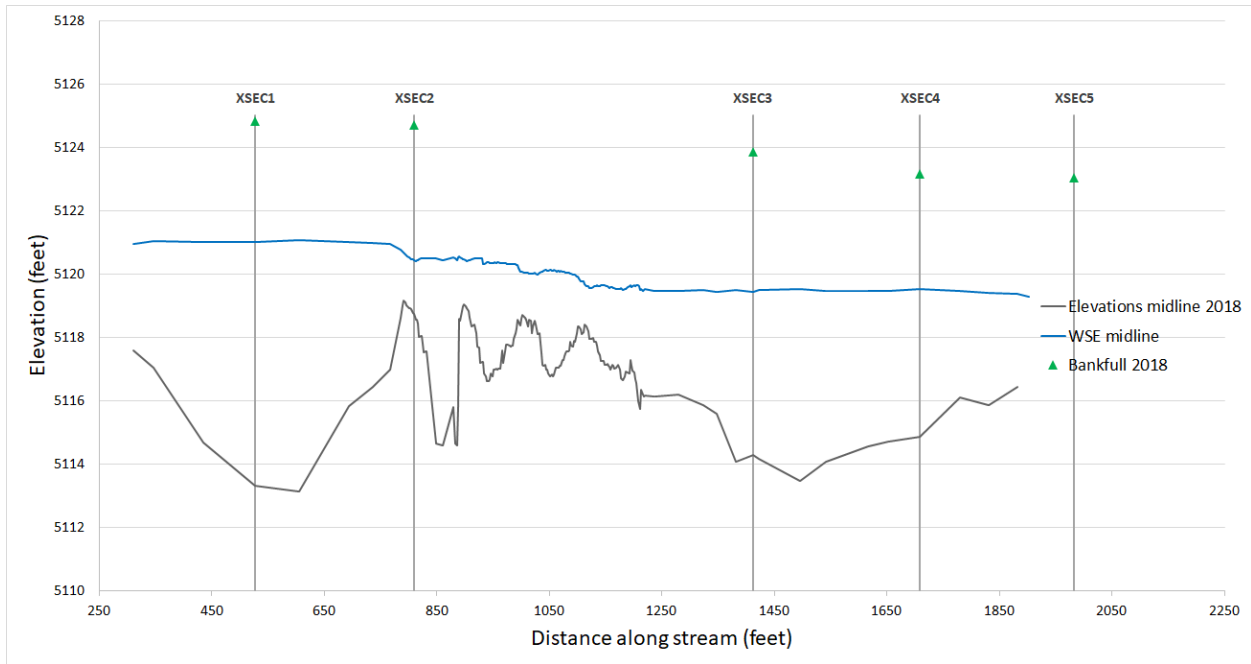
Figure A.1.1. – The longitudinal profile of the Morad Park project reach in October 2018.

The longitudinal profile (Figure A.1.1) shows that two deep pools are still maintained, and may have shifted slightly, as both pools were located just downstream of each of the pool cross-sections 1 and 3. The depth of the pools was calculated by subtracting the elevation of the lowest point of each pool from the closest surveyed bankfull height. Pool 1 was located just downstream of cross-section 1 and had a bankfull depth of 11.64 ft (Table 4). Pool 2 was located just downstream of cross-section 3 and had a bankfull depth of 10.03 ft. The desired pool depth is at least 75% of the design depth of 12.2 ft. In 2018, pool 1 was 95% of the design depth and pool 2 was 82% of the design depth.

The longitudinal profile (Figure A.1.1) also shows ‘troughs; below each of the riffle arms, which improve habitat diversity for fish. The differences in elevation between the top of the riffle arms and the bottom of the scour pools below them are much greater in 2018 than in 2016. In 2016, the differences were all approximately 1 ft. In 2018, survey data showed differences of 4.57 ft, 2.43 ft, and 1.94 ft for riffle arms 1, 2, and 3, respectively.

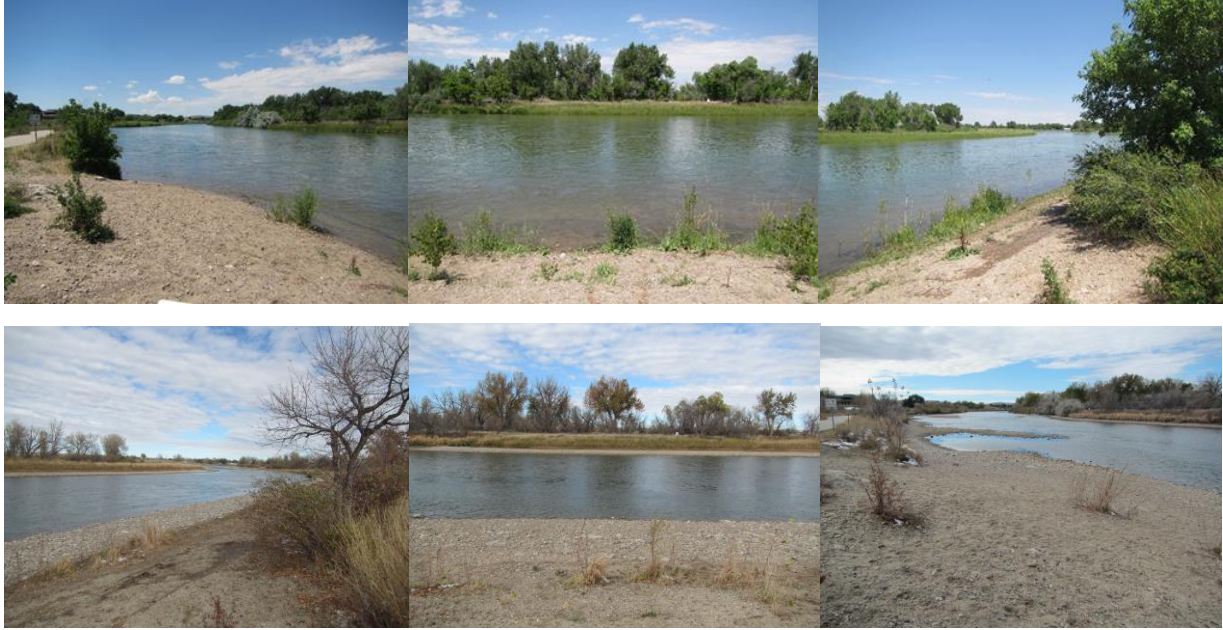
Figure A.2.2. Views from photo point MP-1 looking upstream (left), across (middle), and downstream (right). Looking upstream, deposition near the right bank continues to maintain the cobble/gravel bar. Vandalism affected vegetation plantings along these banks, but some willows and cottonwoods survived. This area receives a lot of foot traffic. Establishment of vegetation over much of the area may be difficult.

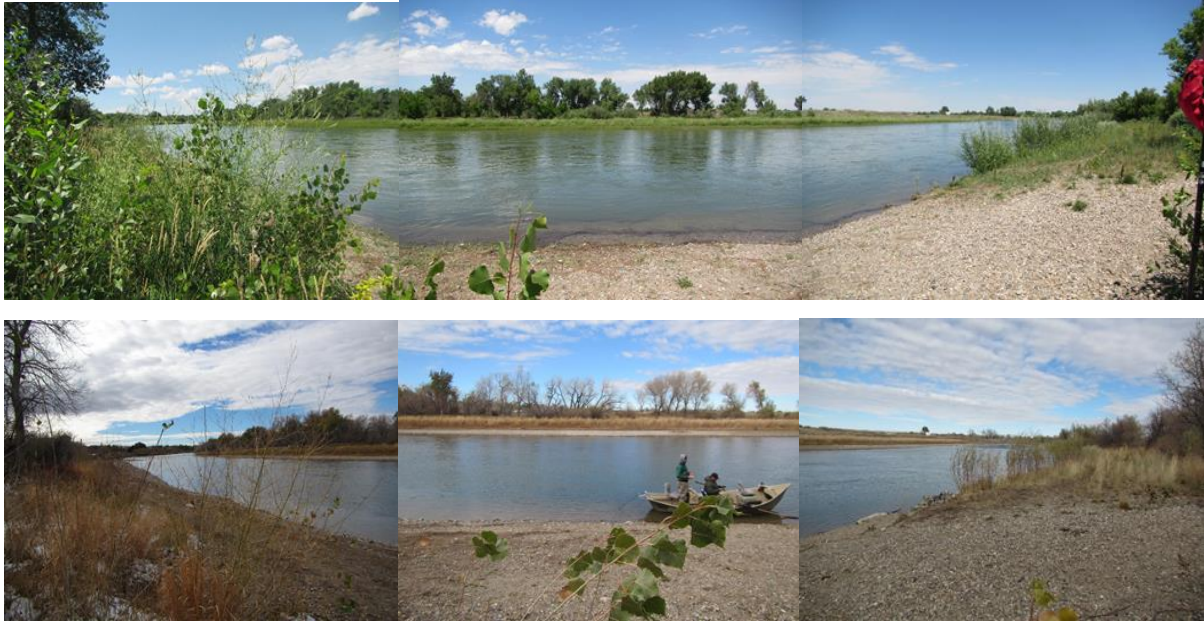
Figure A.2.3. Views from photo point MP-2 looking upstream (left), across (middle), and downstream (right). There is significant vegetation growth both upstream and downstream, compared to the 2015 and 2016 photos. In the downstream photo, willow establishment and growth is evident above the toe wood structure.

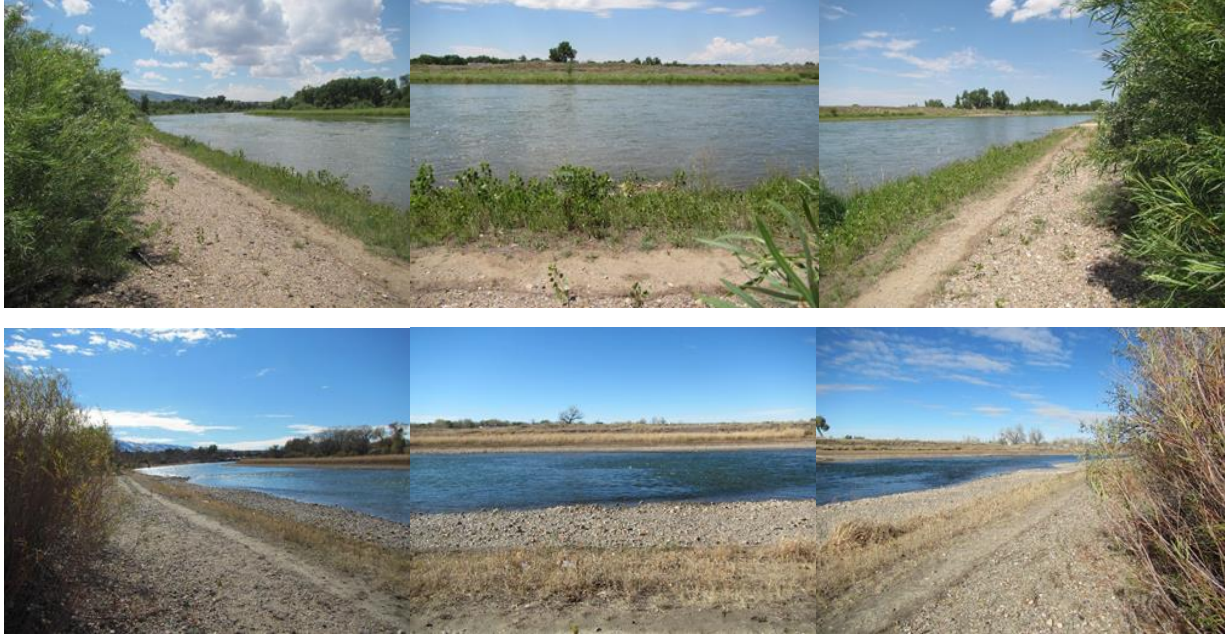
due to its proximity to trails and the park (Figures A.2.4). However, photo points MP-2, MP-3, and MP-4 show that cottonwoods and willows have established well along much of the right bank (Figures A.2.4 - A.2.6). On the left bank, willow and cottonwood stakes did not survive in some areas and much of the bank is dominated by herbaceous vegetation (Figures A.2.7 - A.2.8).

Figure A.2.4. Views from photo point MP-3 looking upstream (left), across (middle), and downstream (right). Photos indicate that there has been some increase in vegetation growth since 2016 along the right bank. Vandalism in 2015 resulted in all live stakes being removed but many willow and cottonwood shoots are currently growing near the inner berm. Cottonwoods have also sprouted from natural sources nearer to the mature willow line. The turbulence in these images are caused by the constructed riffle arms; each created a distinct riffle feature that still appear to be holding the grade of the stream bed as intended.

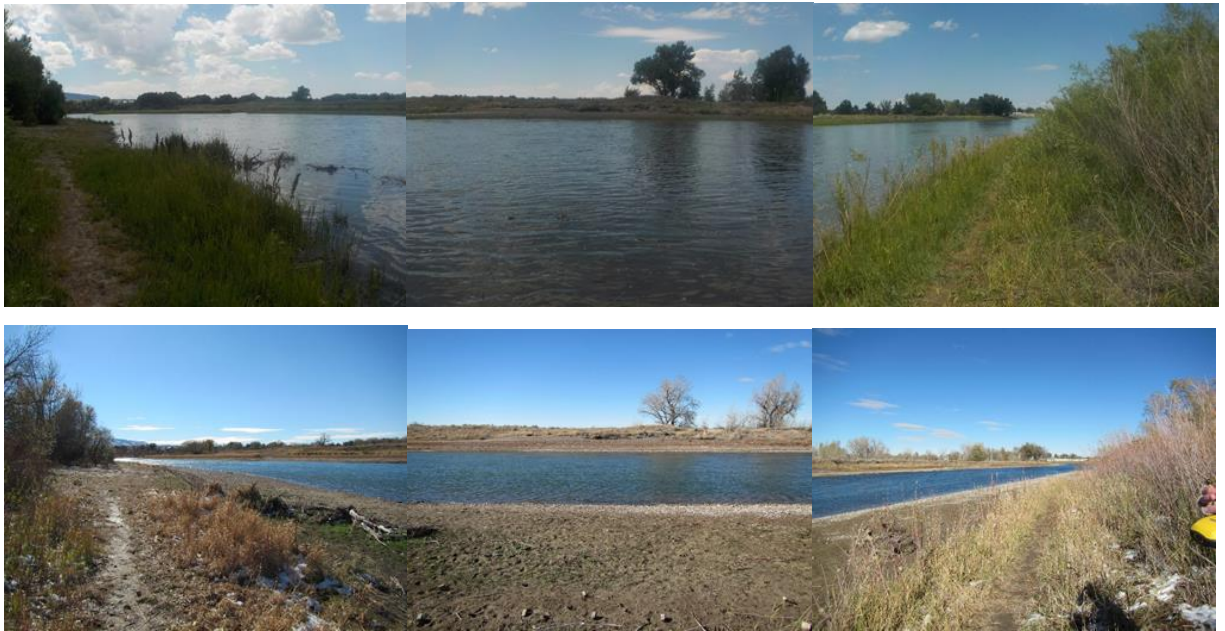
Figure A.2.5. Views from photo point MP-4 looking upstream (left), across (middle), and downstream (right). Vandalism in 2016 also resulted in loss of most stakes along this bank. Most of the vegetation establishment has been herbaceous, although many young willows have established downstream.

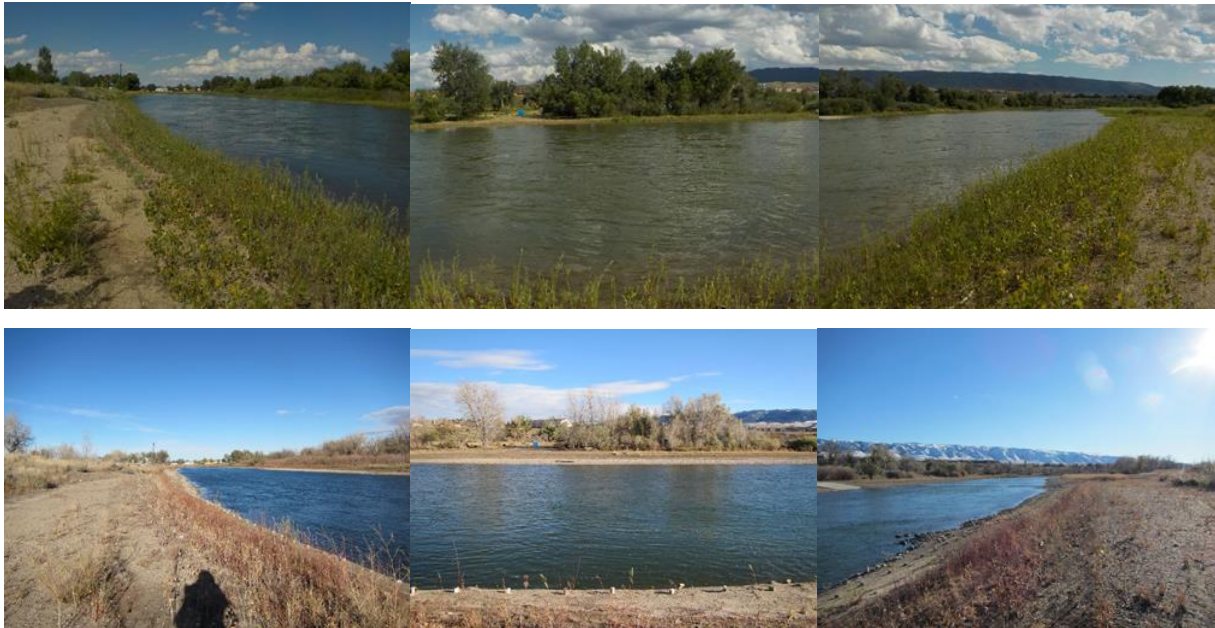
Figure A.2.7. Views from photo point MP-6 looking downstream (left), across (middle), and upstream (right). Many cottonwoods and willows are established and doing well both upstream and downstream. However, the top of these banks are still mostly bare. The upstream image shows the constructed riffle vanes, which continue to function to control the grade and direct flow to the center of the channel.

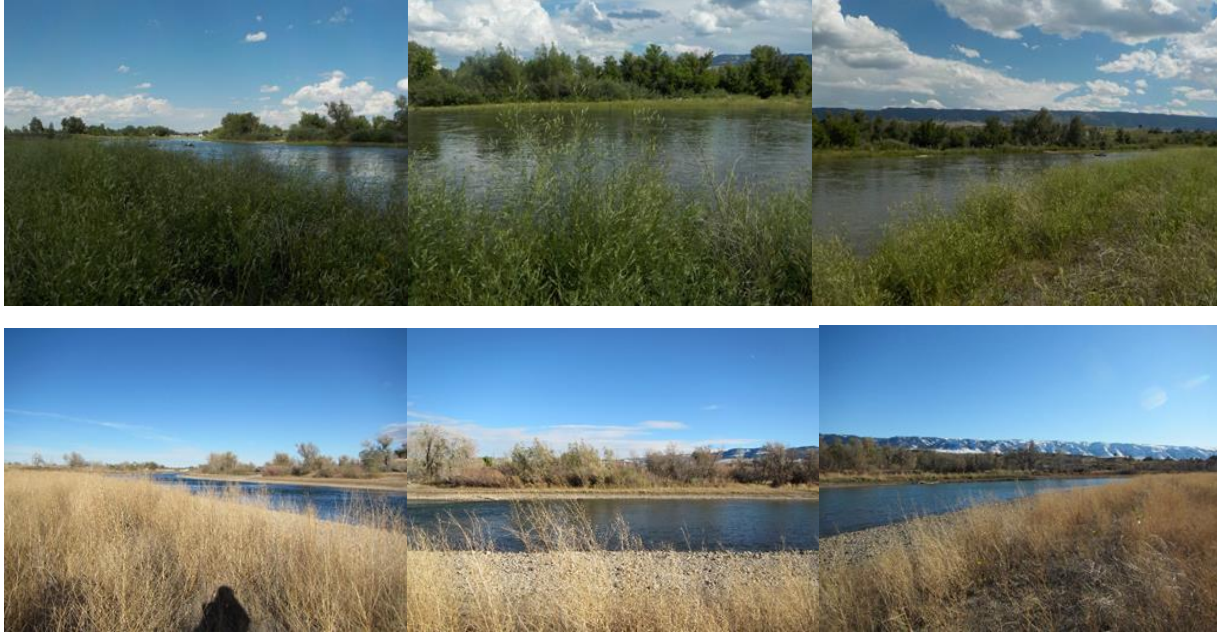
Figure A.2.8. Views from photo point MP-7 looking downstream (left), across (middle), and upstream (right). In the channel at this station an island was removed from the channel and a backwater wetland was created (not visible in photos). Herbaceous vegetation has established on this site and there is no evidence of any of the planted stakes surviving. Although much of the banks have vegetation cover, bank stability may be at risk if woody vegetation does not establish.

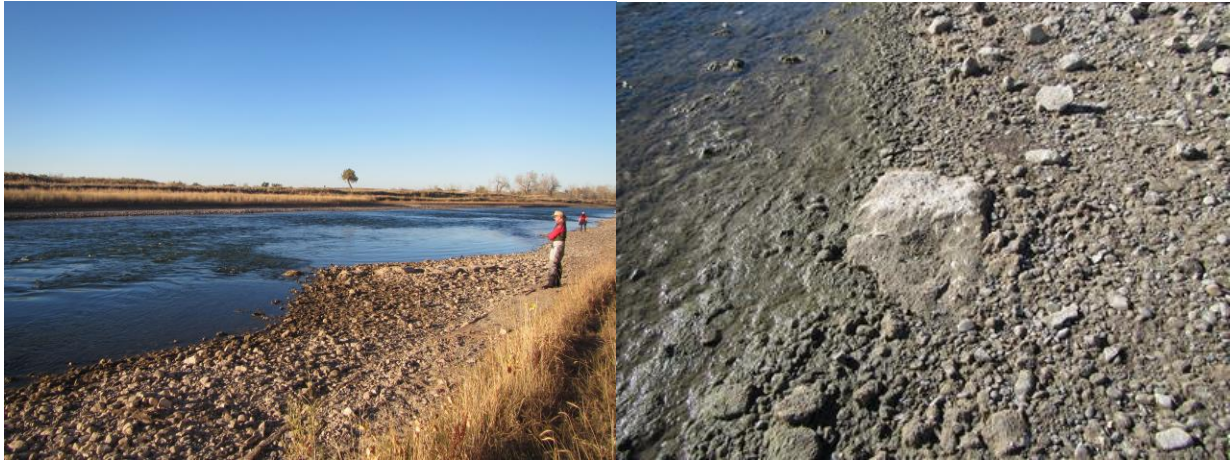
riffle arms seemed to have at least some deposition over them, but deposition was greater on the two downstream arms. Riffle arms 1 and 2 received an erosion/deposition rating of “1 (minor deposition)” while riffle arms 3 and 4 received a rating of “2 (deposition along 25-50% of structure)”. The differences in elevation between the top of the riffle arms and the bottom of the scour pools below them are much greater in 2018 than in 2016 (Figure A.1.1). In 2016, the differences were all approximately 1 ft. In 2018, survey data showed differences of 4.57 ft, 2.43 ft, and 1.94 ft for riffle arms 1, 2, and 3, respectively (Figure A.1.1). The depths of pools between riffles arms will likely vary year to year. As a whole, the constructed riffle seems to continue to function as grade control, directs stream flow to the center of the channel to maintain narrow channel dimensions, and maintains pools for fish habitat.

Figure A.3.1. Site 1 - Morad Park, standing on the left bank, looking downstream at the constructed riffle (left) on 10/15/2018. Arm 1 of the constructed riffle is in the foreground, with multiple boulders visible out of water on the right bank. Turbulence from arms 2 and 3 can be seen downstream in background. On the left is one of the only visible boulders in the fourth (most downstream) arm of the constructed riffle.

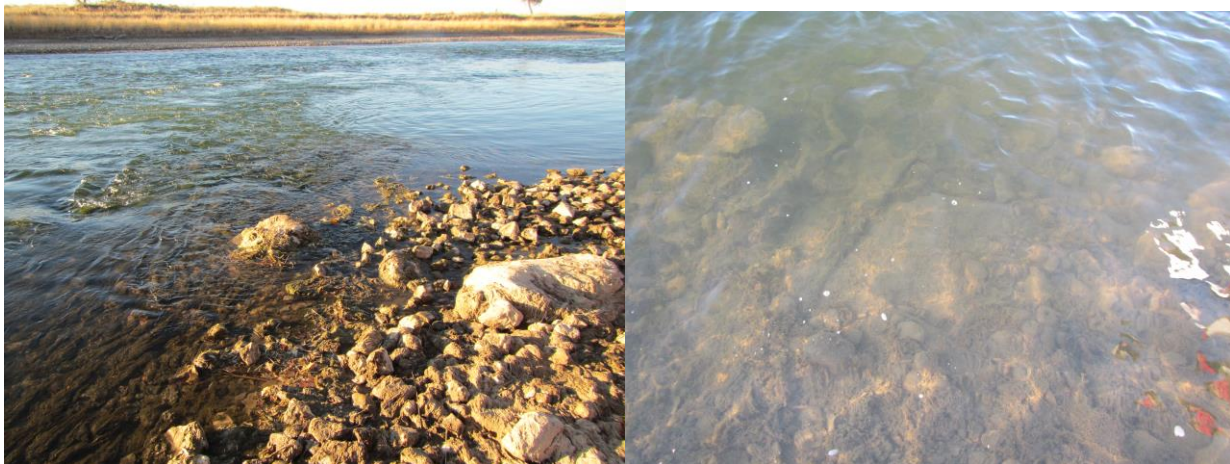
The three rock vanes remain in their appropriate locations according to design plans. Sorted cobble-sized substrate was deposited downstream of the underwater portion of each rock vane, making them seem almost buried, as intended. Scour pools are well-defined on the downstream side of each rock vane. The main intent of the rock vanes is to direct flows away from the bank toe and toward the center of the channel. Rock vane 1 functions to protect the toe wood immediately downstream from scour. The intended function of rock vane 2 was to help transition out of a pool and into a riffle. According to the design engineer, a rock vane in this location may experience high aggradation and the structure may not have been essential at this location. Rock vane 3 was constructed at the upstream end of a pool and was intended to protect the left bank as the river bends to the right and to direct flows from the side channel back toward the center. All three rock vanes received a rapid assessment procedure structural integrity rating of “Intact” (Table A.4.1). Rock vanes 1 and 2 received an erosion/deposition rating of “1”, because of minor deposition over the center of the structure and a well-defined pool being maintained. Rock vane 3 received an erosion/deposition rating of “2” because of more significant deposition along 25-50% of the structure that is affecting the intended function of the structure. An eddy, about 50 feet long, was observed just downstream of rock vane 3. It likely formed due to excessive deposition associated with the rock vane and may cause higher near-bank stress on the left bank. Rock vane 3 was difficult to rank for structural integrity using the rapid assessment descriptions because the structure is intact but it is likely not functioning as intended. There is no ranking that accounts for that condition.

Figure A.3.2. Site 1 - Morad Park, standing on right bank, looking across the channel at Rock vane 1 (left). The header boulders are visible above base flow in the foreground (left). Boulders underwater at the same level of the surrounding substrate further into the channel (right).
