## **2019 Annual Monitoring Report for the North Platte River Restoration Project**

Joanna Harter, Aquatic Habitat Project Biologist, Wyoming Game and Fish Department, 5400 Bishop Blvd, Cheyenne, WY 82006

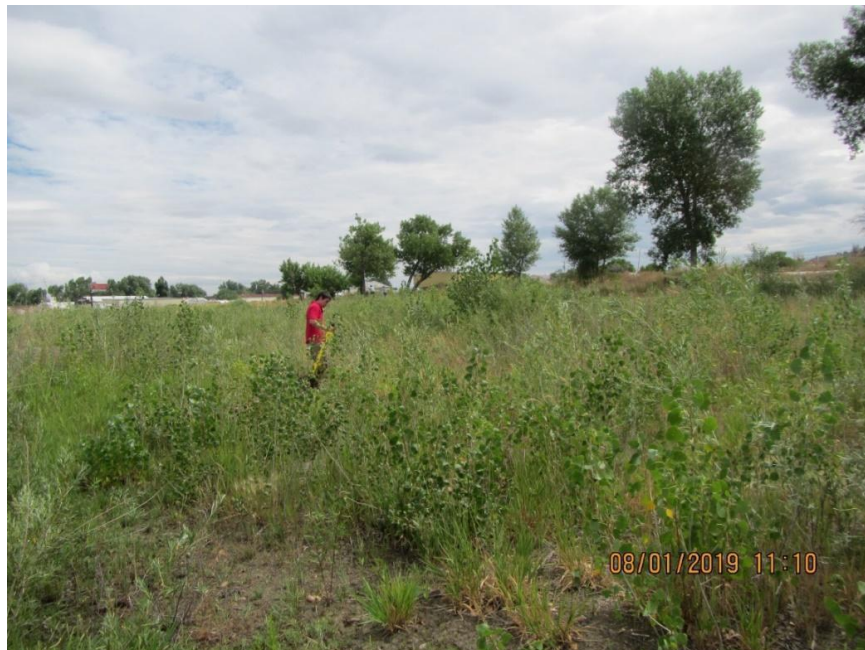
Along the right bank of the project reach, on the constructed floodplain along SW Wyoming Boulevard, woody and herbaceous vegetation has become well established, with young cottonwoods over 6 ft tall (Figure 5, A.4.7). Restoration was completed in this upper part of the reach in 2015 and unusually high flows occurred May-June 2016, (Figure A.3.1). Peak runoff exceeded 7,100 cfs (Figure A.3.1) and flows remained above bankfull flow for over a month, inundating the floodplain. The time period of floodplain inundation, coupled with the bare soil following construction, created ideal conditions for cottonwood regeneration. Restoration was not completed on the lower part of the reach until fall 2016, so the riparian area did not receive the same benefit from the extended, high runoff of 2016. Willows have established well above all three toe wood structures along the constructed floodplain (Figures 6, A.5.1-A.5.6). Downstream of the water intake structure on the right bank, willows and herbaceous vegetation are sparse (Figures A.4.10, A.5.7). As the coir fabric deteriorates in the future, this area should be monitored for vegetation establishment to ensure long-term stability of the reconstructed banks.

FIGURE 5. A stand of young, healthy cottonwoods on the constructed floodplain between the relocated stream channel and SW Wyoming Boulevard, near photo point WY-7.

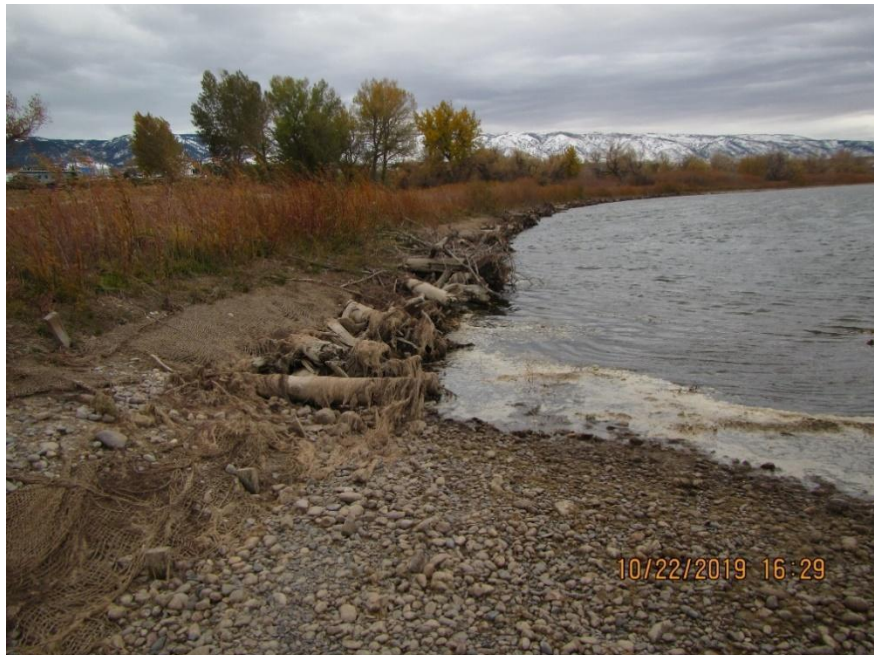
FIGURE A.5.2. Site 2 & 3 - Wyoming Blvd, standing at downstream end of toe wood 1, looking upstream. Willows have established well above the structure, contributing to long-term bank stability.

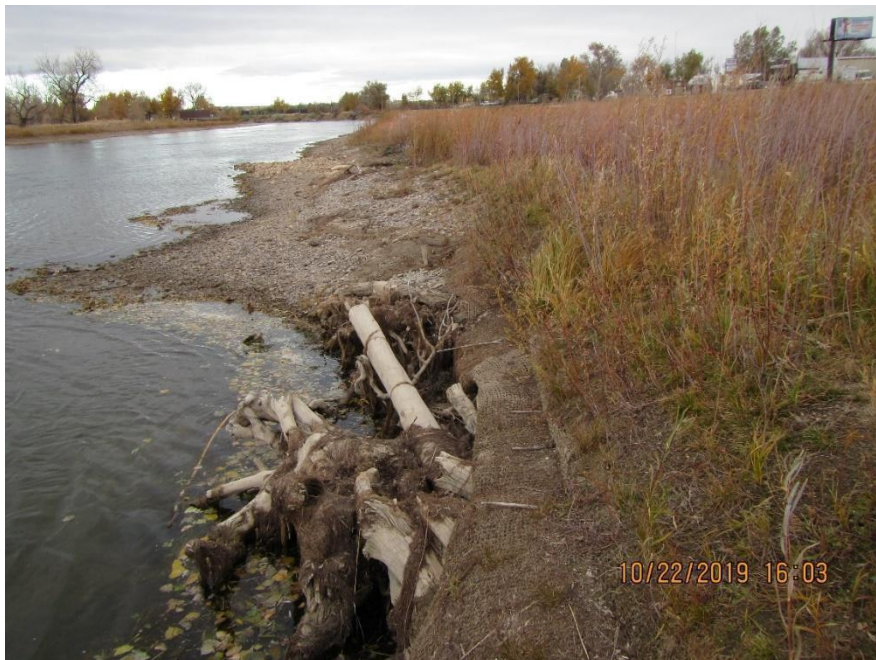
Toe wood 2 is approximately 115 ft long, located just downstream of toe wood 1 and upstream of the first set of wetland outlet cross vanes (Figures A.5.3, A.5.4). Localized bank scour was observed around multiple logs in this structure, resulting in more log length being exposed. Toe wood 2 should continue to be monitored closely for further signs of bank erosion between the vegetation line and the root wads, especially as coir fabric deteriorates. Young willows have established well above the structure. Toe wood 2 is not providing much fish cover or habitat as the root wads were elevated above the water surface elevation at base flows in both 2018 and 2019 and there was no pool being maintained along the structure. The elevation difference between the tops of the root wads or logs and the water surface at base flow ranged from 1.5 to 3.0 ft, with an average of 2.1 ft.

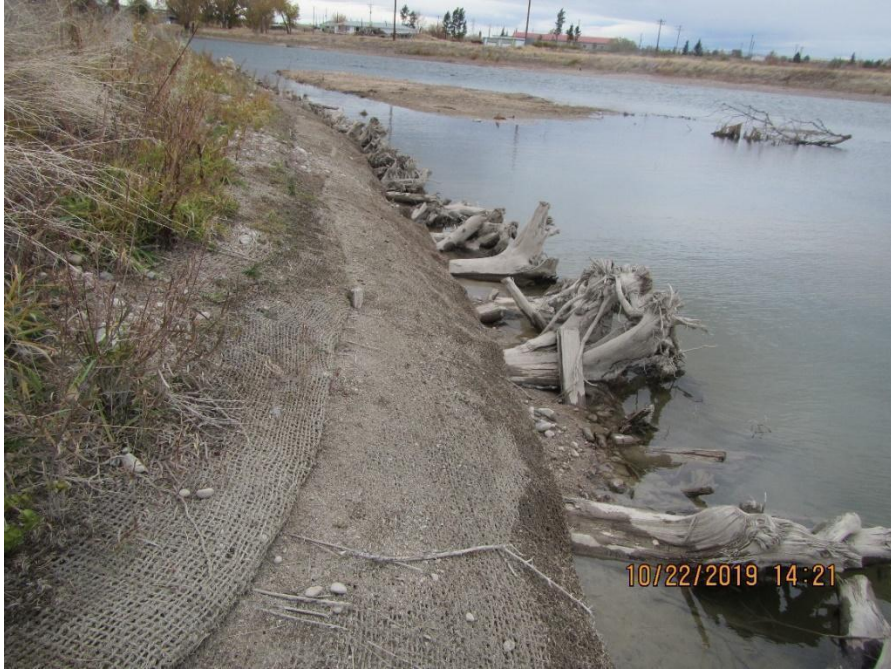
Toe wood 5 is approximately 345 ft long, located on the left bank, just downstream of the oxbow wetland (Figures A.5.9, A.5.10). This structure was not in the 100% design plans but was constructed to provide extra protection for the streambank along the water treatment facility wells (T.C. Dinkins, Stantec Design Engineer, personal communication). The river bends right at this location, which likely places additional shear stress on the left bank. Rock vanes 4 and 5 help direct channel flows into the center, rather than this outside bend. Fine sediment deposition was observed just below and between the root wads, likely due to sediment settling out of the slower water downstream of the oxbow wetland. A sediment bar is also forming at the mouth of the oxbow wetland, indicating that the bank is not experiencing high shear stress. The oxbow wetland was intended to be more isolated from the main channel than it currently is, so the deposition is acceptable (T.C. Dinkins, Stantec Design Engineer, personal communication). Some willows have begun to establish above the toe wood, but not as densely as above the first three toe wood structures.

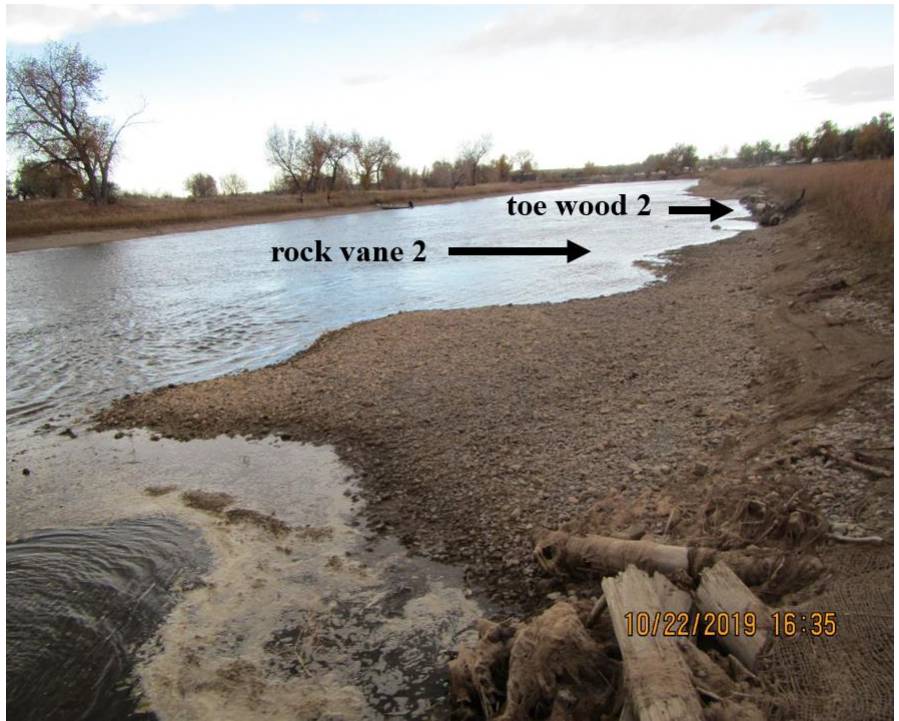
Rock vane 2 is located upstream of toe wood 2 (Figure A.5.12). In 2019, only one small boulder could be visually identified. Rock vane 2 received a “damaged” rating for structural integrity and a “4” rating for deposition because over 75% of the structure was buried. A pool was maintained upstream of the structure and toward the middle of the channel. This may be contributing to deposition upstream of rock vane 2. This may not be an ideal structure and location combination, as they tend to become aggraded. The vane was intended to help transition out of a pool and into a riffle and the structure might not have been necessary (T.C. Dinkins, Stantec Design Engineer, personal communication).

FIGURE A.5.12. Site 2 & 3 - Wyoming Blvd, standing just upstream of rock vane 2 on river right, looking downstream at rock vane 2 (rocks not visible in photo).

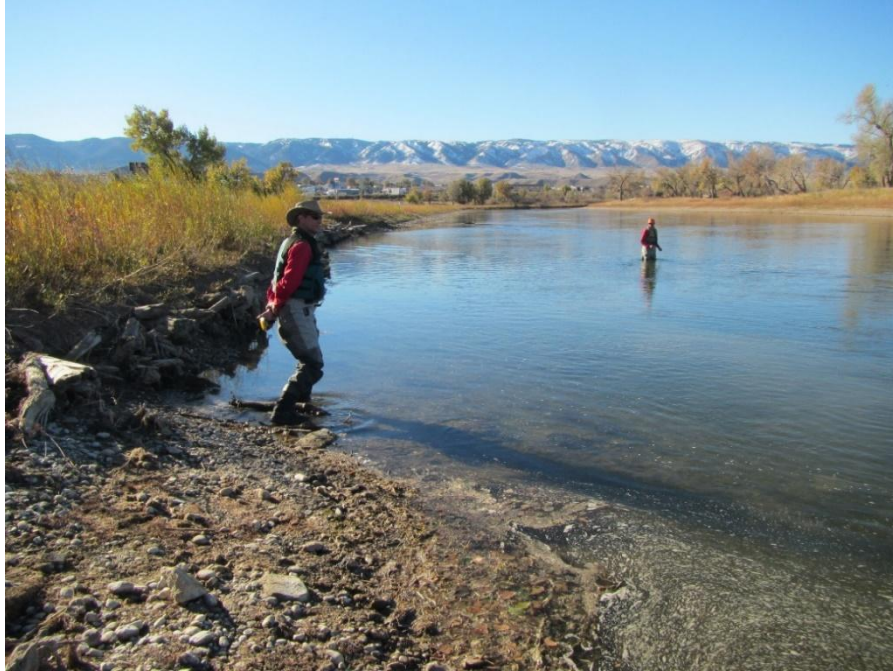
Rock vane 3 is located just downstream of toe wood 3 and upstream of a water intake structure (Figure A.5.13). The intended function is to deflect water flow energy away from the downstream bank and further downstream water intake structure. In 2019, none of the boulders in the vane could be located. Thus, rock vane 3 also received a “damaged” rating for structural integrity and a “4” rating for deposition because over 75% of the structure was buried. The downstream bank was not modified during construction but is relatively well-armored with rock and concrete. Thus, the bank and intake structure do not appear at risk of additional erosion due to the potential loss of the function in this rock vane.

FIGURE A.5.13. Site 2 & 3 - Wyoming Blvd, standing just downstream of rock vane 3 on river right, looking upstream at rock vane 2. The two individuals are standing on the first and last visible boulders of rock vane 3. This photo is from October 2018, as the boulders could not be located in 2019.

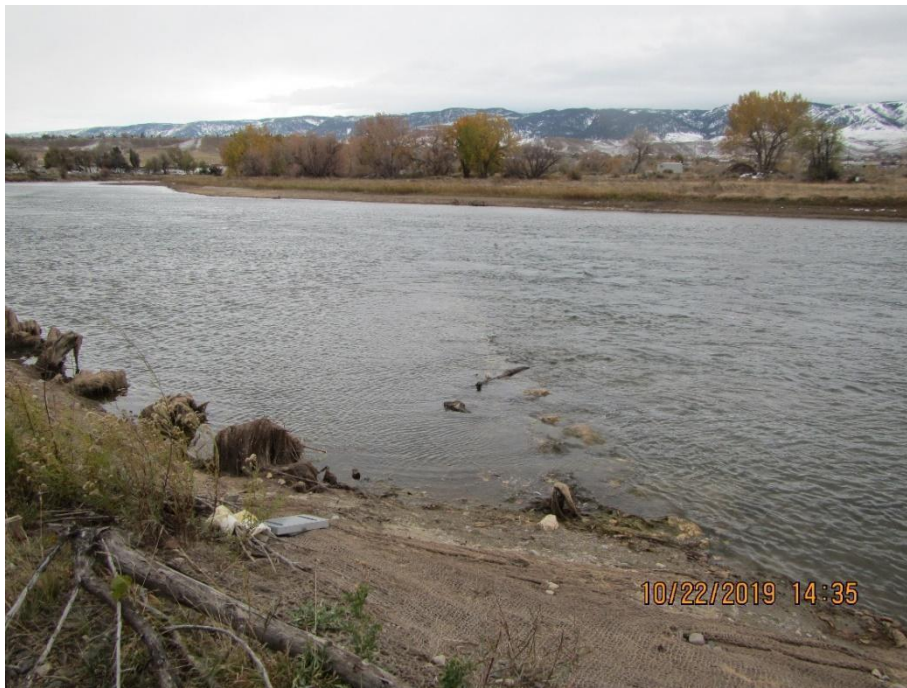
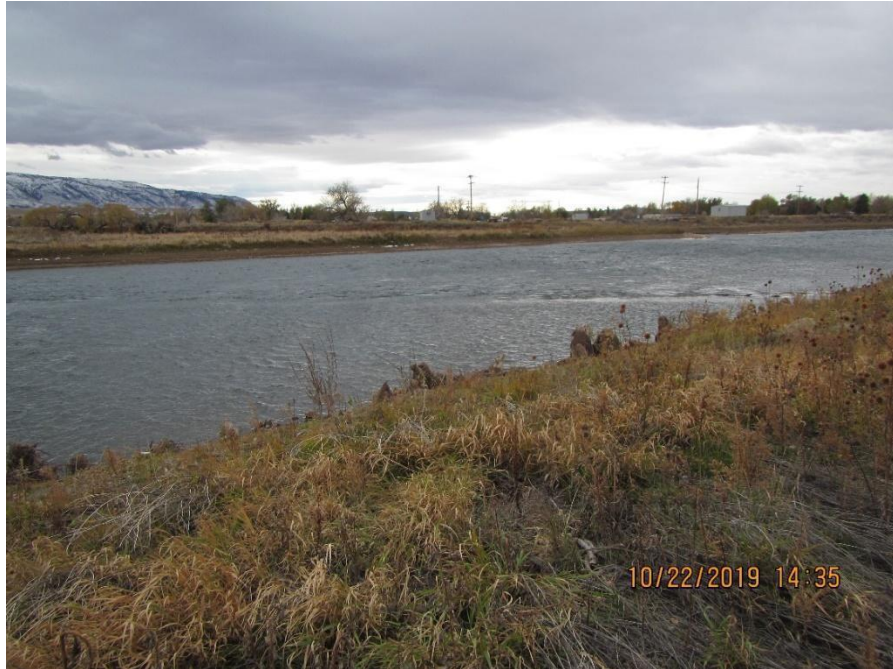
Rock vane 4 is located just downstream of toe wood 4 and was not in the 100% design plans (Figures A.5.14, A.5.15). Rock vane 4 spans over half of the channel width at base flow. Two boulders in the vane (the 21<sup>st</sup> and 22<sup>nd</sup> from the bank) rolled downstream 2-3 ft. A deep, well-defined pool is maintained downstream of the structure. Thus, rock vane 4 received an “intact” rating for structural integrity, as the shifted boulders do not comprise 10% of the structure, and a “0” rating for erosion/deposition, as none was observed.

FIGURE A.5.14. Site 2 & 3 - Wyoming Blvd, standing at rock vane 4 on river right, looking slightly upstream, in direction of rock vane 4. Boulders in the vane are visible near the bank.

FIGURE A.5.15. Site 2 & 3 - Wyoming Blvd, standing just upstream of rock vane 4 on river right, looking slightly downstream, in direction of rock vane 4. The vane's influence on streamflow is visible at these flows past the channel center.

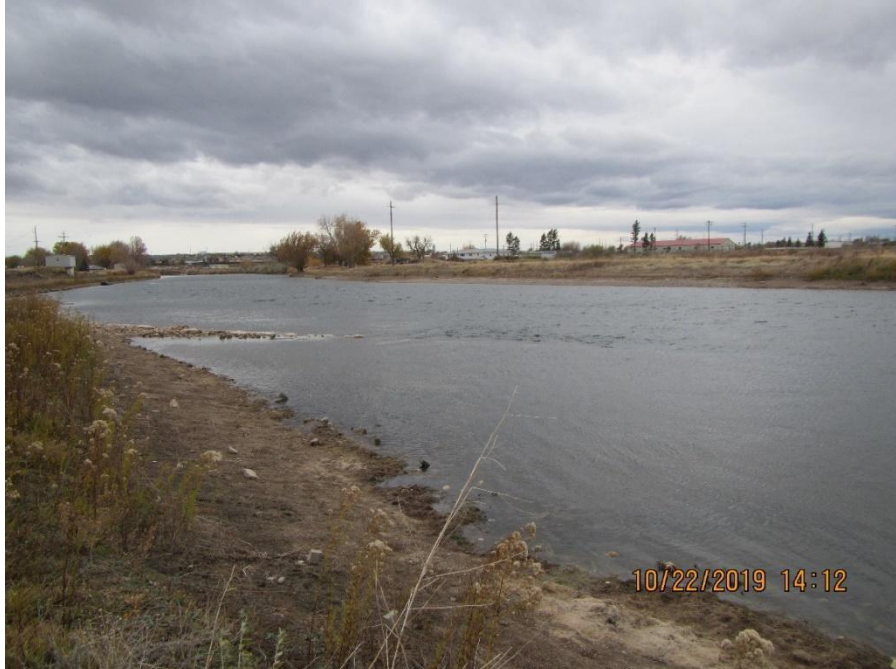
Rock vane 5 is located just upstream of toe wood 5 and upstream of the mouth of the oxbow wetland (A.5.16, A.5.17). Rock vane 5 was also not in the 100% design plans but was added in conjunction with toe wood 5 to protect infrastructure on the left bank. Most boulders in this vane were visible and in place in 2019 so it received an “intact” rating for structural integrity and a “0” rating for erosion/deposition as none was observed.

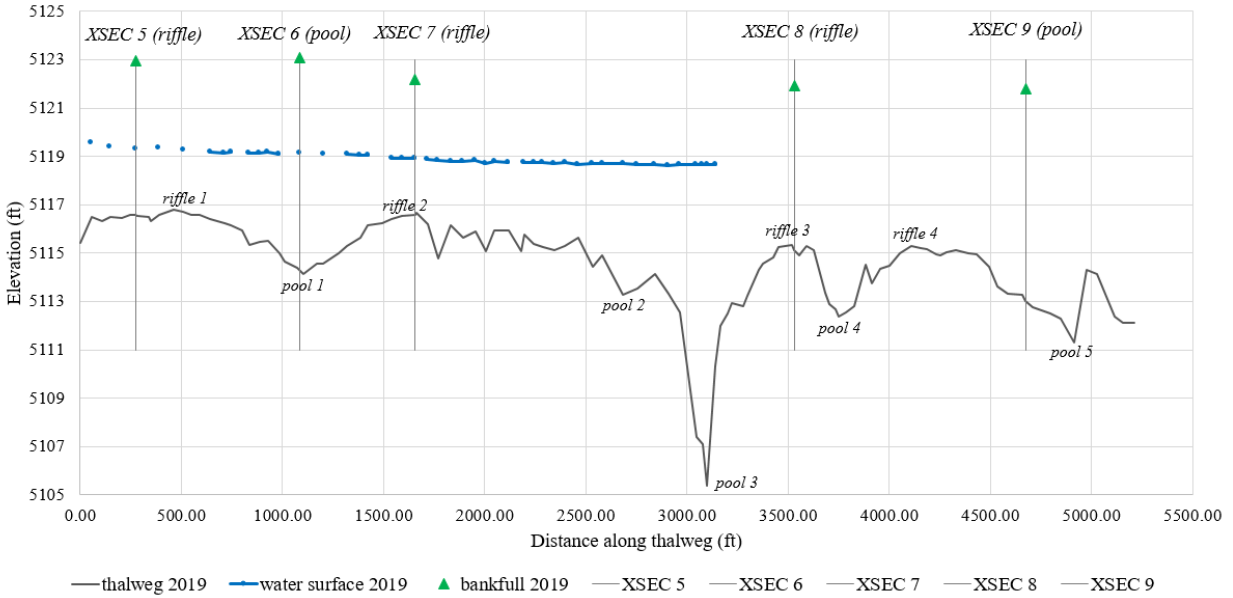
FIGURE A.6.2. – The longitudinal profile of the Wyoming Blvd project reach in October 2019, identified pools and riffles, and the locations of the five surveyed cross-sections.

In 2019, five distinct pools were observed within the Wyoming Blvd project reach (Table 5, Figure A.6.2). A pool along the water intake structure was 16.6 ft deep at bankfull (pool 3 in Figure A.6.2) and was excluded from assessment of improvement in fisheries habitat as the stream in this area was not altered by the restoration work. The other four constructed pools ranged in depth at bankfull from 8.8 ft to 11.2 ft (Table 5). All pools met the criterion that they remain at least 75% of project design depth, which is 9.3 ft in the Wyoming Blvd reach (Table 5).

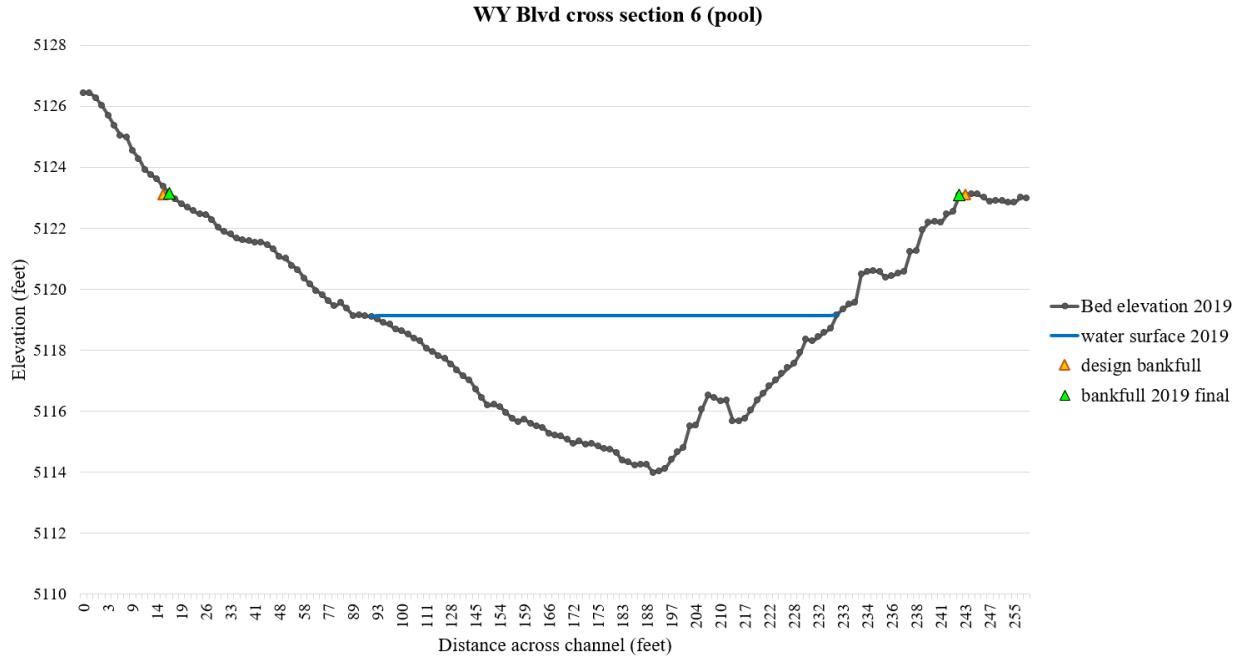
FIGURE A.6.6. – Profile of river bed and bank elevations at cross-section 6 in 2019.

Pool 1 and pool 5 were selected for cross-section surveys. Cross-section 6 captured pool 1 (Figure A.6.6) and cross-section 9 was intended to capture pool 5 (Figure A.6.7). On the longitudinal profile, it appears that cross-section 9 was surveyed slightly upstream from the location of pool 5. However, the cross-section profile shows that the pool depth at the cross-section (11.2 ft) was deeper than the pool depth on the longitudinal profile (pool 5, 10.5 ft; Figure A.6.2). The difference is only 0.7 ft and the discrepancy may be due to missing the exact location of the deepest point of the pool when bathymetry data was collected. Elevation data from the cross-section surveys are more accurate than elevation data recorded during bathymetry mapping when the boat from which recordings were made was moving more quickly and more likely to be influenced by variation in pitch.
