## North Platte River Environmental Restoration Master Plan – Phase I

City of Casper Public Services Department  
Casper, Wyoming

Stantec Consulting Services, Inc.  
2950 East Harmony Road, Suite 290  
Fort Collins, Colorado 80528

May 21, 2012

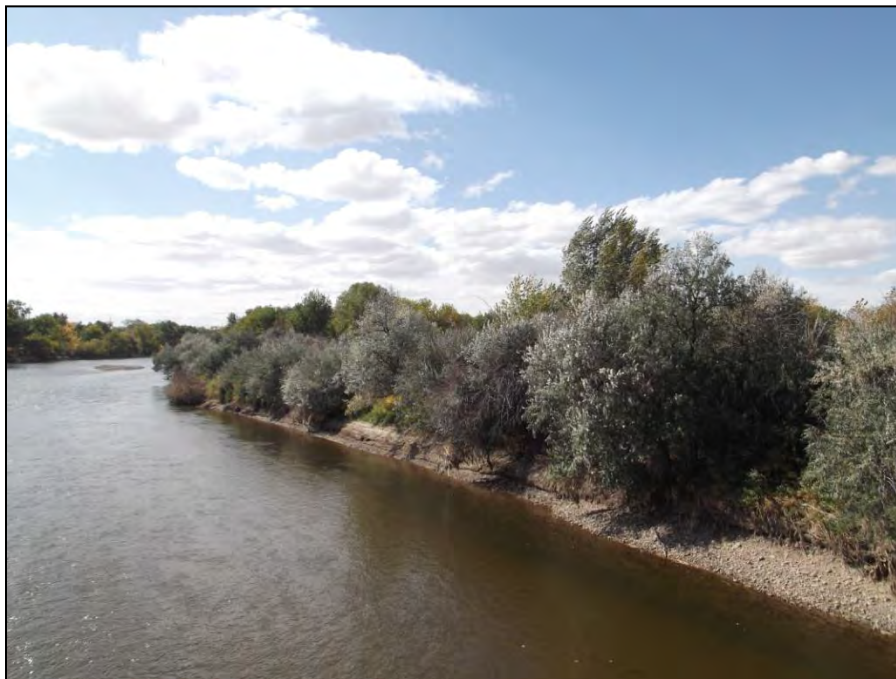
This site is located in the North Platte River Park vegetation restoration priority area (Figure A2). This site is predominantly within the lower terrace zone that is frequently inundated with well-established wetlands. Mature Russian olive is established along the riverbank and saplings are well-established on side channel features and frequently flooded areas (Photopoint 1). Other species observed at this site included reed canarygrass, sandbar willow, scratchgrass, alkali sacaton, fringed sagewort, carex sp., showy milkweed, eastern cottonwood, narrowleaf cottonwood, Canada goldenrod, and sandbar willow.

Photopoint 1. Mature Russian olive established along the riverbank at Site 2.

This site is high priority around the floodplain features. Russian olive saplings could be eradicated through spot treatments. In addition, this area supports the hydrology necessary to establish wetland vegetation. Riverbank enhancements along with side channel improvements and wetland reconstruction would be successful based on river dynamics, hydrology, and established native and wetland vegetation.

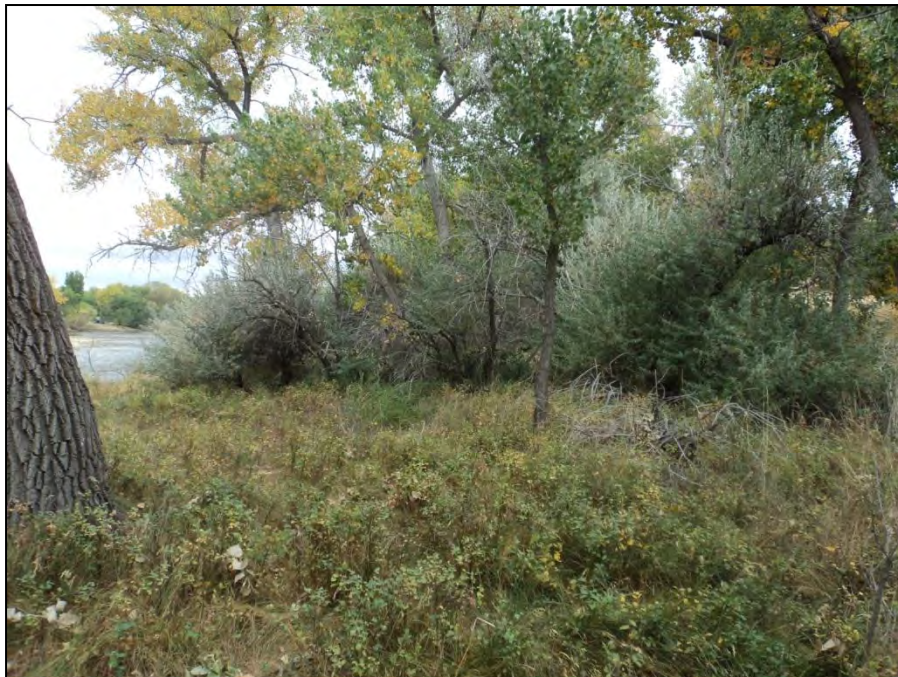
and shrubs are located in the lower terrace zone (Photopoint 2). Severe bank collapse is occurring along the entire riverbank at this site. Russian olive cover is predominately located along the riverbank. This area provides a substantial Russian olive seed source for less invaded areas downstream. Cheatgrass is the dominant groundcover in the upper terrace zone and upland zone. Other species observed at this site included eastern cottonwood, crested wheatgrass, western snowberry, Kentucky bluegrass, scratchgrass, and western wheatgrass

Photopoint 2. Riparian vegetation on lower terrace zone at Site 6.

Russian olive treatment potential is high if prevention of further establishment downstream is a priority. Russian olive is the dominant cover on the riverbank and may be exacerbating the bank collapse at this site with lack of native vegetation and development of high banks for undercutting. Immediate bank stabilization would be necessary if vegetation were to be removed.

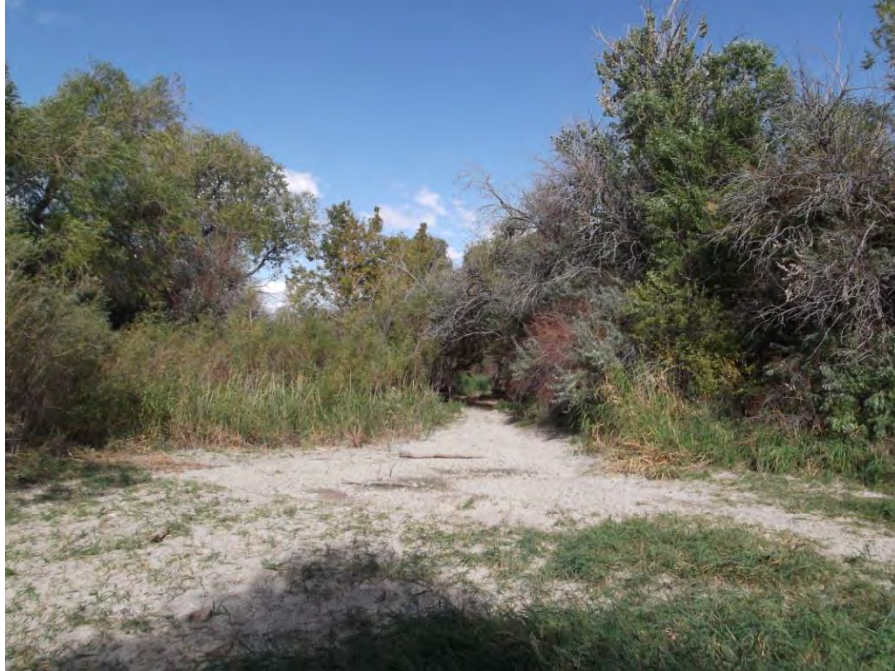
This site is located in the Morad Park vegetation restoration priority area (Figure A11). This area is frequently disturbed and was recently flooded. Russian olive and crack willow (*Salix fragilis*) are co-dominant canopy species (Photopoint 4). Russian olive is well-established but the sandbar willow stands are more dominant in sandier soils along the riverbank and in areas that are more recently scoured. Mature cottonwoods are present although sparse. This area includes a high occurrence of large woody debris and refuse from recent flooding, providing ideal riparian habitat for a variety of wildlife species. Other species observed at this site included sandbar willow, carex sp., reed canarygrass, narrowleaf cottonwood, box elder, red-osier dogwood, western snowberry, crested wheatgrass, and curly dock.

Photopoint 4. Russian olive and crack willow co-dominant canopy at Site 11.

Although Russian olive is co-dominant at this site, riparian willow stands provide a good source for cuttings in areas where Russian olive would be removed. The majority of the riverbank has well-established sandbar willow stands and Russian olive removal would not compromise bank stability. This area is actively flooded and supports natural riparian hydrology, which would help reduce future Russian olive establishment and support native riparian vegetation.

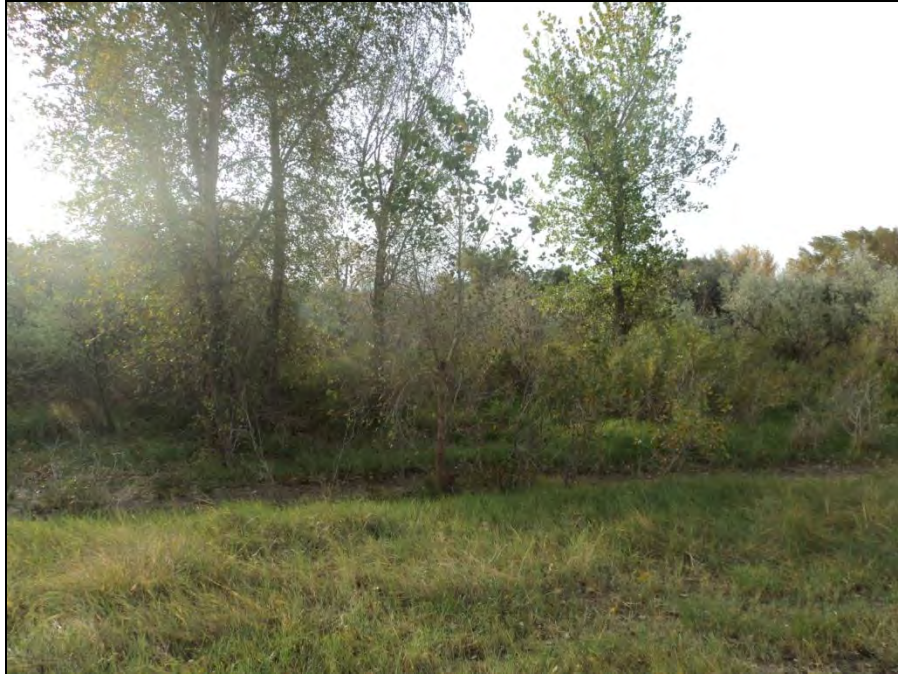
This site is located in the North Platte River Park vegetation restoration priority area (Figure A3). This area supports a sandbar zone, lower terrace zone, and upper terrace zone (Photopoint 5). The area does not have any side channel features and/or flooding features as compared to the downstream site 2. Russian olive is concentrated at the riverbank and is limited in distribution in the upper terrace zone. Other species observed at this site included reed canarygrass, sandbar willow, scratchgrass, alkali sacaton, fringed sagewort, carex sp., showy milkweed, eastern cottonwood, narrowleaf cottonwood, Canada goldenrod, and sandbar willow.

Photopoint 5. Riparian vegetation with Russian olive in the upper terrace zone at Site 3.

Russian olive eradication along the riverbank would be critical to support downstream restoration and revegetation efforts. However, the removal of Russian olive would compromise bank stability and increase erosion potential. Measures would need to be implemented to support bank stability and reduce sedimentation and erosion.

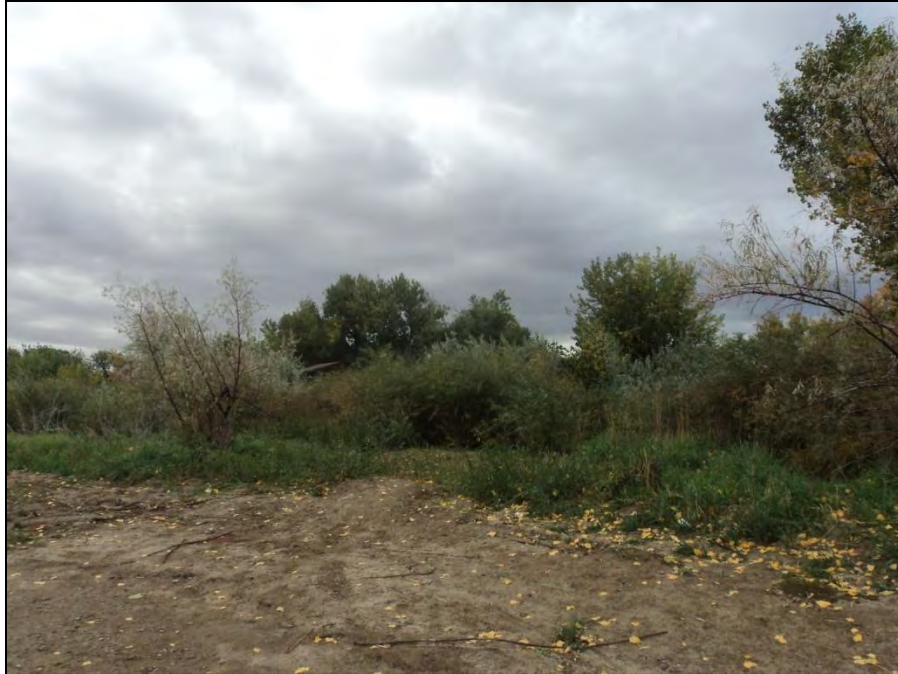
This site is located in the North Platte River Park vegetation restoration priority area (Figure A4). This area is positioned in a heavily flooded reach with significant beaver damage to native cottonwoods. A sandbar zone supports a healthy stand of sandbar willow and reed canarygrass. Russian olive is well established throughout this site and actively establishing within erosional areas as a result of the 2011 flood events (Photopoint 6). Additional species observed at this site included eastern cottonwood, crack willow, sandbar willow, plains cottonwood, reed canarygrass, and curly dock.

Photopoint 6. Russian olive establishment upland of the sandbar zone at Site 4.

This area is highly accessible and may potentially have high recreational use. The majority of mature cottonwoods will need to be removed as a result of beaver damage. Russian olive densities at this site are high and removal and restoration efforts would require complete removal of Russian olives, followed by revegetation with native species and a monitoring and maintenance plan to keep reestablishment of Russian olives at a minimum. Removal and maintenance costs may be high at this site, however this site has high recreational use potential and could serve as a seed source for downstream areas.

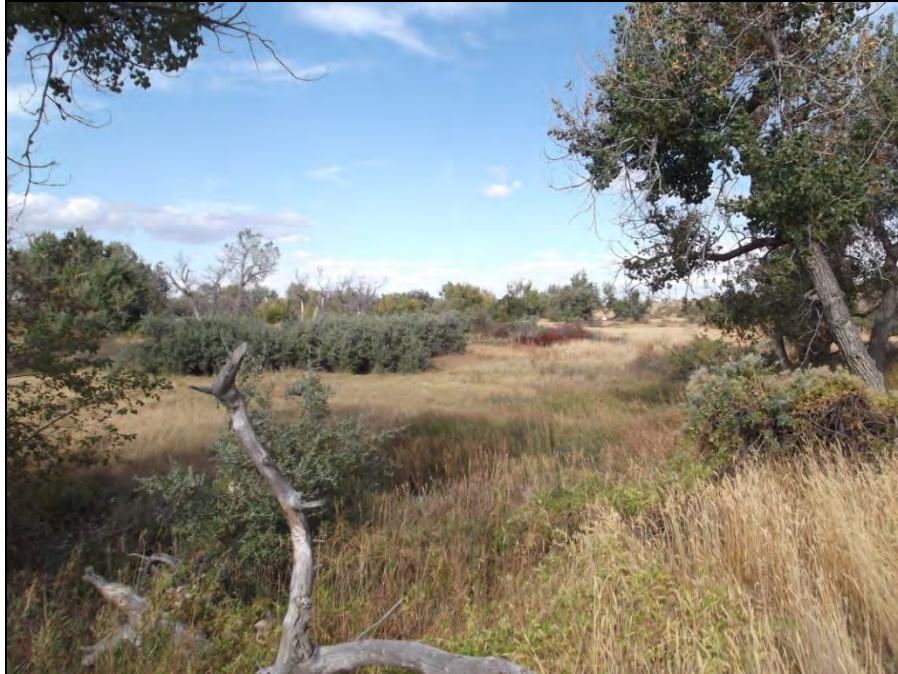
This site is located in the Morad Park vegetation restoration priority area (Figure A12). This area supports several relic side channels and depressions from prior flooding events and channel migration (Photopoint 8). This site is located within the upper terrace zone and supports localized depression swales and wetlands. Russian olive establishment is limited and there are very few large, mature Russian olive trees. Additional species observed at this site included sandbar willow, reed canarygrass, kochia, crested wheatgrass, narrowleaf cottonwood, alkali sacaton, western wheatgrass, western snowberry, prairie rose, Kentucky bluegrass, curly dock, cheatgrass, pennycress, and box elder. The presence of western wheat grass, cheatgrass, and Kentucky bluegrass indicates that non-native grasses have established at this site.

Photopoint 8. Densely vegetated side channel in the upper terrace zone at Site 12.

Although Russian olive densities are low in this area, restoration potential is moderate due to the opportunity to establish native riparian vegetation and enhance and develop existing wetland areas. Increasing wetlands in this heavily used area would increase the aesthetic appeal of Morad Park and provide a runoff and sediment trap to reduce sedimentation to the North Platte River.

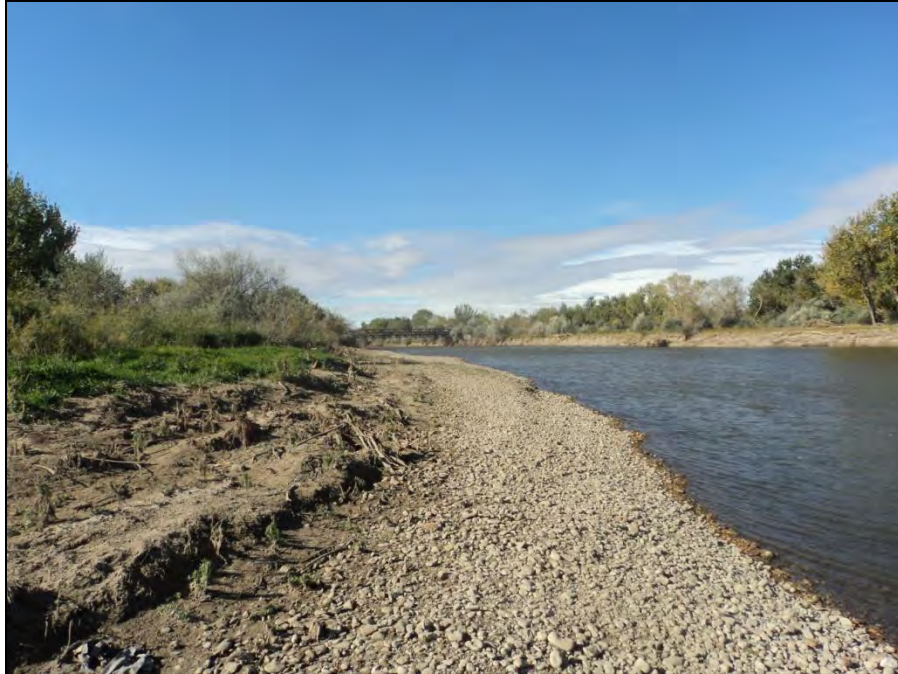
This site is located in the North Platte River Park vegetation restoration priority area (Figure A1). This area has a prominent sandbar zone that is frequently flooded and scoured (Photopoint 9). Cottonwoods on the lower and upper terrace zones are mature and healthy. Russian olive is established but not dominant. A municipal drainage from a large athletic field complex to the south exits into this site. Additional species observed at this site included sandbar willow, carex sp., cheatgrass, reed canarygrass, western wheatgrass, crested wheatgrass, kochia, and crackwillow.

Photopoint 9. Gravel and cobbly riverbed and scoured sandbar along riverbank at Site 1.

Restoration potential in this area may be limited due to the frequency of disturbance from flooding and irregular drainage patterns from the athletic field complex. Russian olive removal and eradication would increase the natural landscape and reduce the seed source. Development of a wetland catchment near the drainage would control the outflow from the drainage and reduce sedimentation from runoff.

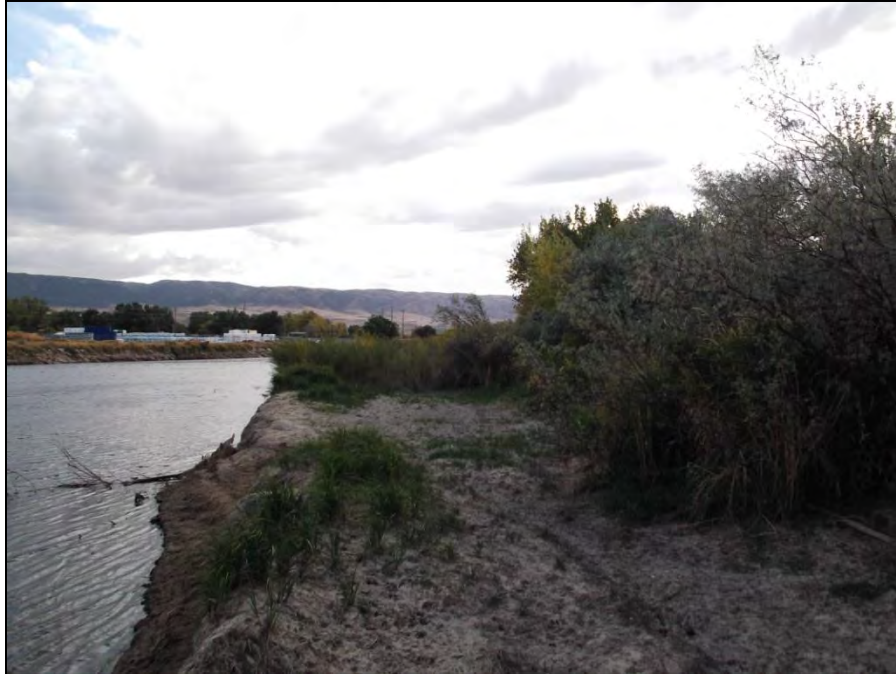
Photopoint 11. Sandbar zone with native riparian vegetation and an established Russian olive stand at Site 9.

This area has well-established sandbar willow stands that will continue to thrive with existing flow dynamics and hydrology. Russian olive may potentially become stressed with frequent flooding events and the spread of native vegetation. Access to the riverbank would be limited due to the active side channel and densely distributed sandbar willow. In addition, the long term management of this area may be limited due to private ownership.
