# Edge Engineering Group

## First Street Environmental Inspection and Report July 2022

| <b>Project:</b> First Street River Restoration | | <b>Owner:</b> City of Casper | |
| <b>Location:</b> North Platte River – Poplar Street Bridge to BNSF railroad Bridge | | | |

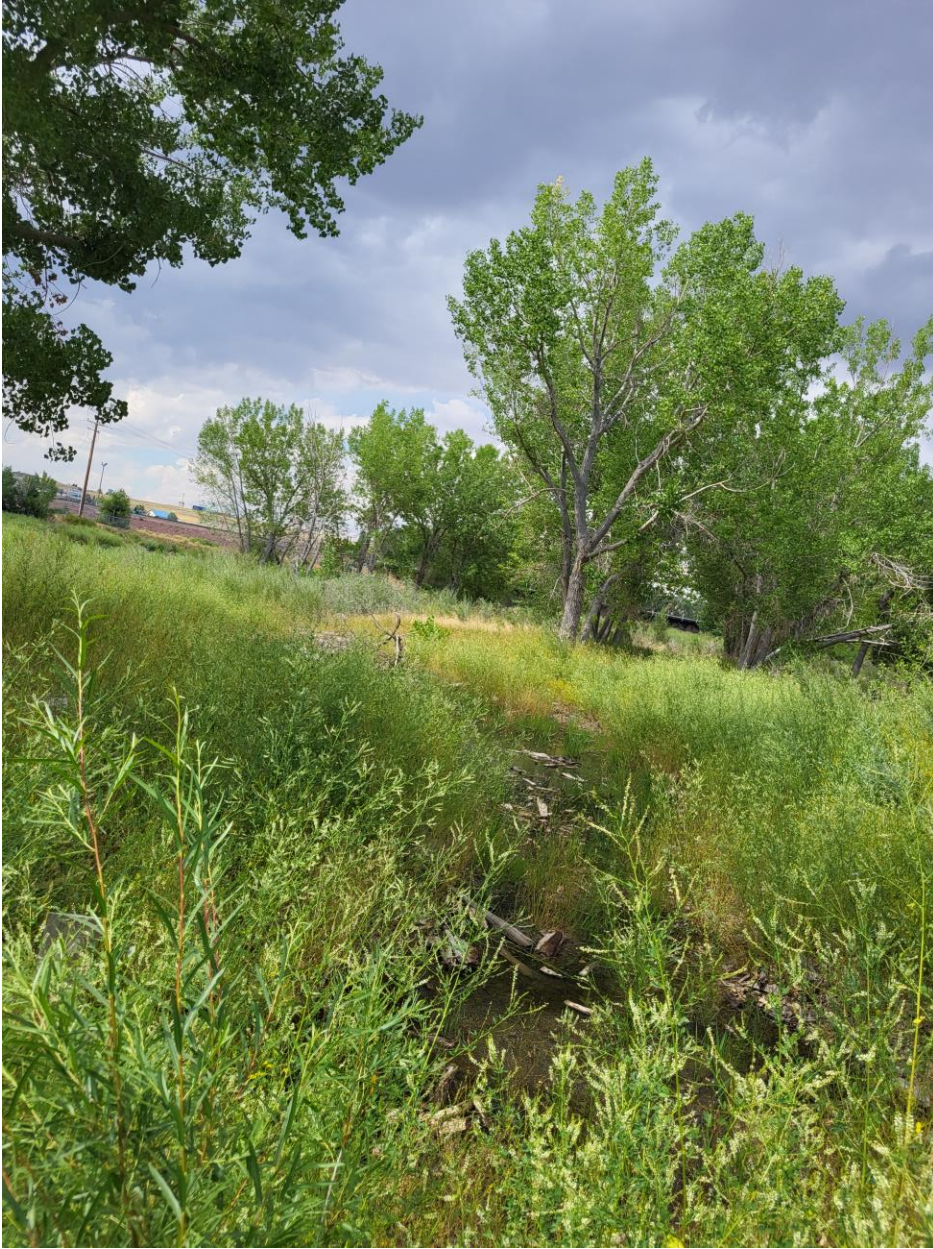
**Constructed overflow channel and wetlands, river right**

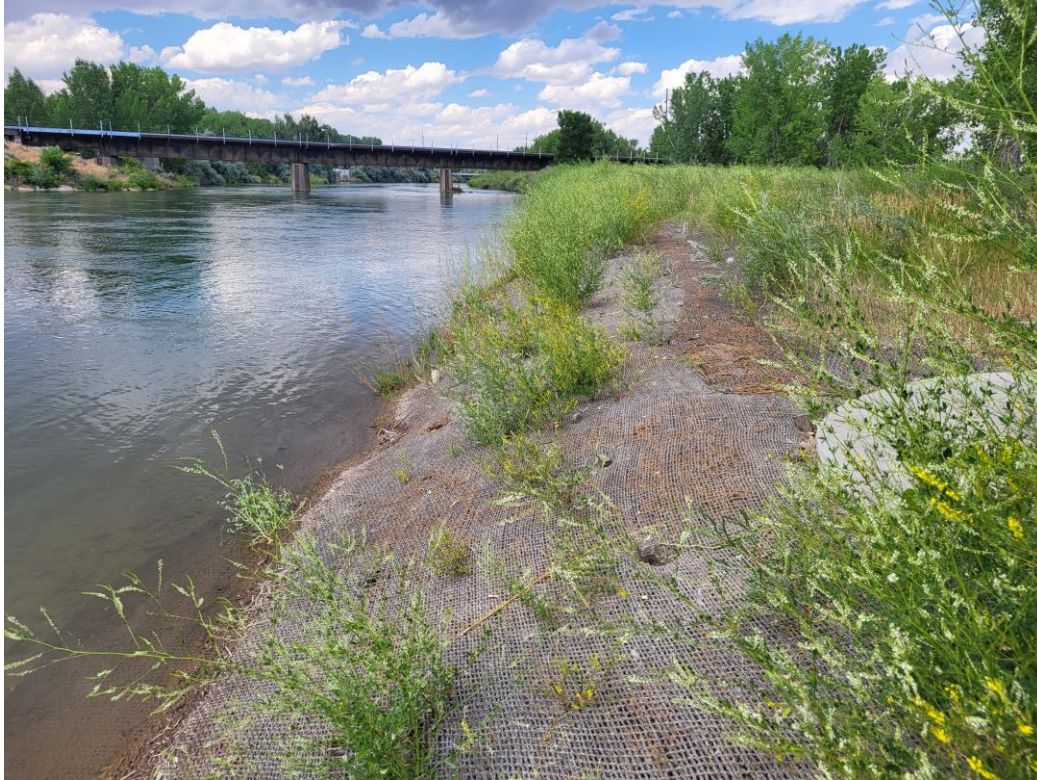
**Limited vegetation river right, approximately Sta. 23+00**

- Reseed and replant in the areas outlined in the attached drawings.

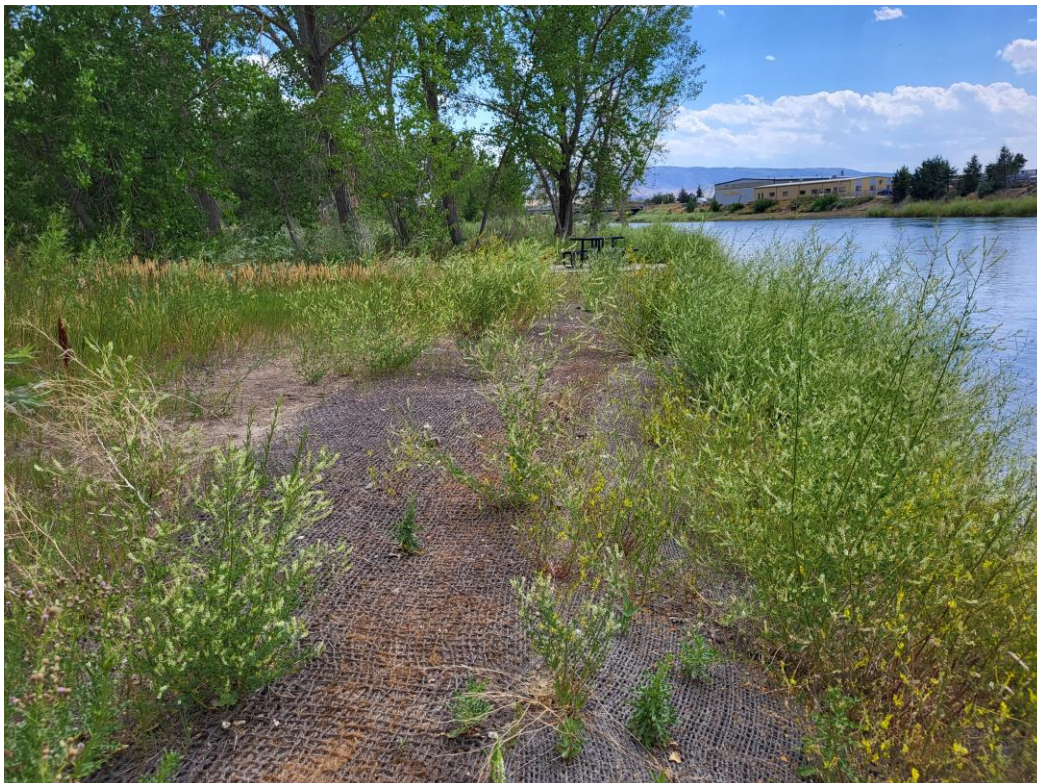
**Limited vegetation river right, approximately Sta. 23+00**

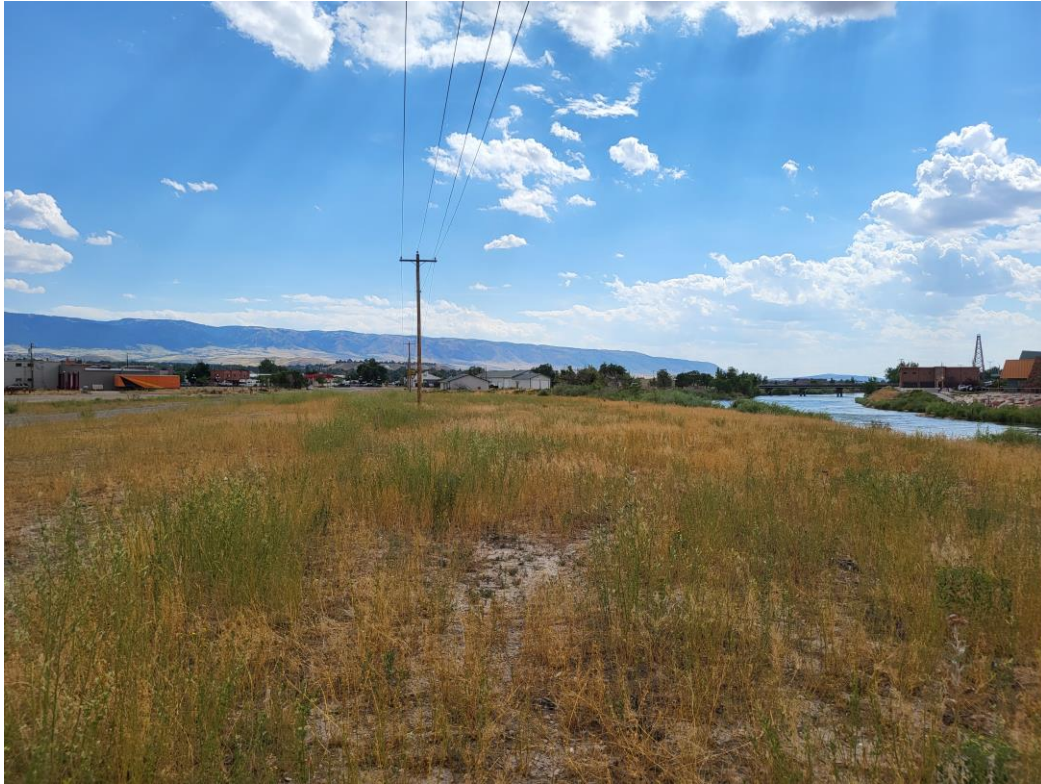
**Vegetation in the contractor's staging area has reestablished to 70% coverage or better**

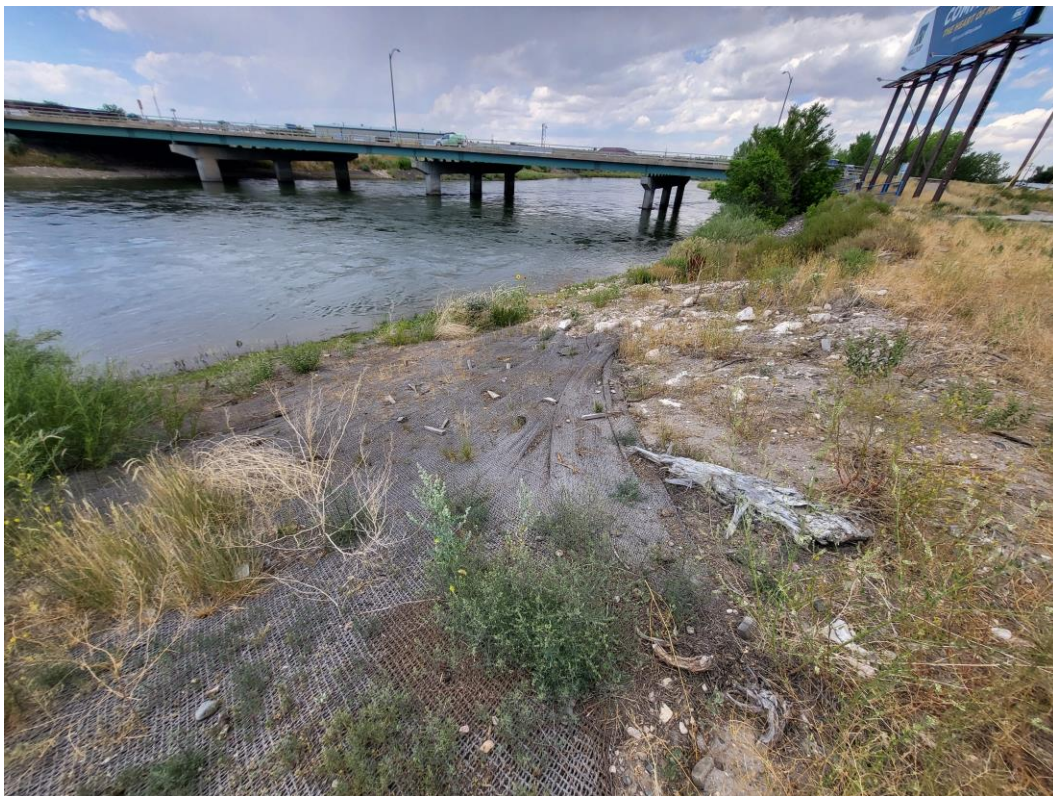
**Vegetation on construction access ramp is approximately at 10% coverage**

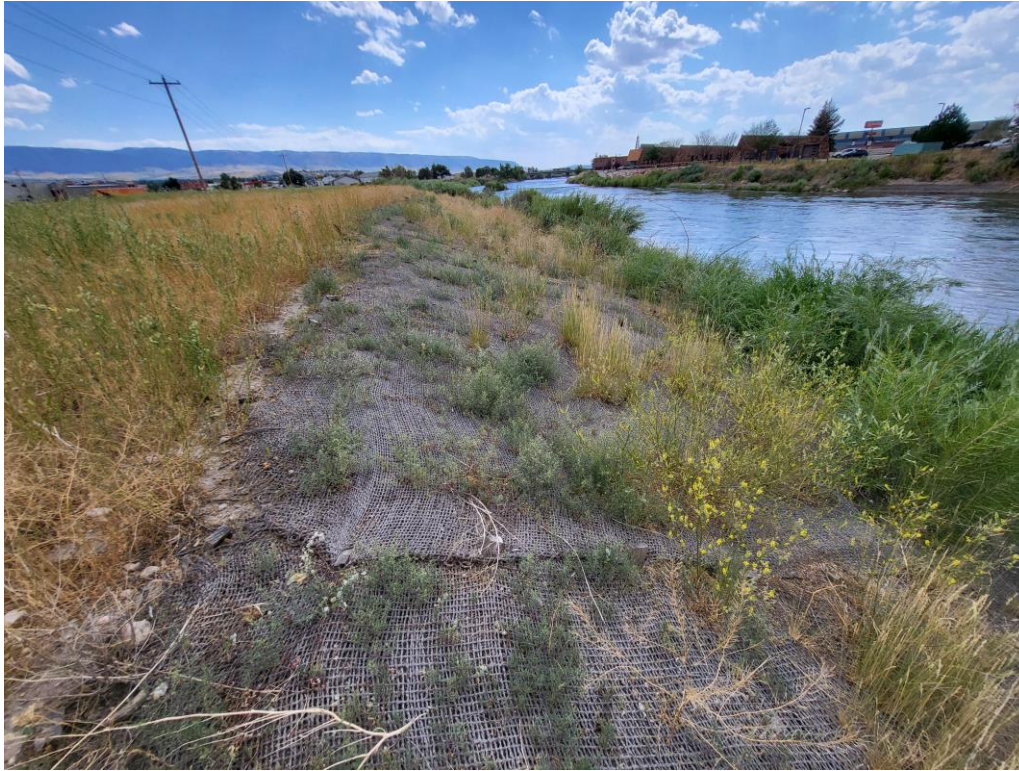
**River bank slope adjacent/south of access ramp river right, willows next to rivers edge established. Away from rivers edge is 10 to 20% coverage.**

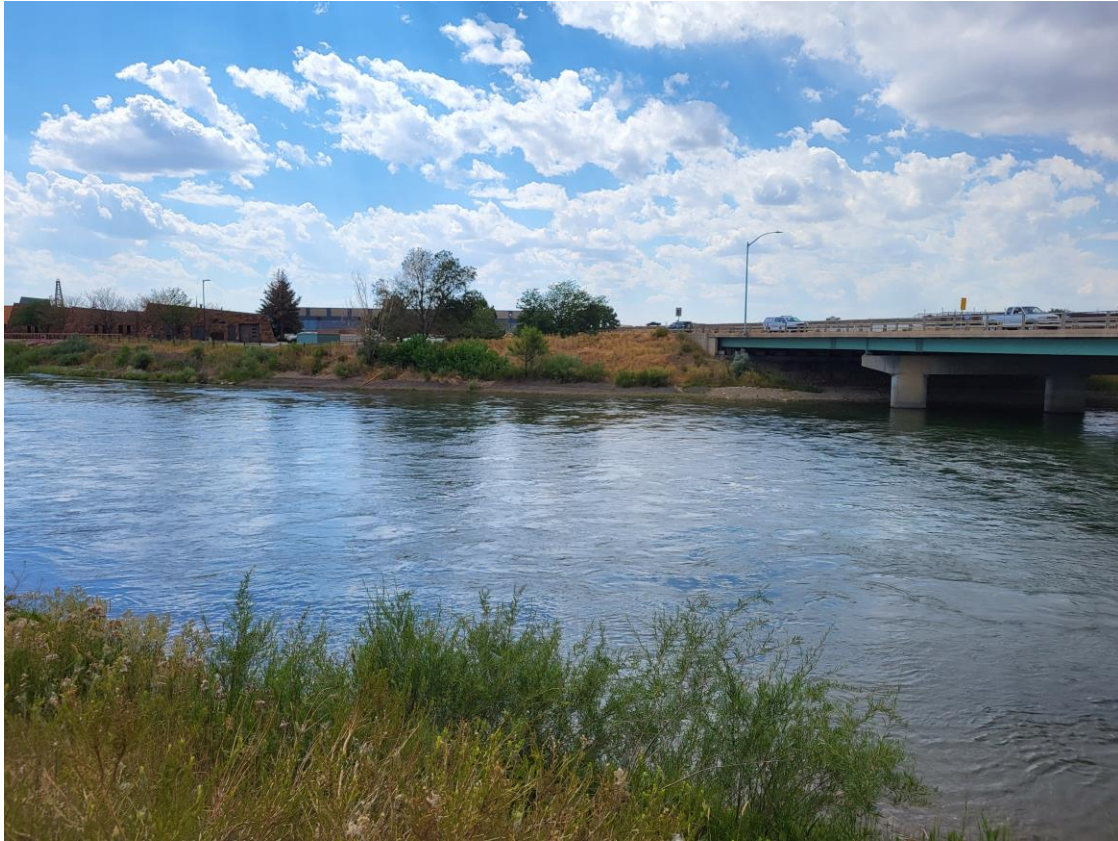
**River left sta 7+00 to first street bridge. Vegetation is approximately 30% coverage**

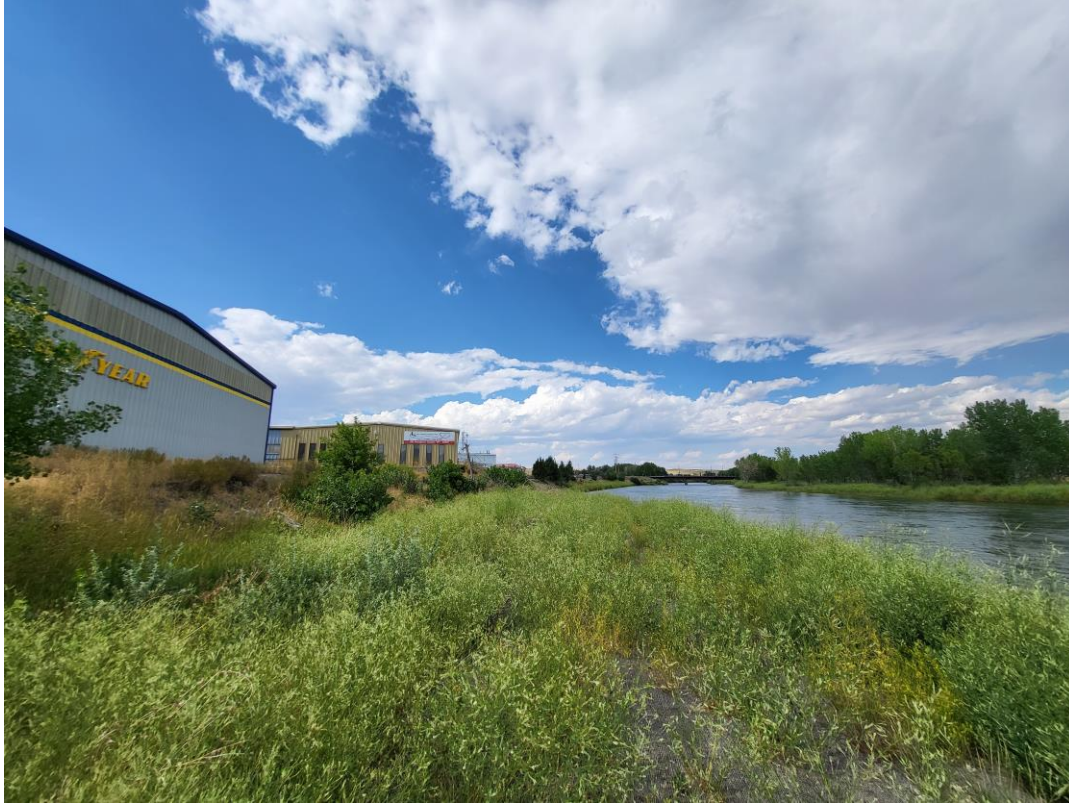
**River left from sta. 13+00 to 15+00, more than 70% coverage with a majority of all growth being weeds**

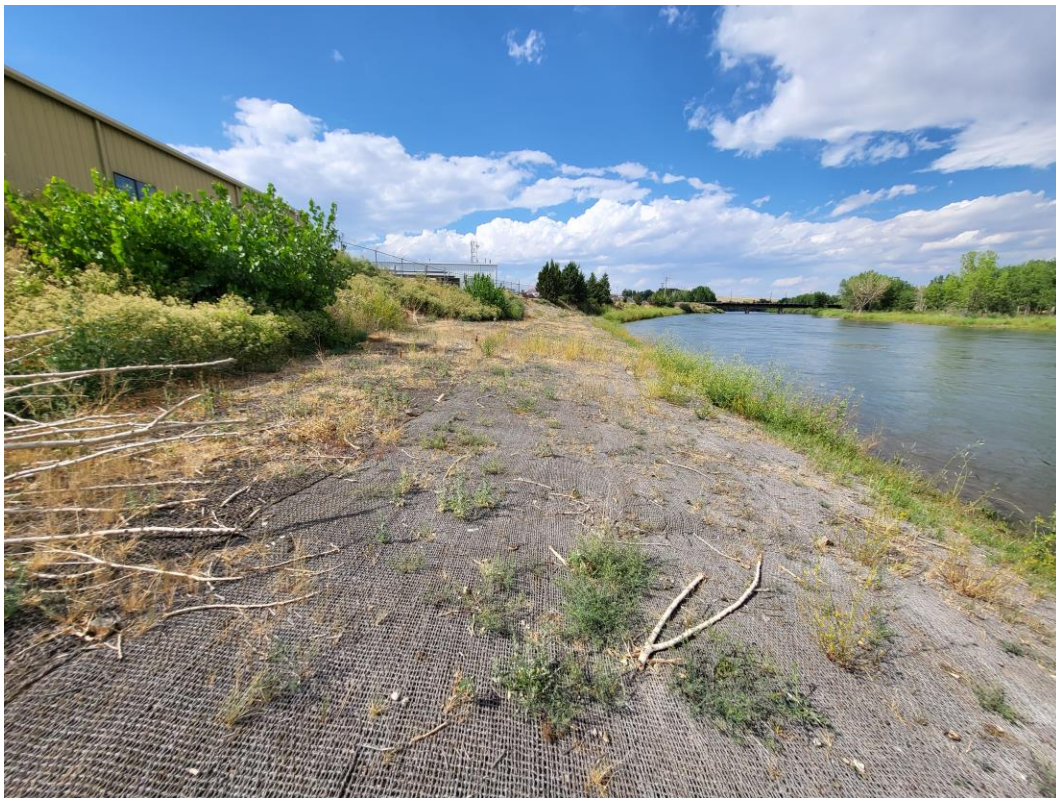
**River left from sta. 13+00 to 15+00, more than 70% coverage with a majority of all growth being weeds**

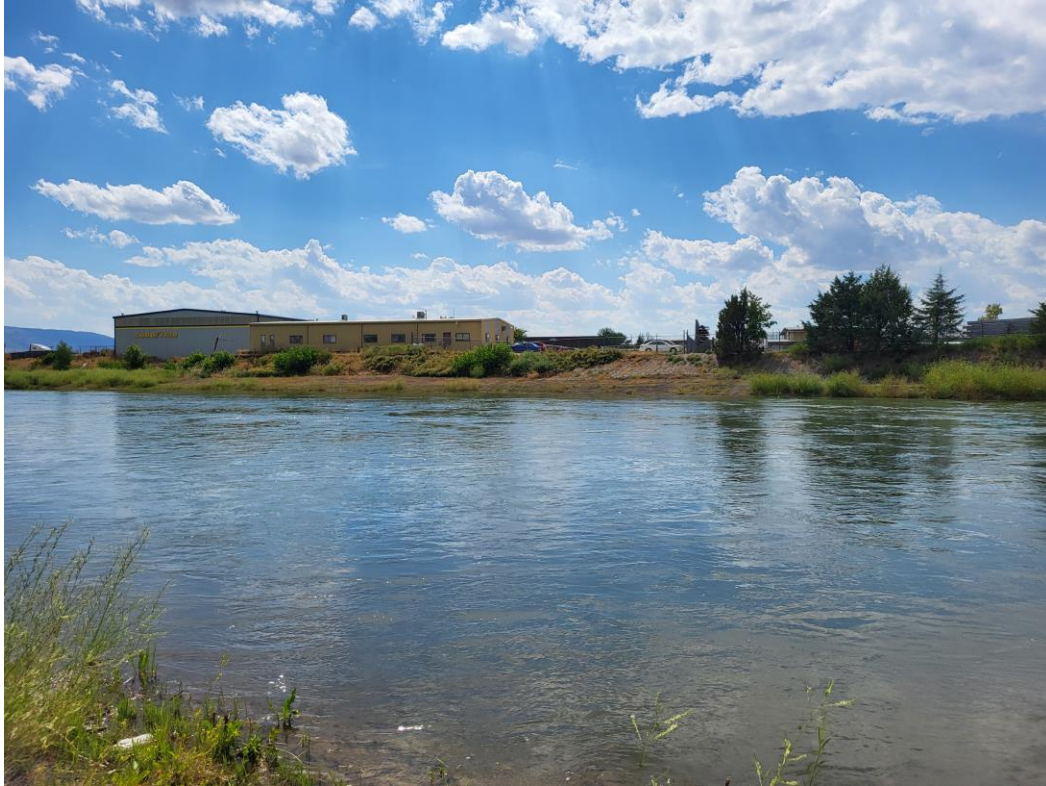
**River left from sta. 15+00 to 17+00, 10 to 20% coverage**

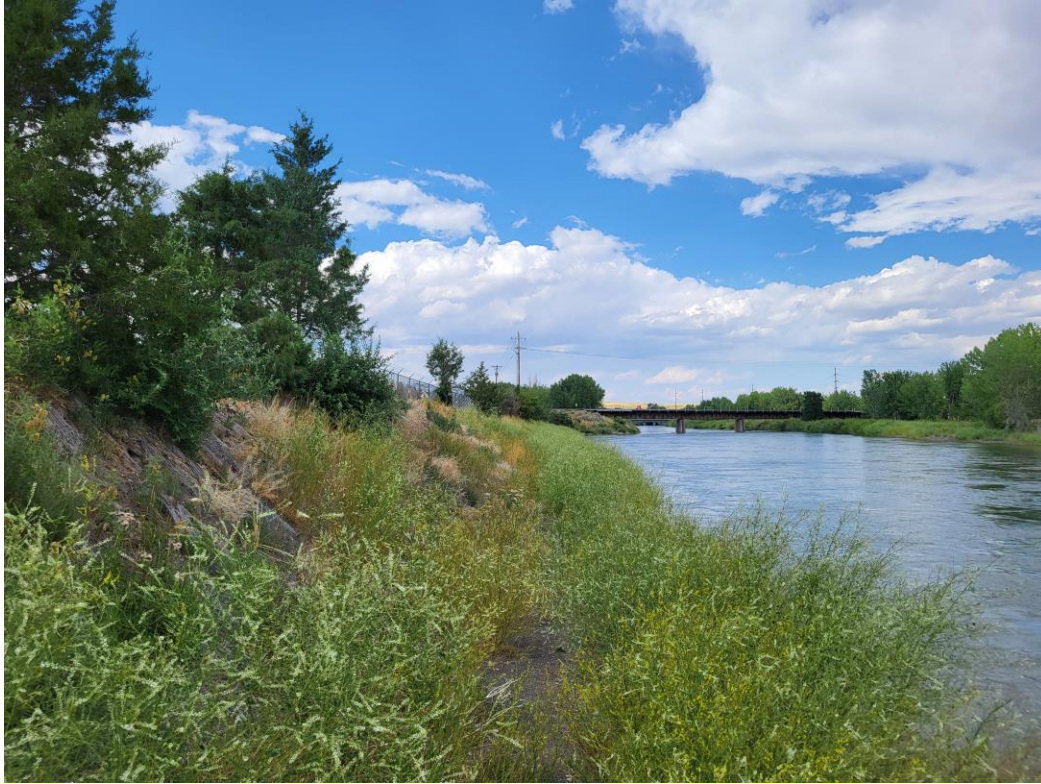
**River left from sta. 15+00 to 17+00, 10 to 20% coverage**

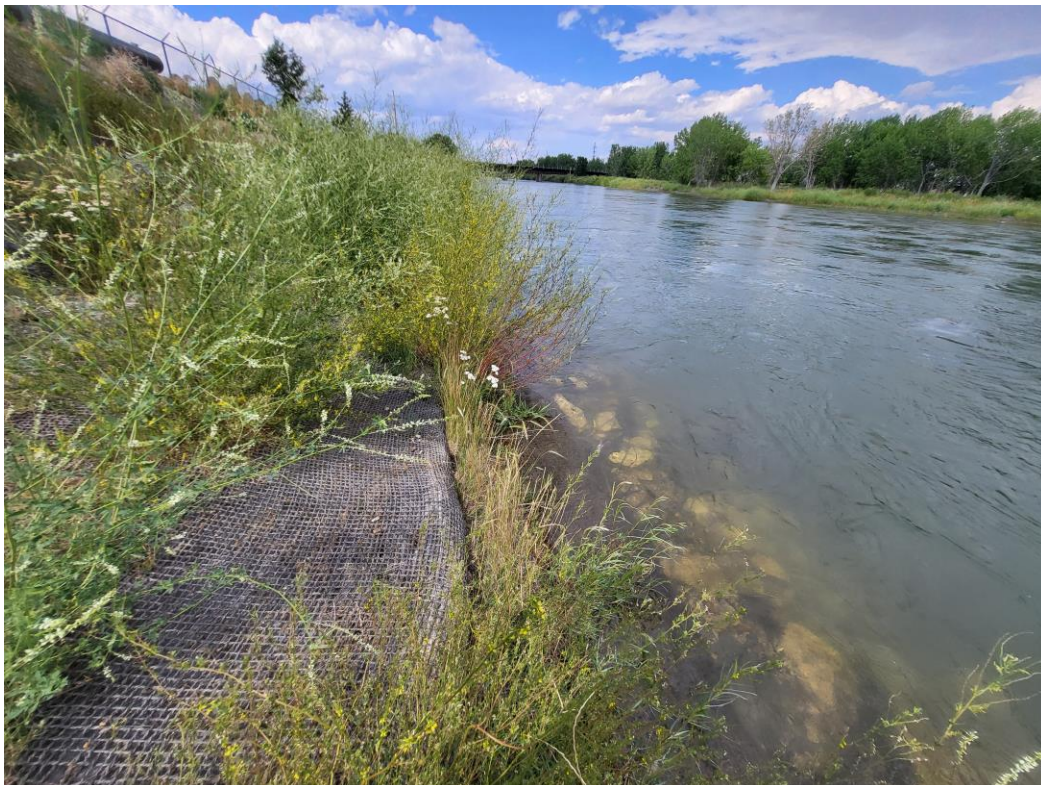
**River left from sta 17+00 to BNSF Railroad, 70% coverage with a majority of weeds**

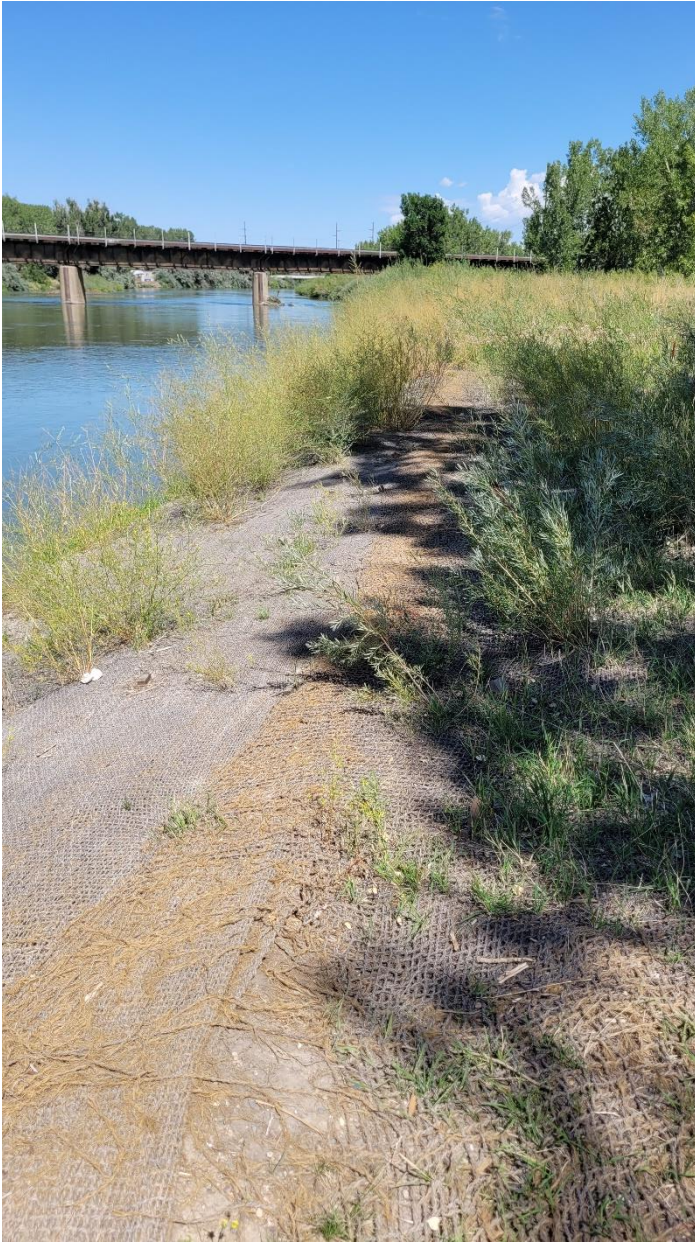
**Photo taken from river right looking generally downstream. Note BNSF bridge just visible in center right of photo. Note generally weedy appearance of much of the vegetation at this location.**

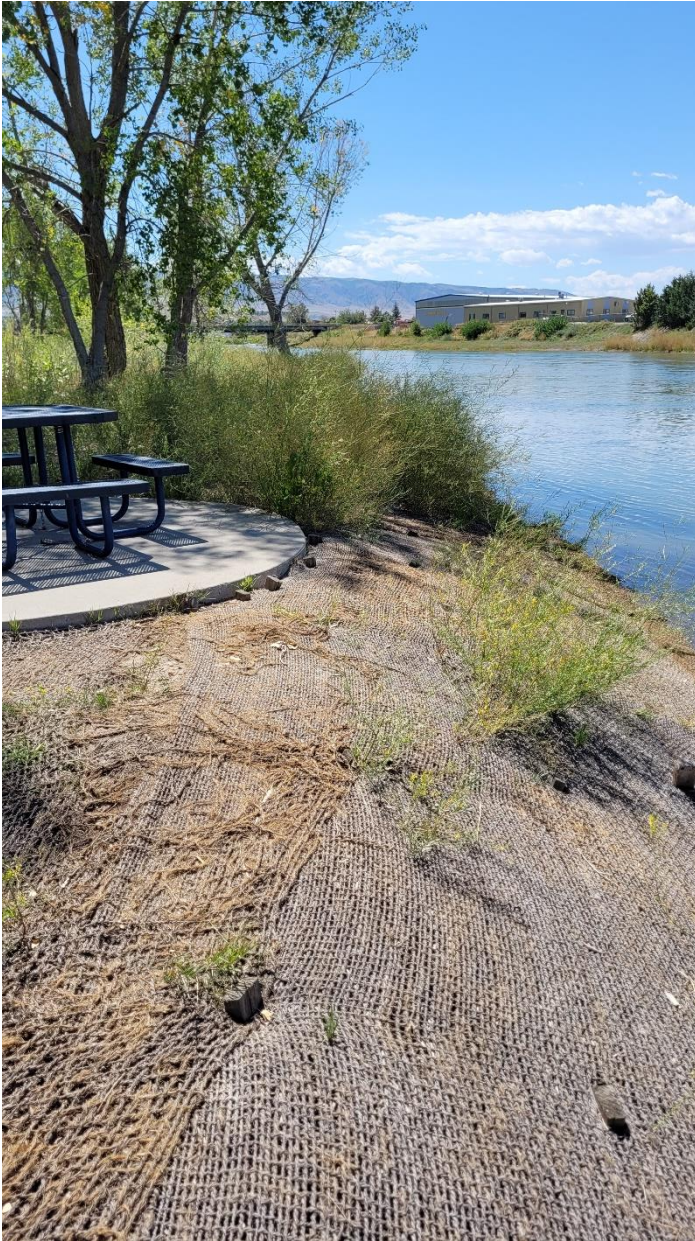
**Limited vegetation river right, approximately Sta. 23+00.**

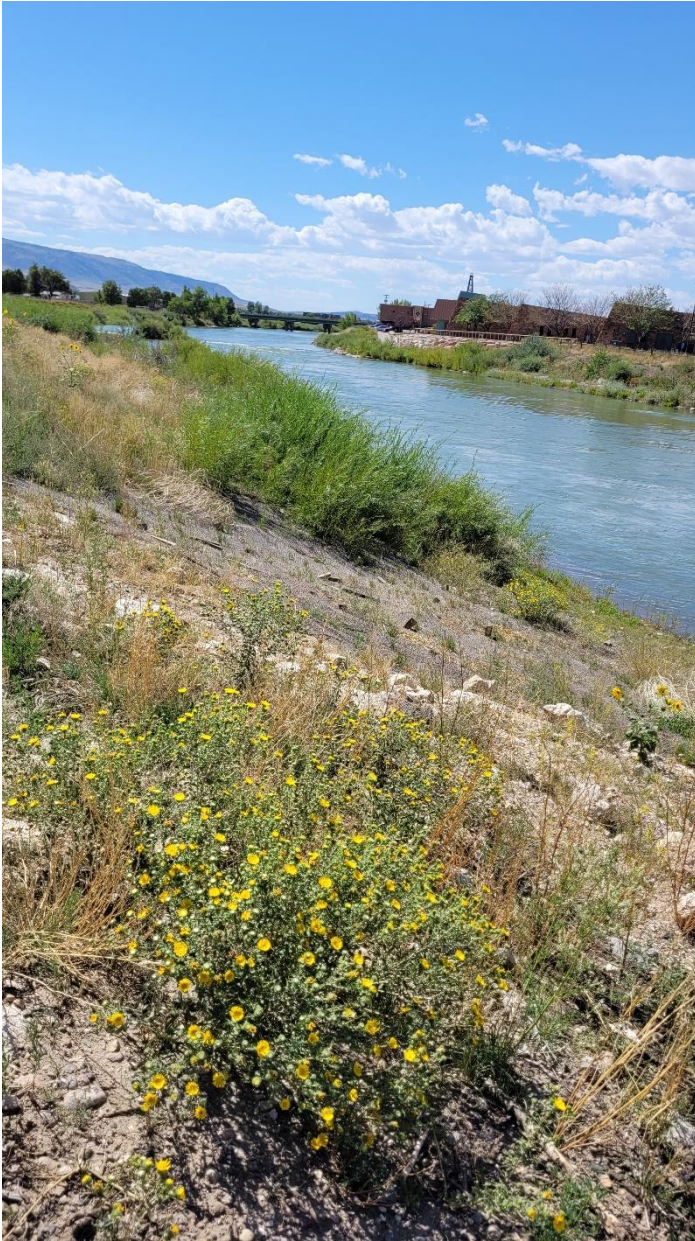
**Limited vegetation river right, approximately Sta. 23+00.**

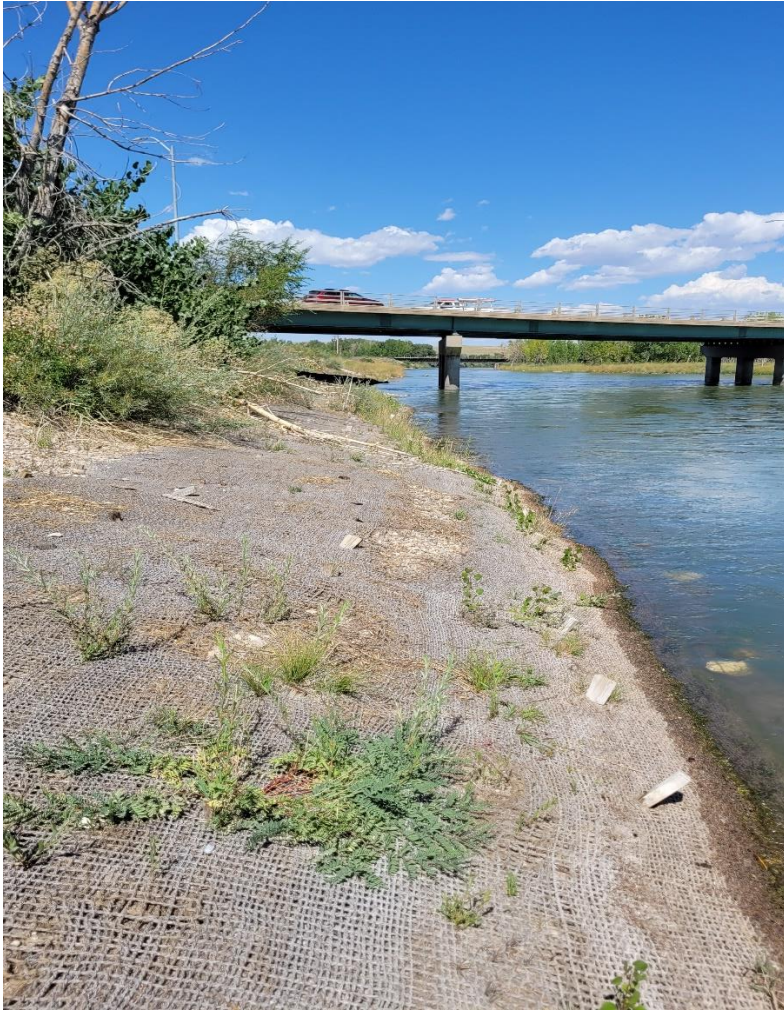
**River left, approximately sta 7+00, looking toward 1<sup>st</sup> Street bridge in upper left of photo. Vegetation is approximately 30% coverage.**

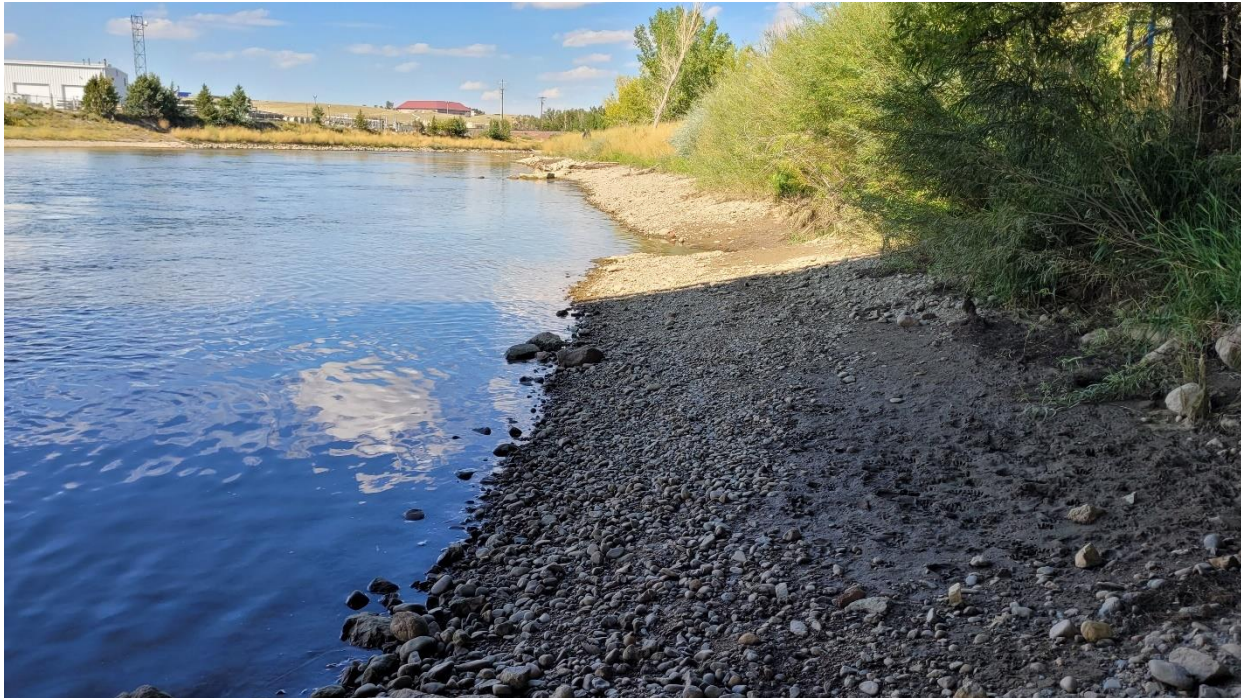
**Photo taken from river right looking generally downstream. Note BNSF bridge visible in upper left of photo, and picnic table in center right of photo behind vegetation. Note exposed stream bank due to low flow condition. Note generally weedy appearance of much of the vegetation at this location, and sparse coverage of vegetation in some areas.**

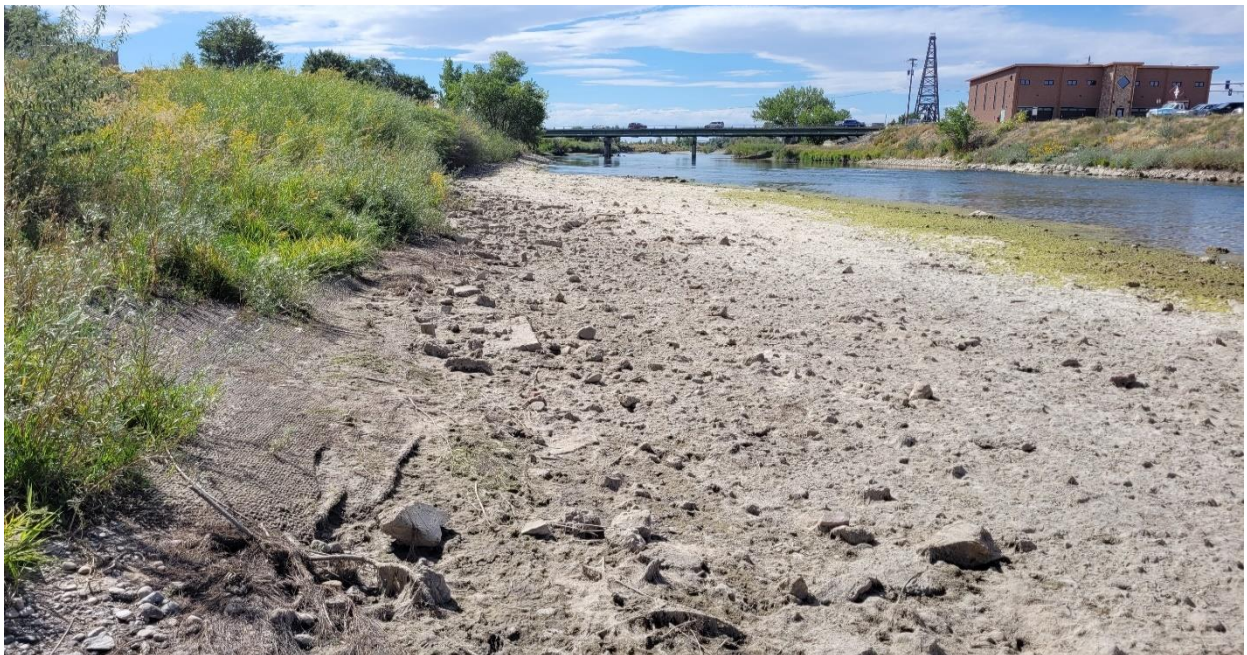
**Vegetation on construction access ramp is still sparse compared to area immediately upstream, adjacent to river. Note decrease in vegetation away from river upstream of construction access. View looking upstream from river right, Jonah Bank just visible in upper right of photo.**

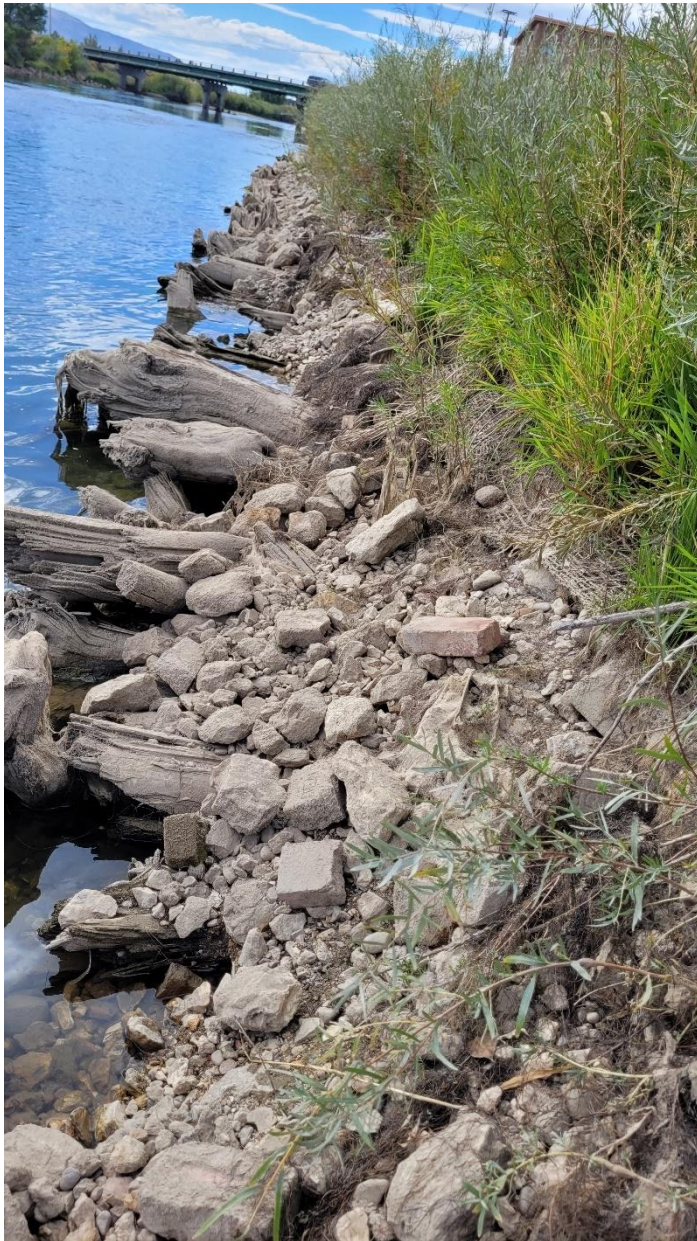
**River Left, looking upstream, from Jonah Bank area, Popular Street bridge in upper center of photo. Willow stakes in first burrito established, second burrito rap willow stakes did not grow. Note generally sparse vegetation in second burrito wrap.**

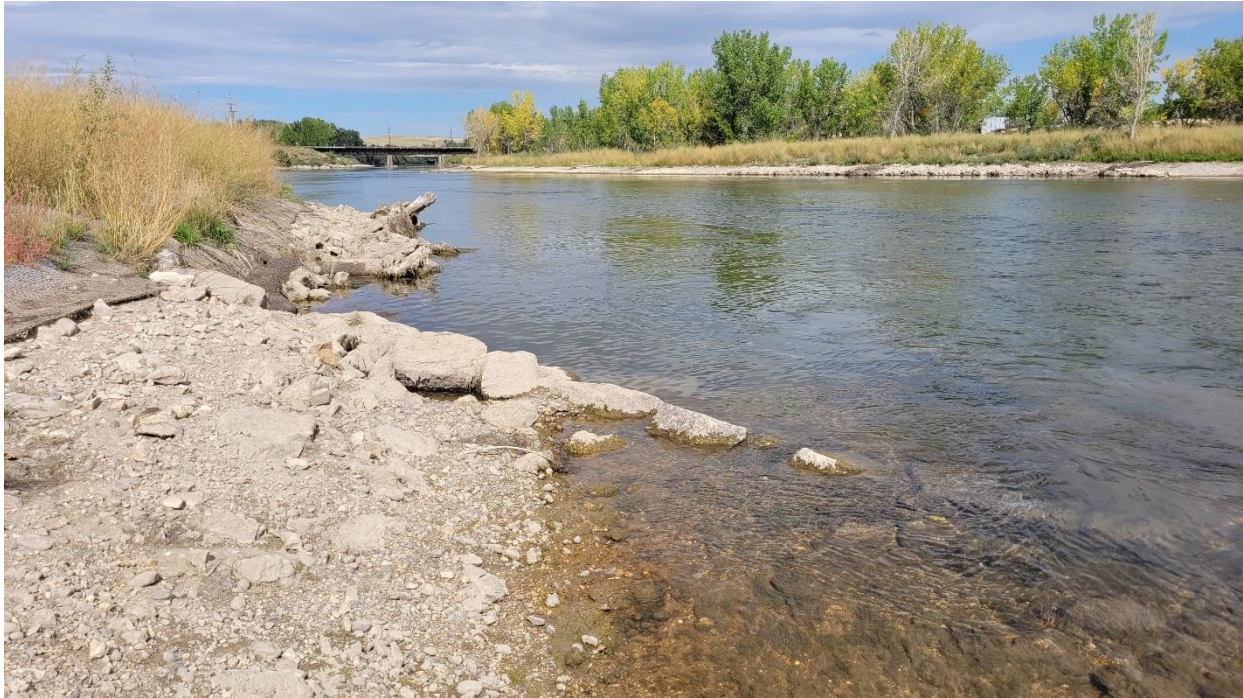
**View river left, looking upstream from 1<sup>st</sup> Street bridge. Note line of vegetation establishing along high water line, but sparse vegetation otherwise in construction area.**

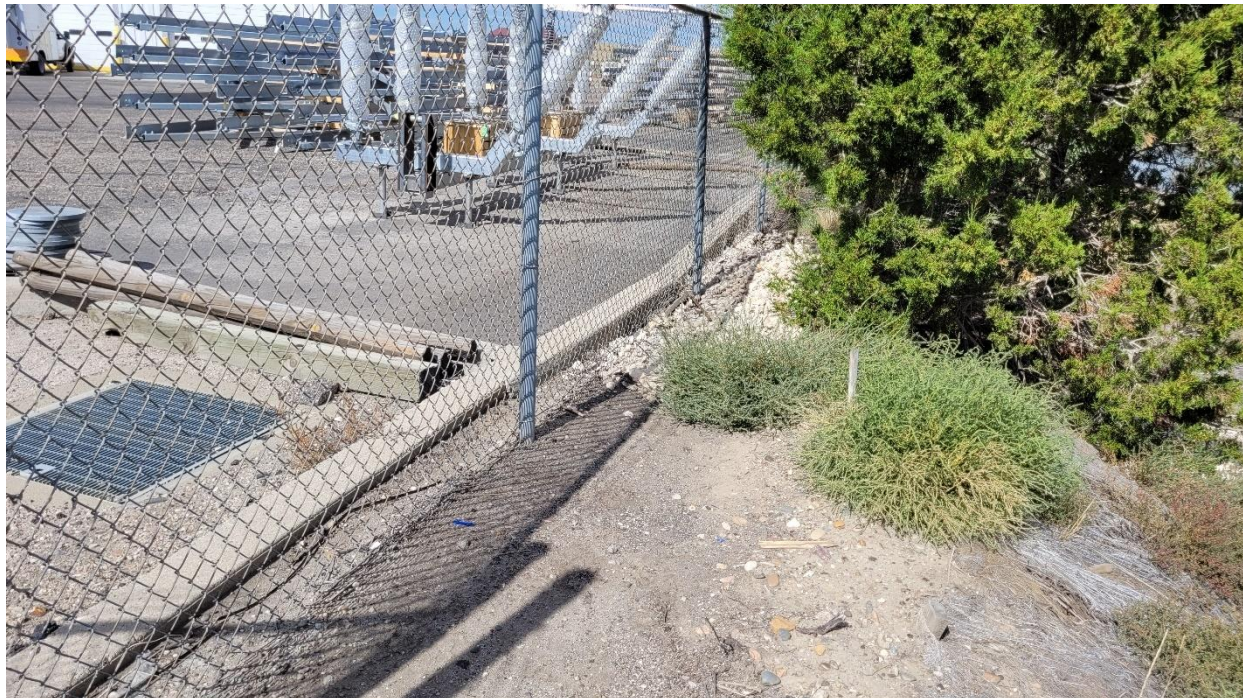
Also, on river left downstream of the 1<sup>st</sup> Street bridge, there is some erosion occurring that appears to be related to water runoff from a power company yard, eroding the higher portions of the riverbank. Rock has been dumped in the eroded area in an apparent attempt to address this problem. This issue does not appear to be related to river construction work; as noted above, it appears to be related to runoff from a power company yard (see photos).

**River left, downslope from power company yard. Note white gravel placed since construction, on top of burlap, to fill in bank erosion, apparently from runoff from paved area above.**

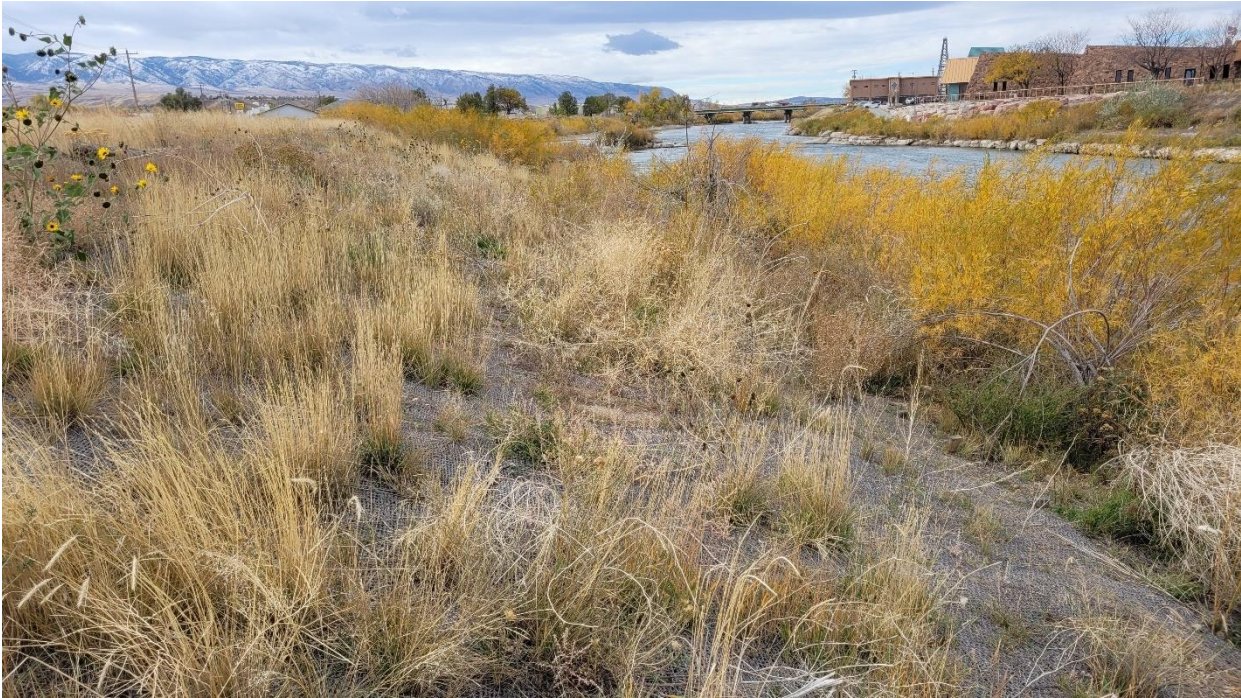
**View looking upstream, river right. 1<sup>st</sup> Street Bridge visible at upper right of photo. Note locally bare areas in vegetation.**

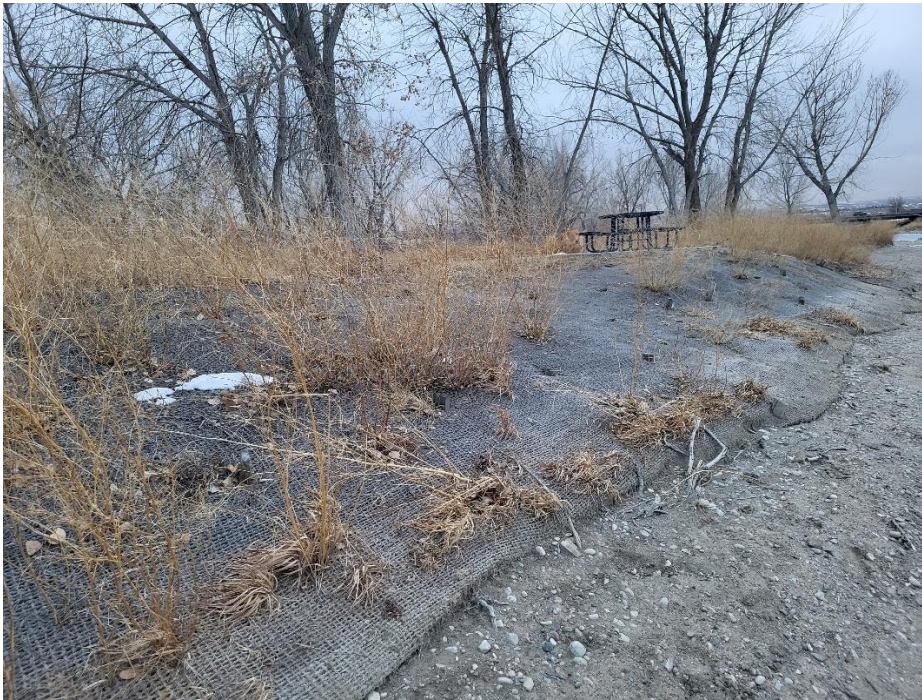
**River right, behind Hose and Rubber shop**

The river has started to freeze or ice over, so inspection along the rivers edge and in the water was very limited due to personal safety. Some snow on the ground in spots, but a majority of the river banks were observed. Too early in the winter to see ice jams and the effect on the shore line and the structures.

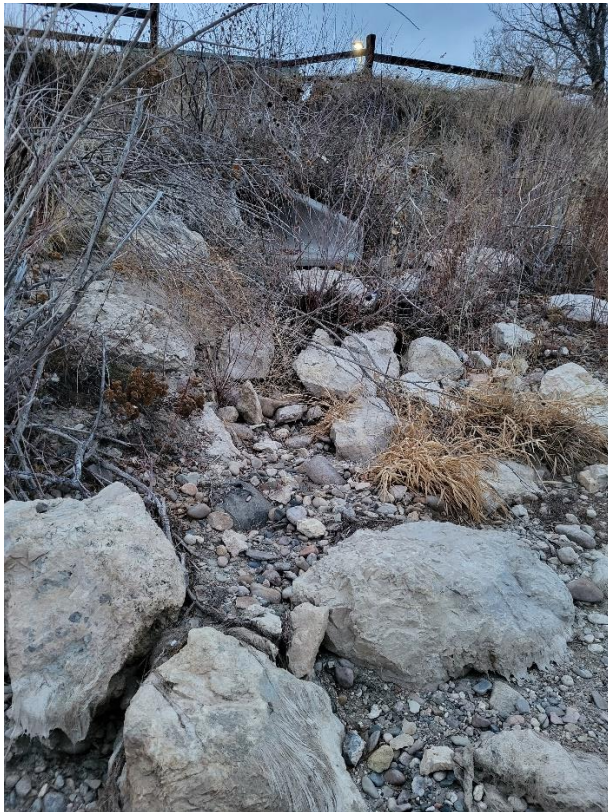
**River left, outlet below Jonah Bank looks good**

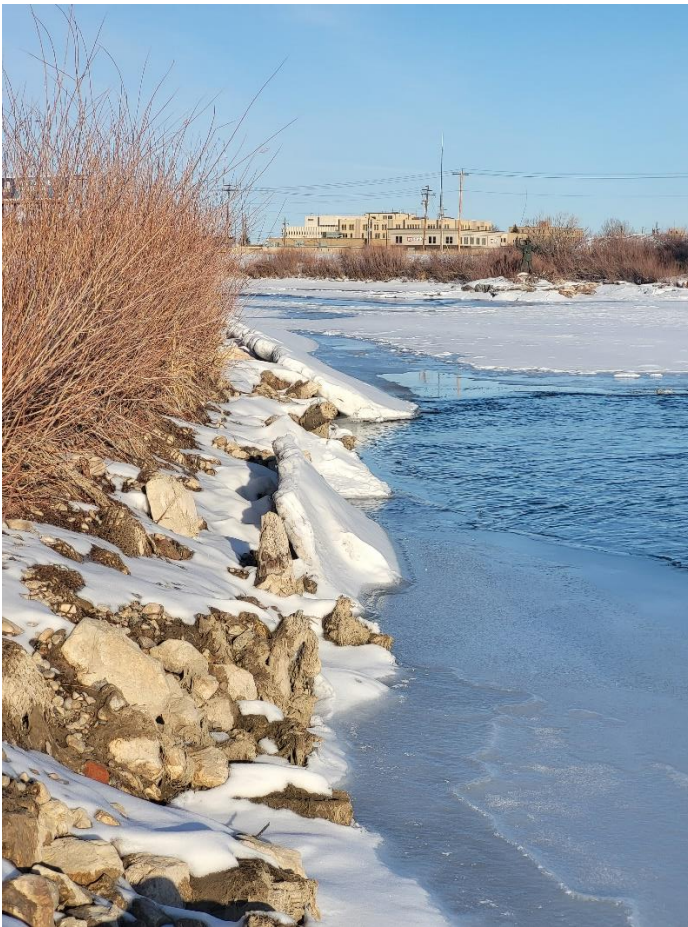
**Ice slab pushed up on shore river left, below Jonah Bank at woody toe location**

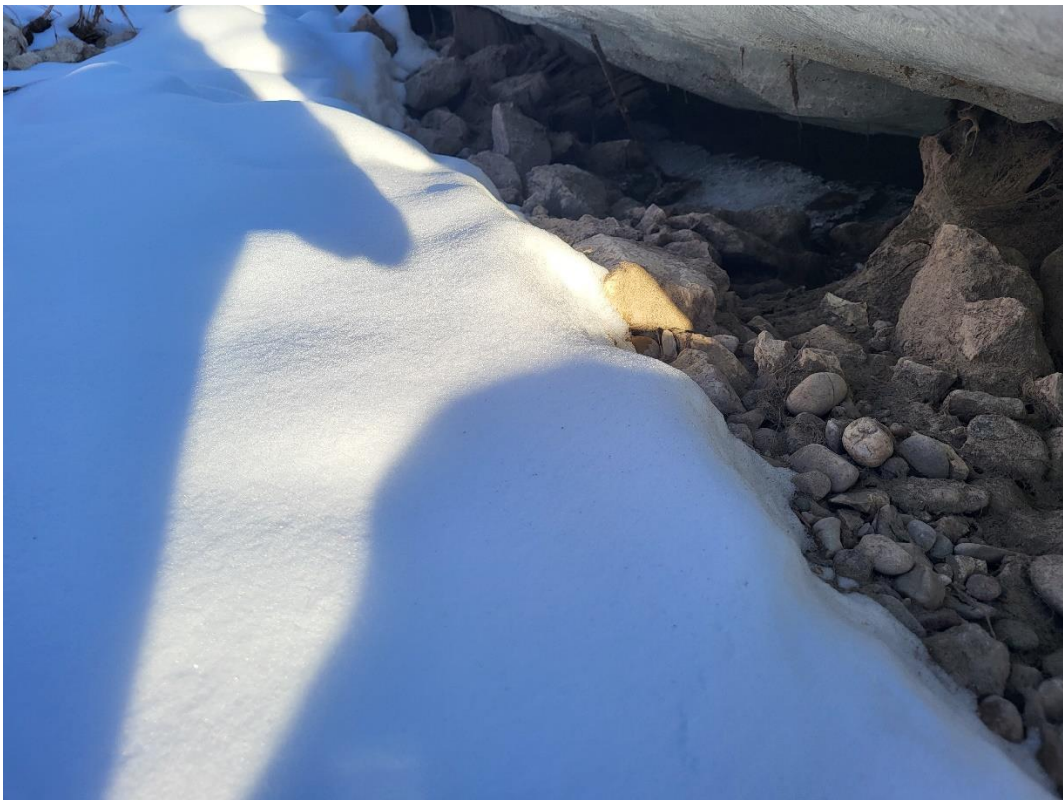
**View under ice slab**
