# Edge Engineering Group

## First Street Environmental Inspection and Report July 2022

| <b>Project:</b> First Street River Restoration | | <b>Owner:</b> City of Casper | |
| <b>Location:</b> North Platte River – Poplar Street Bridge to BNSF railroad Bridge | | | |

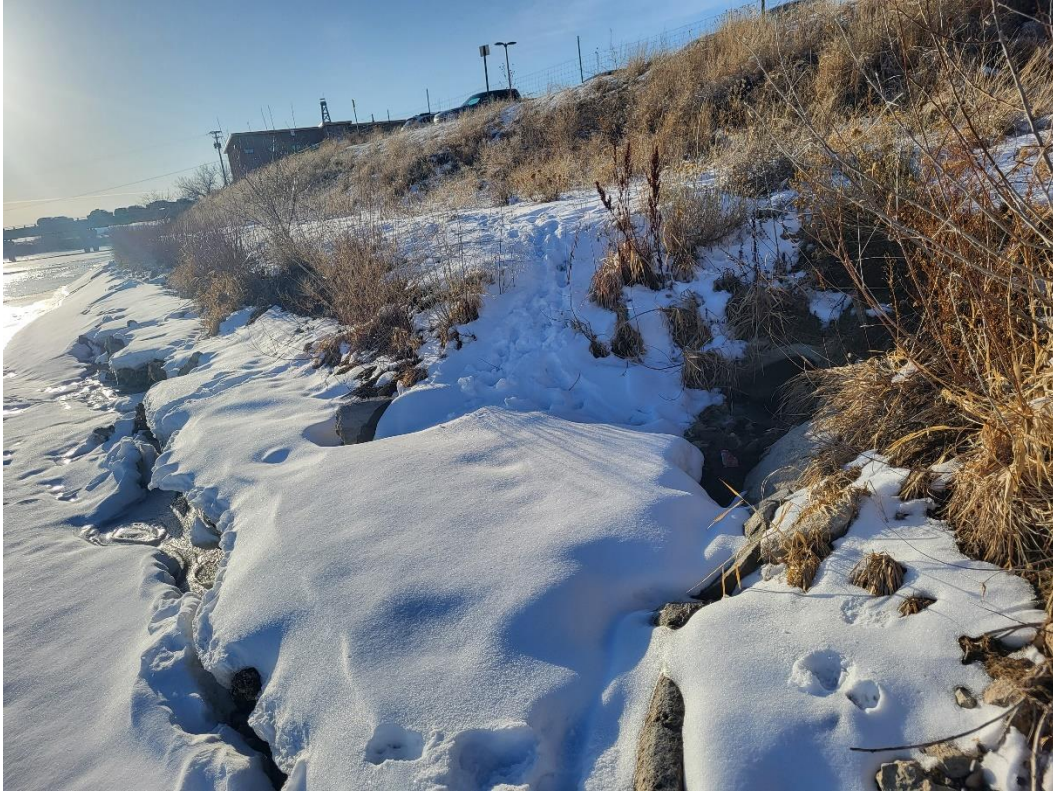
**Ice jam and outlet structure**

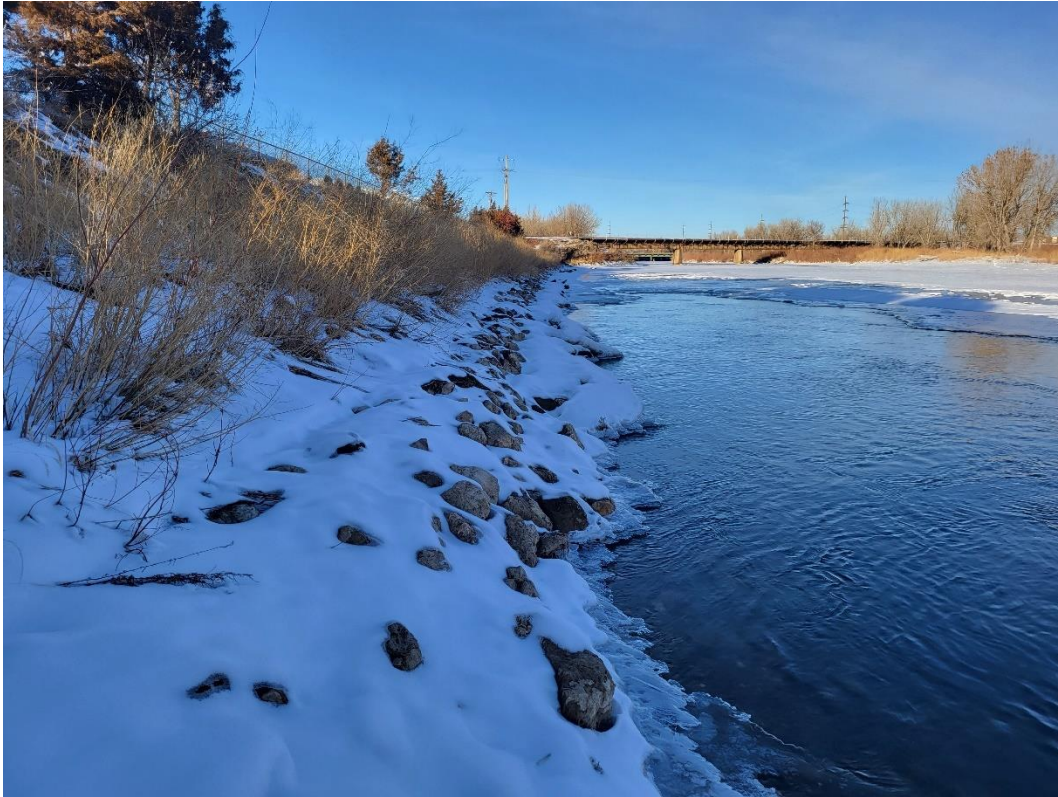
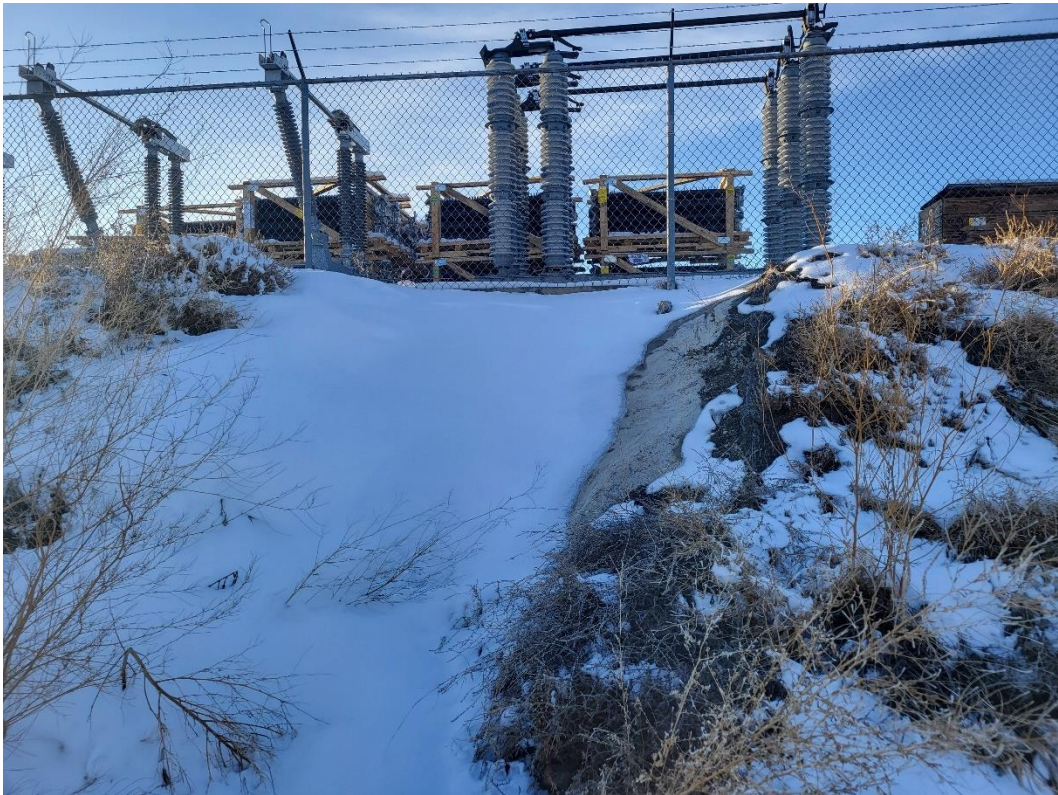
**River left, erosion area on the back of the utility yard. A concrete apron was added to this area. Watch for erosion to occur past the concrete apron**

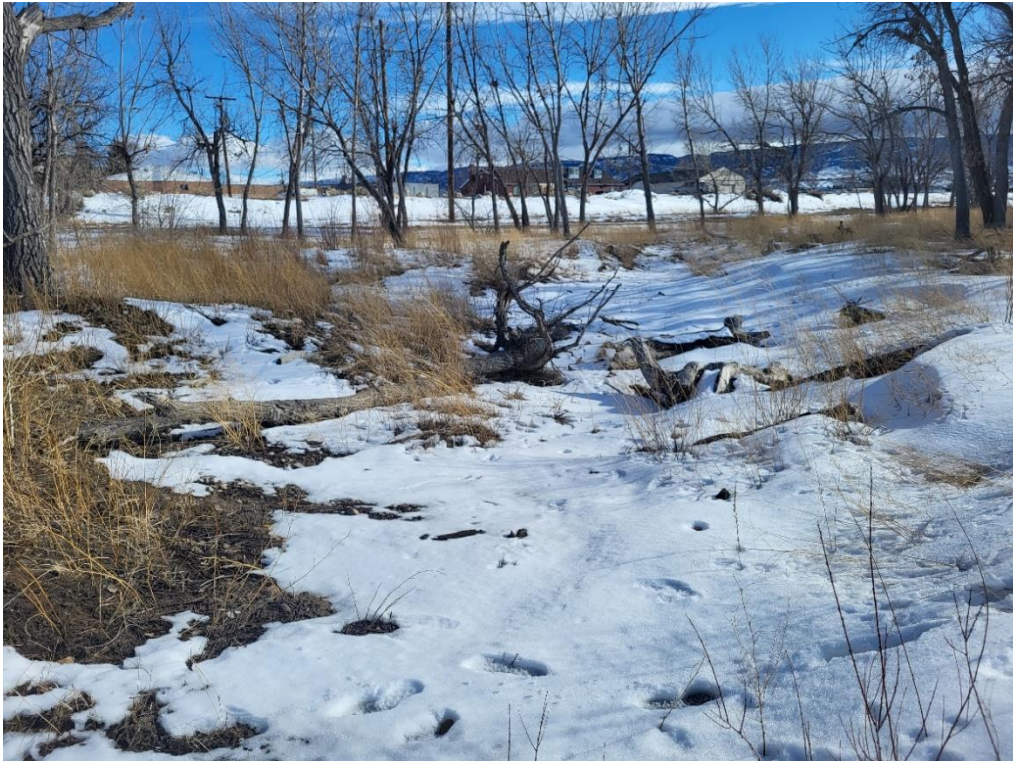
**Wetland channel, low area located river right sta. 22+00**

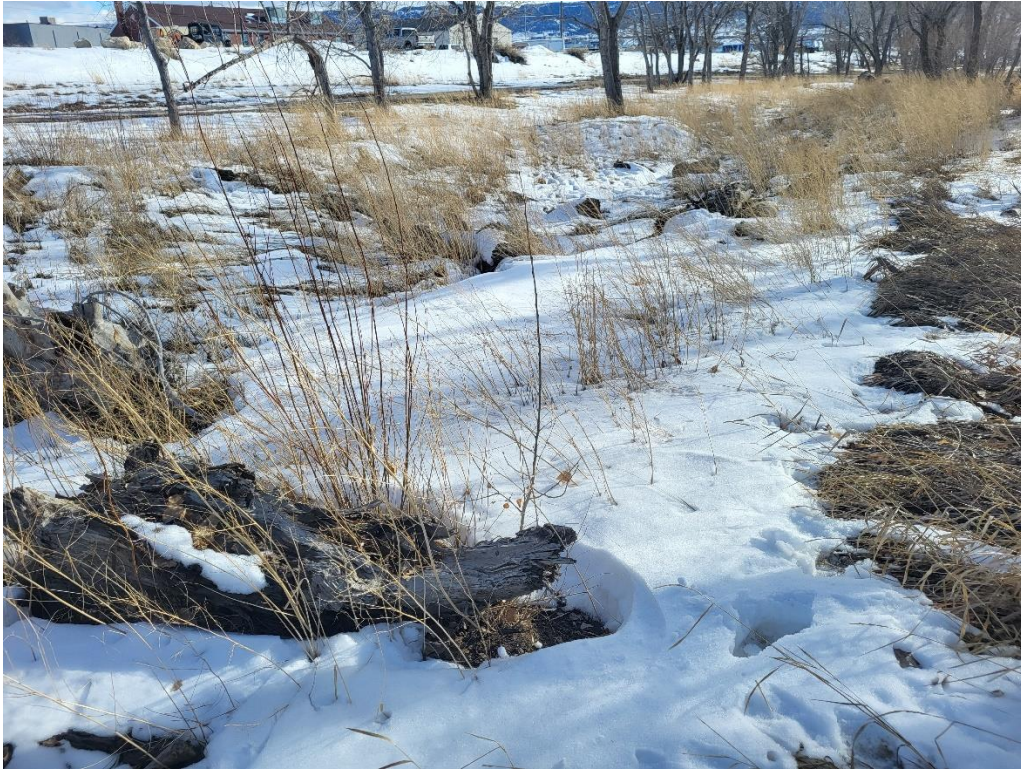
**Wetland channel/low area river right sta. 21+00**

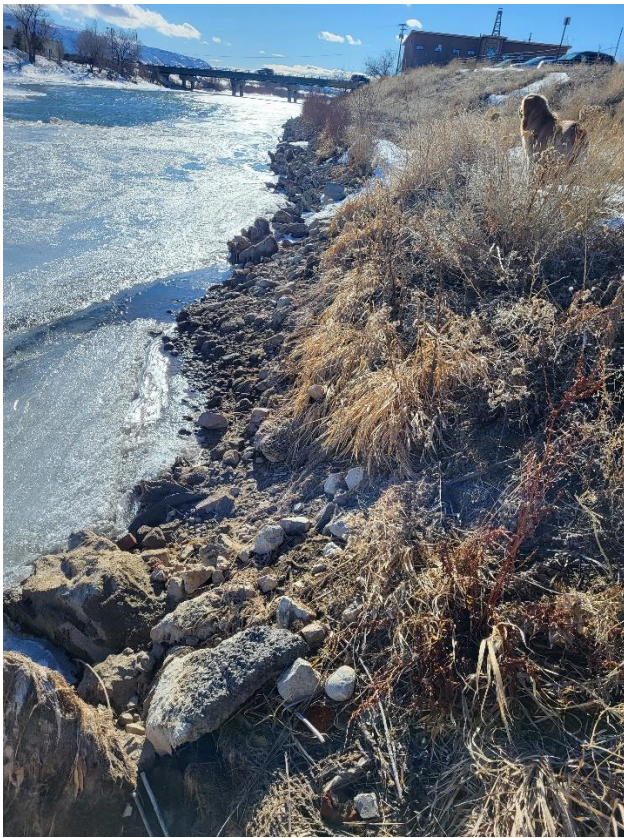
There are two local spots along the woody toe structure where some of the smaller filler material (gravel and rocks) have been removed from the top of the structure. This is very minor erosion but should be watched through spring flush and runoff. The two locations are located at approximate station 4+25 and 4+75 river left.

**Small erosion area river left sta. 4+75, just upstream of outlet structure**

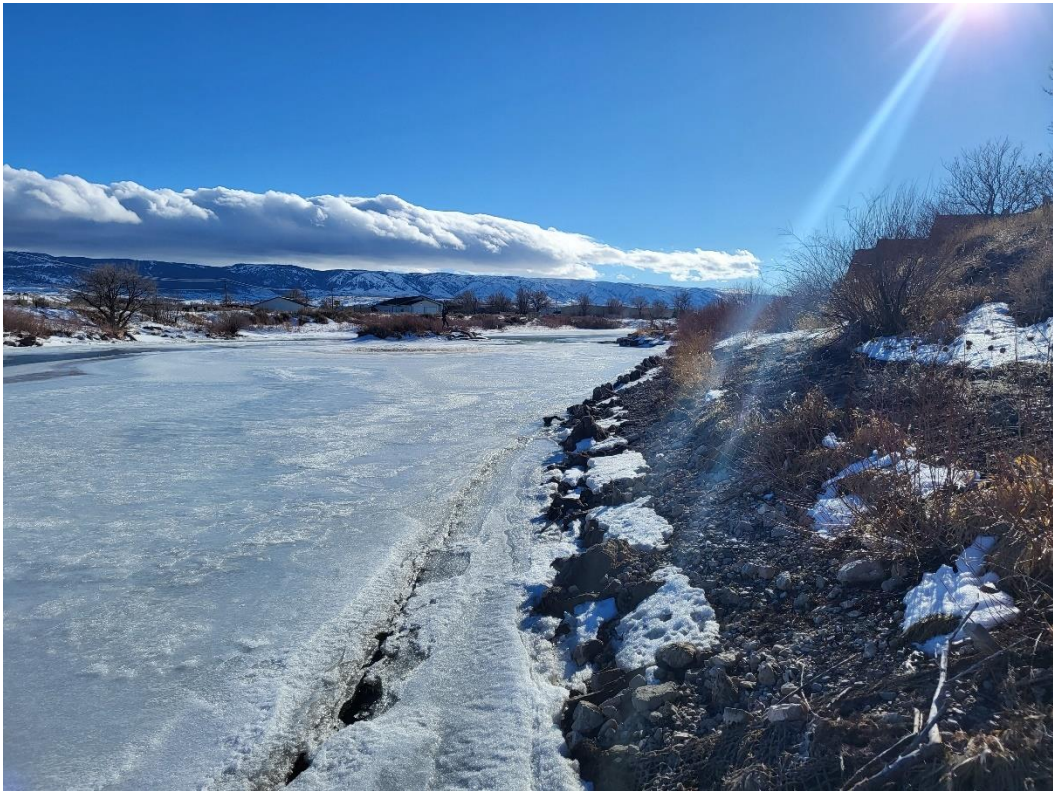
**River left sta. 11+00 looking upstream, sparse vegetation**

- Reseed and replant in the areas as noted in July and August 2022 inspection reports (drawings from July 2022 are at end the of this report, with recommended reseed and replant areas noted)

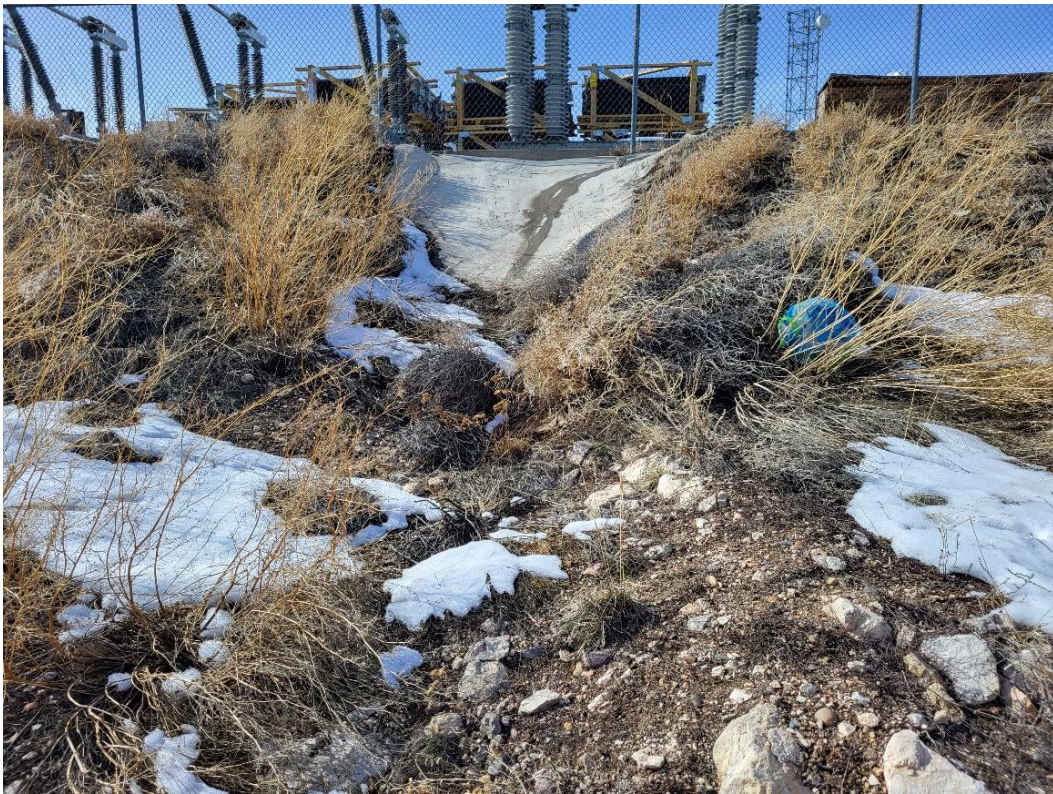
A concrete apron was installed river left, on the backside of the utility yard around sta. 22+50. The concrete apron was installed in replacement of recently placed rip-rap. This is another area to watch as we go through this years rainstorms.

**Concrete apron below utility yard river left sta. 22+50**
