## **2019 Annual Monitoring Report for the North Platte River Restoration Project**

Joanna Harter, Aquatic Habitat Project Biologist, Wyoming Game and Fish Department, 5400 Bishop Blvd, Cheyenne, WY 82006

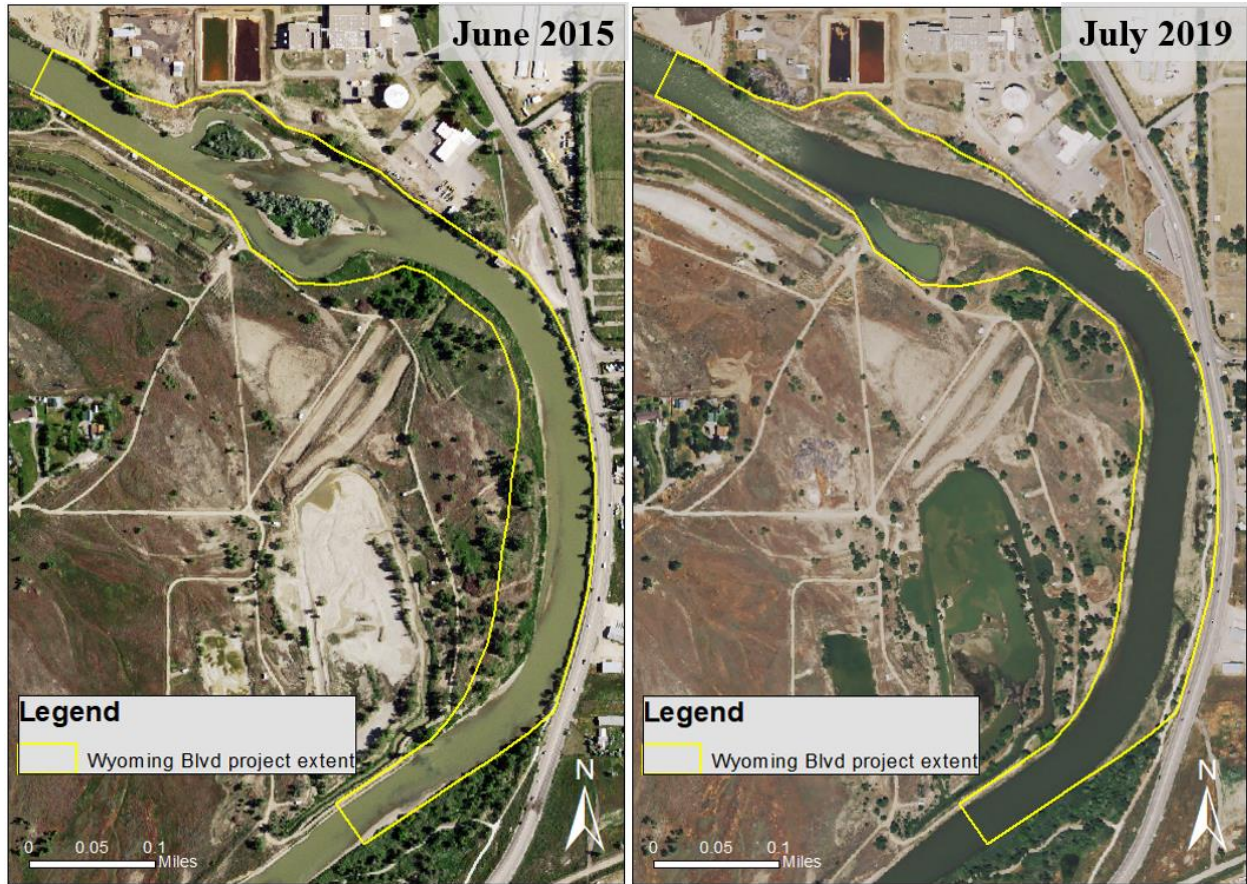
FIGURE 2. National Agricultural Imagery Program (NAIP) images of the Wyoming Blvd project reach before restoration on June 20, 2015 (left) and after restoration on July 19, 2019 (right).

National Agricultural Imagery Program (NAIP) images from 2015 and 2019 illustrate some of the major changes in the stream following restoration (Figure 2). Mid-channel bars and islands in the lower stretch were removed and replaced with a single thread channel. Additionally, the stream channel was moved approximately 130 ft away from SW Wyoming Boulevard and a new floodplain was constructed. Photos from 2019 (Figure 3, Appendix A.4) demonstrate that stream banks throughout the reach have remained stable since construction. The coir fabric used to stabilize soil lifts in the reconstructed banks is still visible and intact in many places. The rebar marking photo points WY-10 and WY-12 could not be located in 2019 but photos were taken from the coordinates for each point and aligned with previous photos.

Toe wood 1 is the longest of the five structures, running approximately 575 ft along the right bank (Figures A.5.1, A.5.2). The river channel in this location was relocated approximately 135 ft west of its former location, immediately adjacent Wyoming Boulevard (Figure 2). Toe wood 1 is important for maintaining stability of the new streambank and floodplain. A few logs protrude further into the channel from the bank, especially toward the downstream end (Figure A.5.1). These logs were not cut at installation and are not indicative of structural instability (T.C. Dinkins, Stantec Design Engineer, personal communication). Willows have established well above the toe wood and contribute to the long-term stability of the new streambank (Figure A.5.2). The elevation difference between the tops of the root wads or logs and the water surface at base flow ranged from 1 to 2.5 ft, with an average of 1.7 ft.

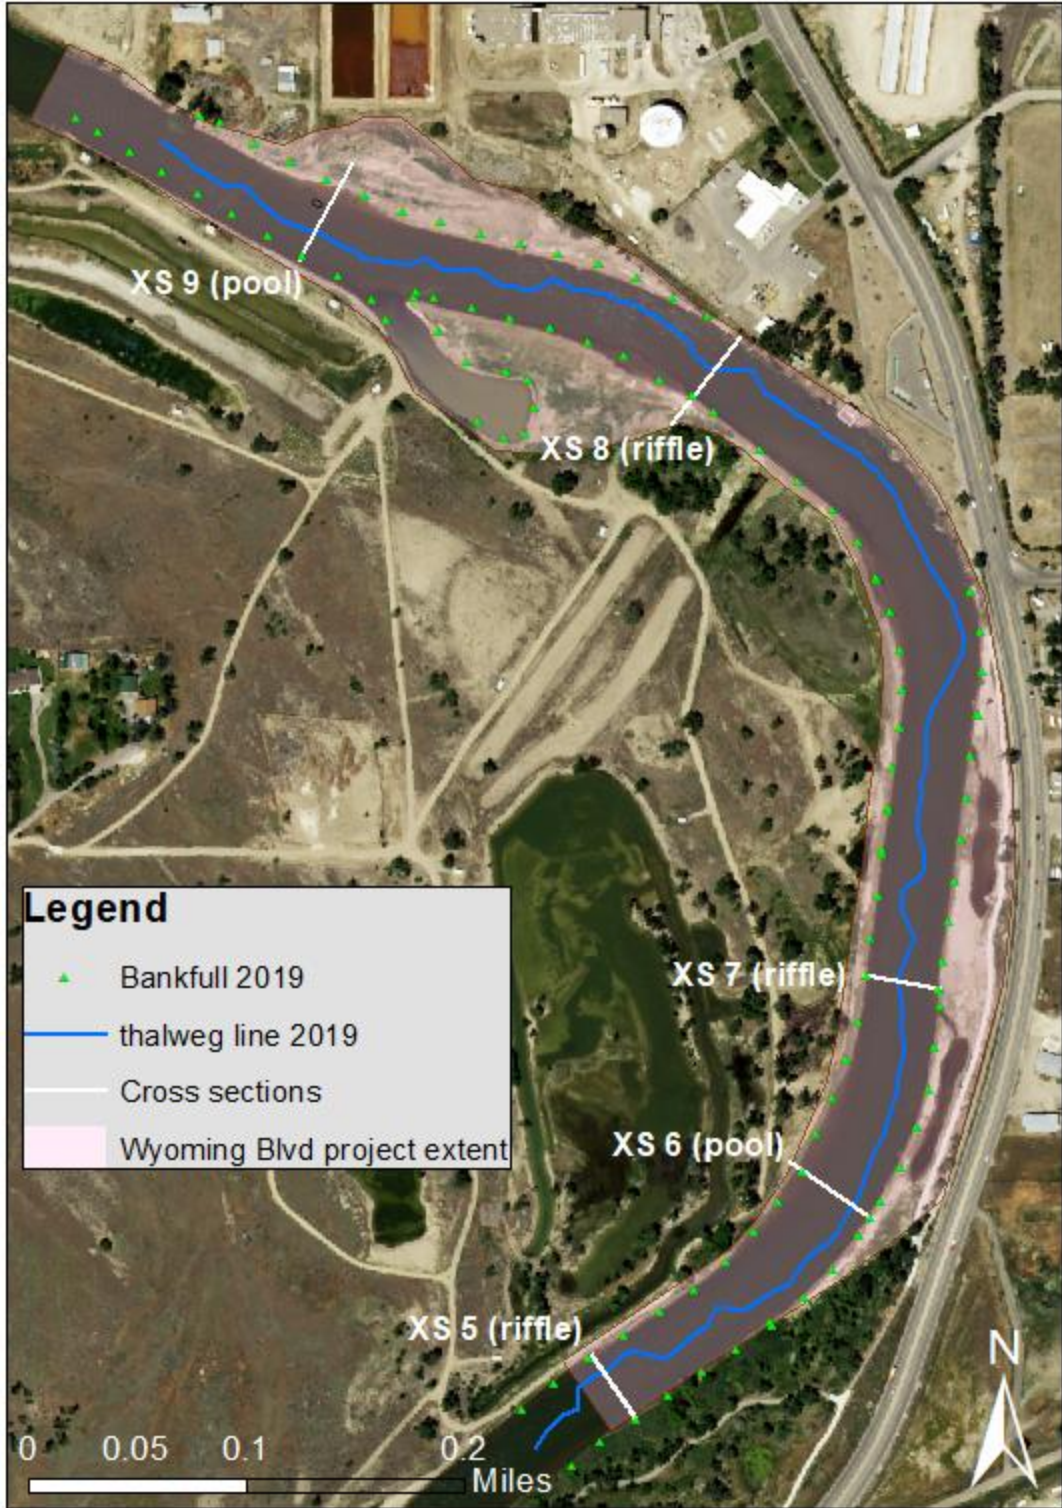
FIGURE 7. Bankfull elevations along the Wyoming Blvd project reach.

Bankfull elevation was surveyed on both banks along the entire project length and mapped (Figure 7). As this was the first time the bankfull line was mapped, this data serves as a baseline for comparison in future to track potential areas of channel migration.

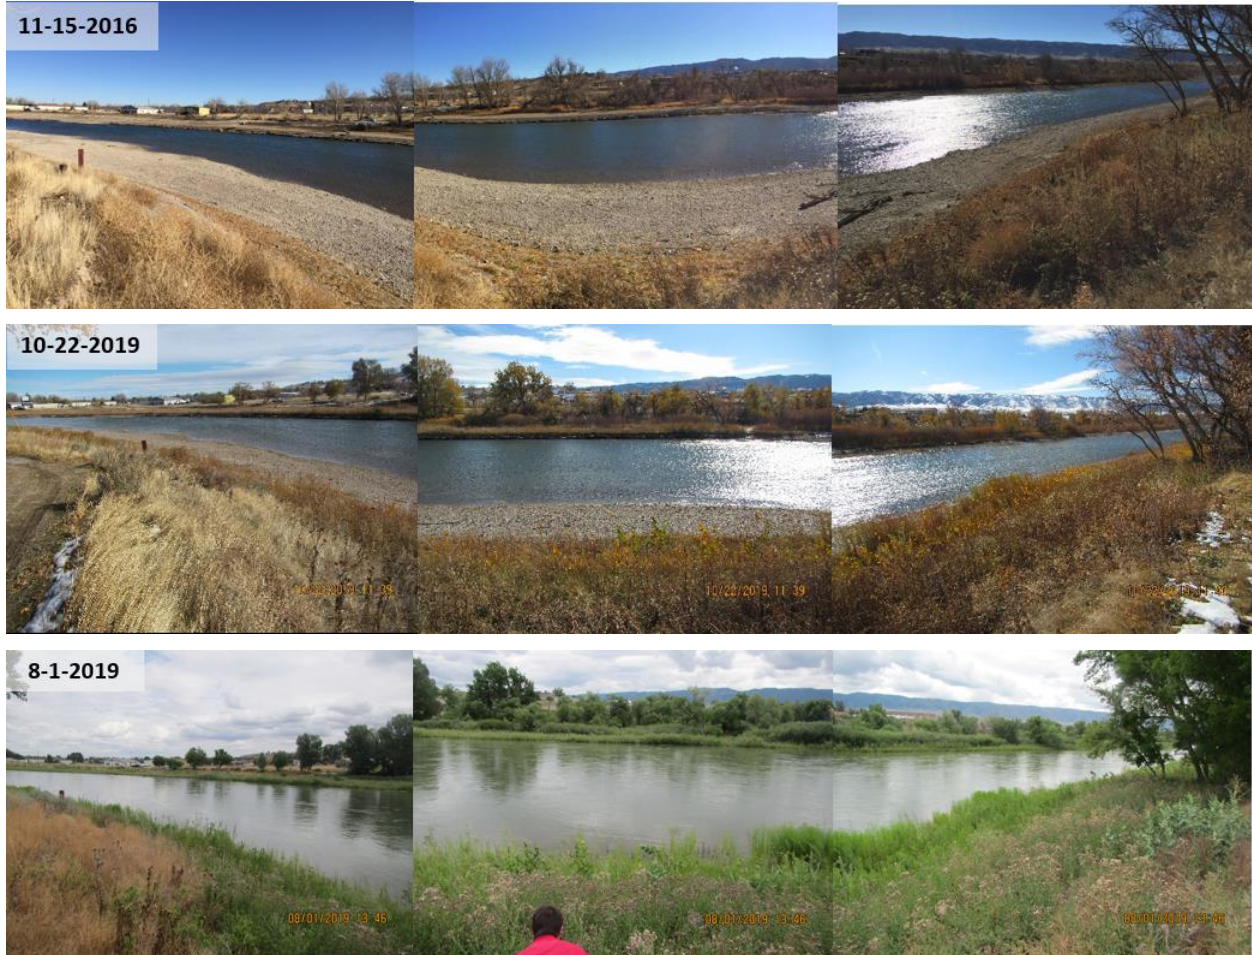
FIGURE A.4.1. Views from photo point WY-1 looking downstream (left), across (middle), and upstream (right).

Along the left bank of the WY Blvd reach, young willows were observed growing along the water’s edge near WY-1 and WY-2, (Figures A.4.1, A.4.2). Many young cottonwoods were also observed on the floodplain on the left bank at photo point WY-3 (Figure A.4.3). Downstream of WY-3 little new woody riparian vegetation growth was observed (Figures A.4.5, A.4.12). Some willows have established on top of toe wood 5 (Figures A.5.9, A.5.10). The left bank between WY-3 and WY-12 is an inner bend and receives less erosive stress from stream flow. However, downstream of WY-12, establishment of willows along the left bank is desirable to help maintain long-term stability of banks that serve as a barrier to the water treatment plant ponds and infrastructure. Vegetation around the oxbow wetland on the left bank is primarily herbaceous (Figure A.4.11).

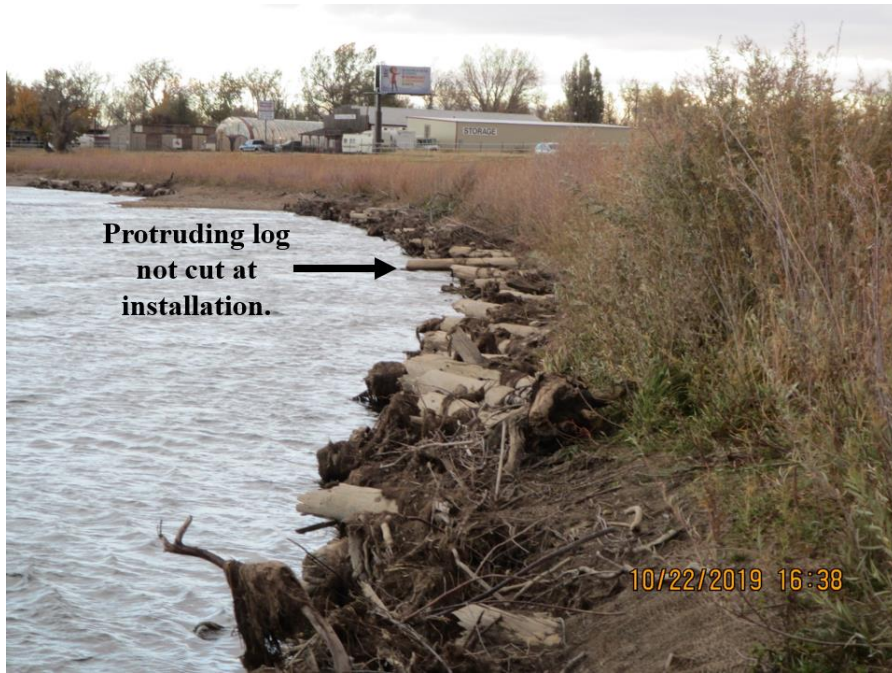
FIGURE A.5.1. Site 2 & 3 - Wyoming Blvd, standing near upstream end of toe wood 1, looking downstream.

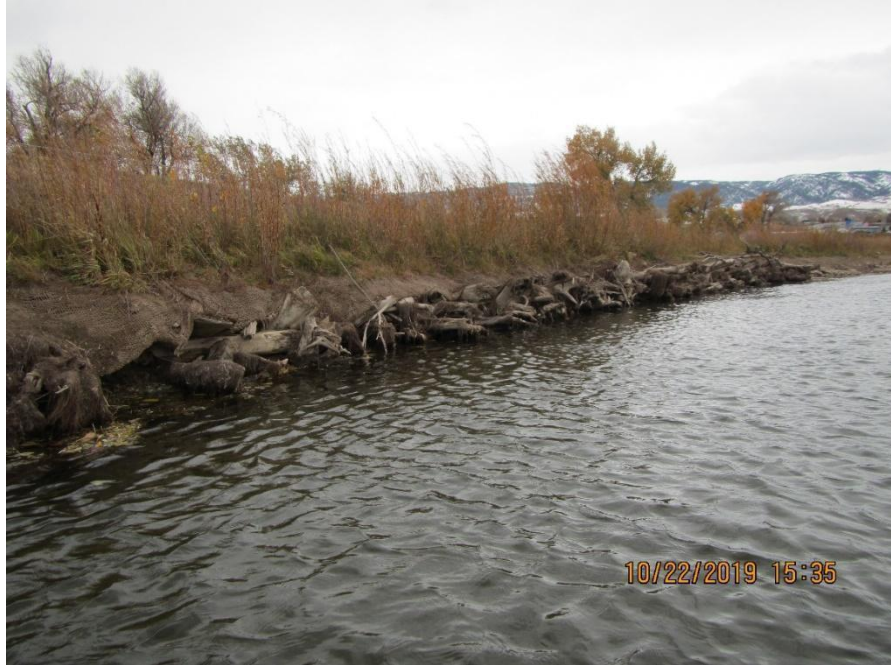
The third geomorphic goal was to stabilize stream banks. Excessive bank erosion was not evident in the Wyoming Blvd reach. Toe wood was largely intact and functioning to protect constructed banks. At toe wood 2 and 3 the bank should continue to be closely monitored for signs of slumping and erosion in locations where root wads appear missing or have larger gaps.

FIGURE A.5.5. Site 2 & 3 - Wyoming Blvd, at middle of toe wood 3 in-stream, looking at upstream half of toe wood 3.

- In addition to the structural and erosion/deposition rapid assessment ratings of toe wood structures, past photos of the structures from 2018 and 2019 should be used to evaluate any changes during future monitoring. Particularly, these photos will be useful to monitor potential ongoing erosion of toe wood 2 and any potential changes in toe wood 3 where wider spacing between logs was observed.

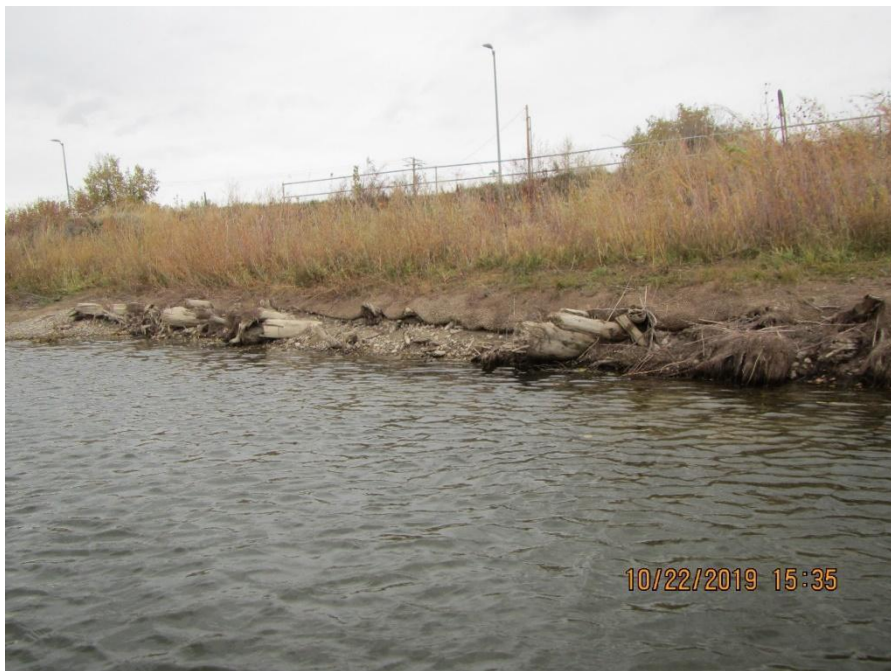
FIGURE A.5.6. Site 2 & 3 - Wyoming Blvd, at the middle of toe wood 3 in-stream, looking at downstream half of toe wood 3.

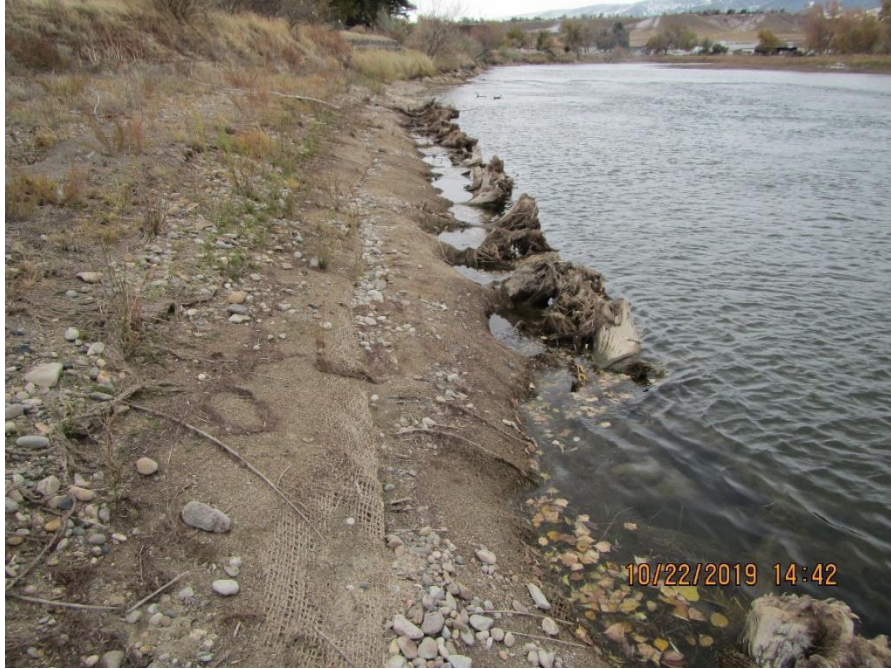
FIGURE A.5.7. Site 2 & 3 - Wyoming Blvd, standing at middle of toe wood 4, looking upstream at upper half of toe wood 4.

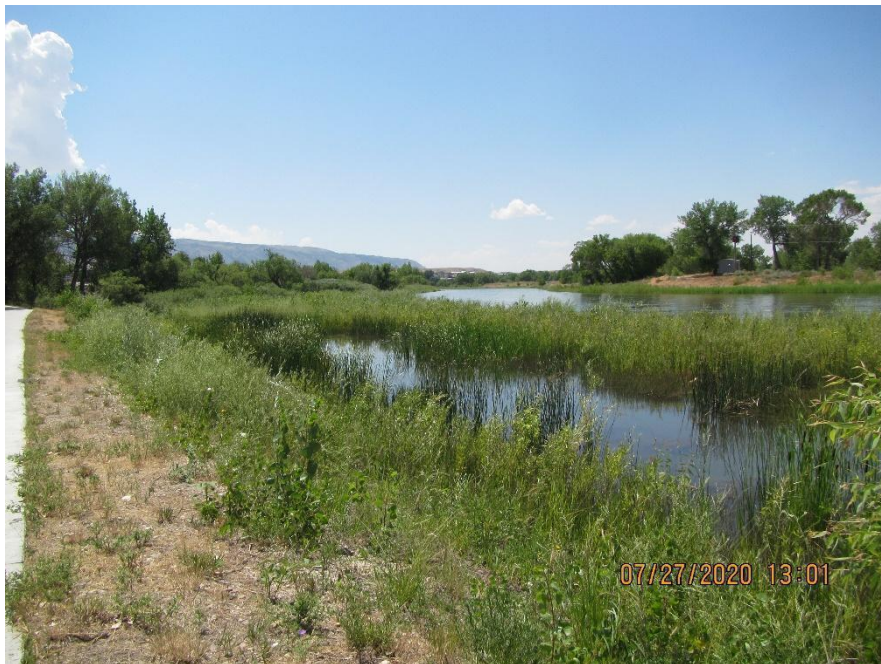
FIGURE A.5.18. Site 2 & 3 - Wyoming Blvd, at middle of upstream wetland along Wyoming Boulevard, looking upstream.

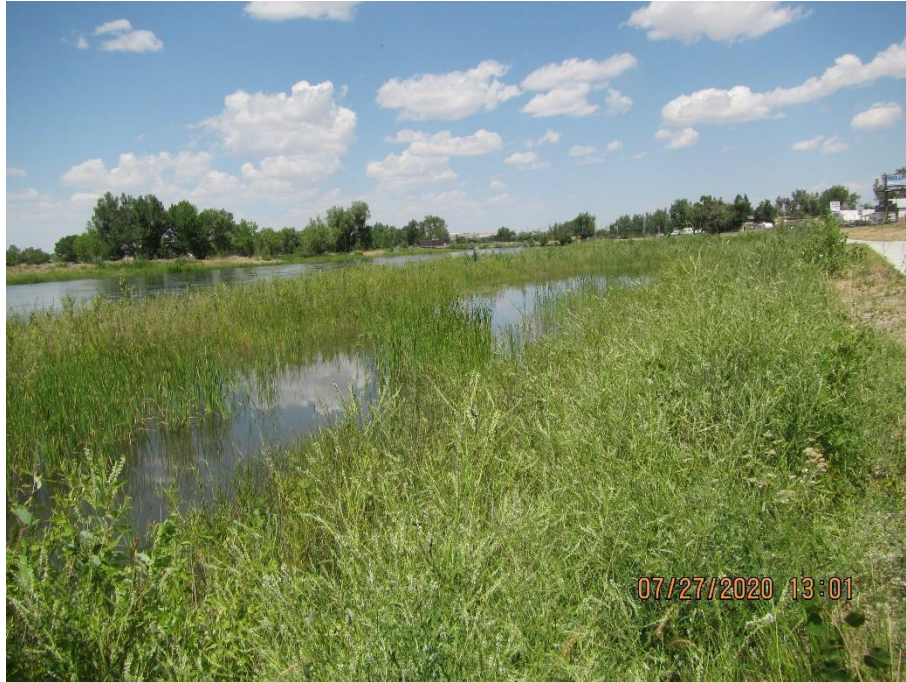
FIGURE A.5.19. Site 2 & 3 - Wyoming Blvd, at middle of upstream wetland along Wyoming Boulevard, looking downstream.

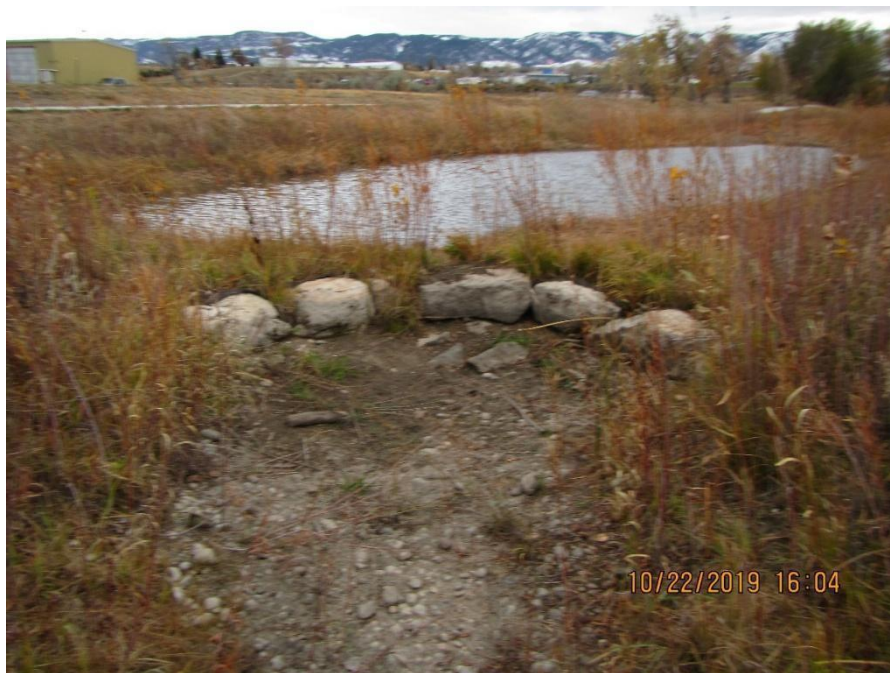
FIGURE A.5.20. Site 2 & 3 - Wyoming Blvd, at upstream set of wetland cross vanes, looking at cross vane 37.

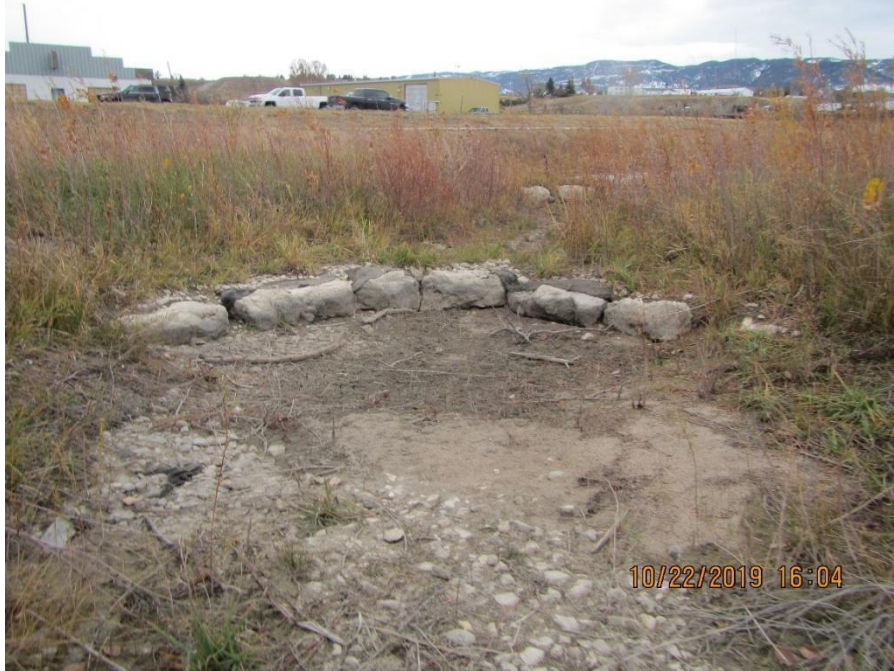
FIGURE A.5.21. Site 2 & 3 - Wyoming Blvd, at upstream set of wetland cross vanes, looking at cross vane 38.

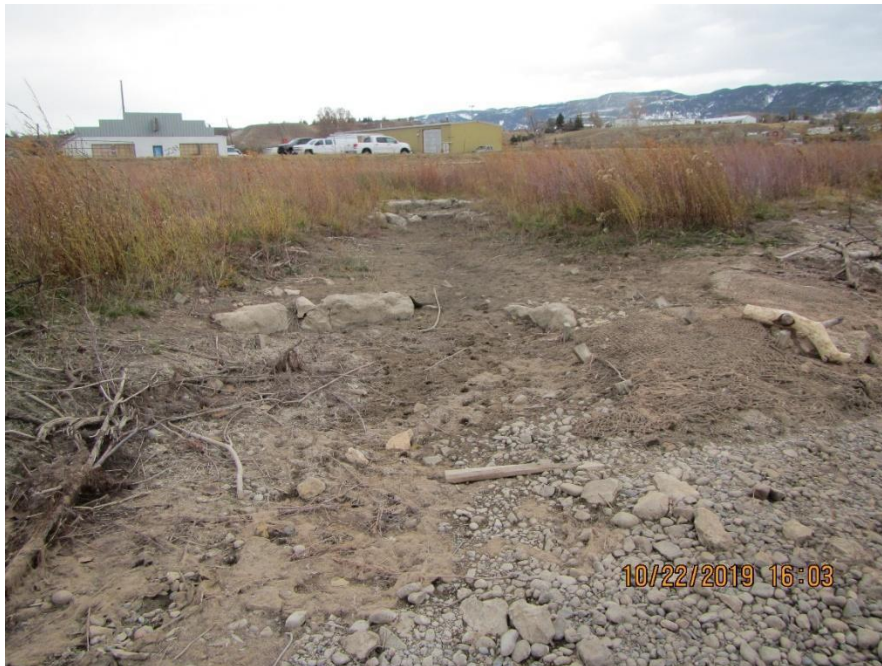
FIGURE A.5.22. Site 2 & 3 - Wyoming Blvd, at upstream set of wetland cross vanes, looking at cross vanes 39A (middle) and 39B (closest). Cross vane 38 is also visible (furthest).

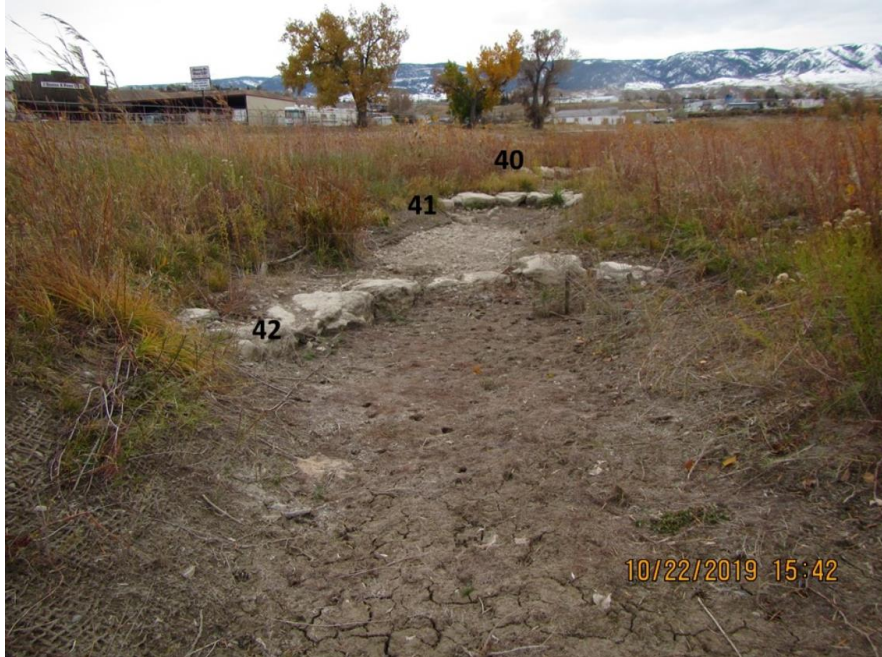
FIGURE A.5.23. Site 2 & 3 - Wyoming Blvd, at downstream set of wetland cross vanes, looking up at cross vanes 40,41, and 42.

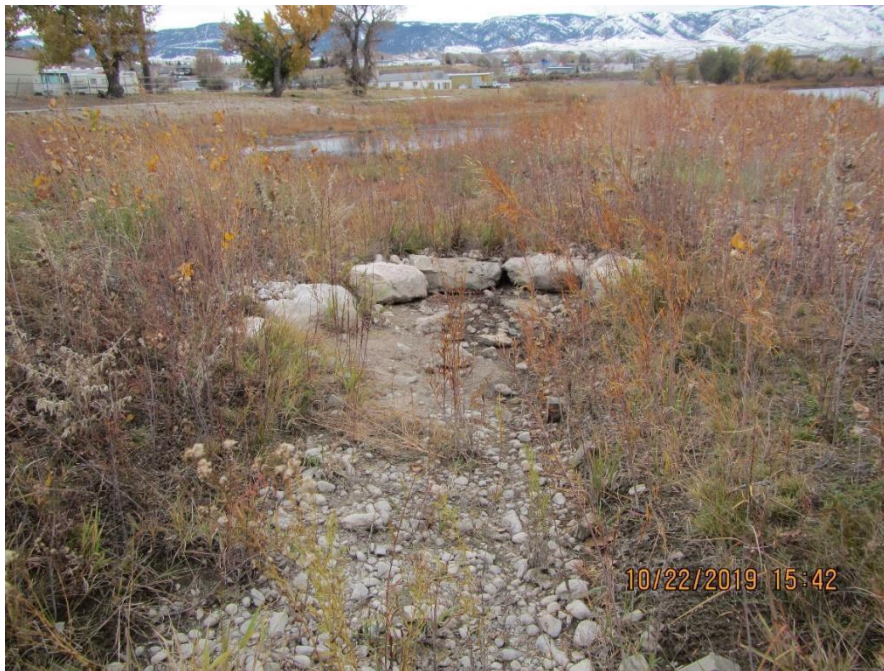
FIGURE A.5.24. Site 2 & 3 - Wyoming Blvd, at downstream set of wetland cross vanes, looking up at cross vane 40.
