## North Platte River Environmental Restoration Master Plan – Phase I

City of Casper Public Services Department  
Casper, Wyoming

Stantec Consulting Services, Inc.  
2950 East Harmony Road, Suite 290  
Fort Collins, Colorado 80528

May 21, 2012

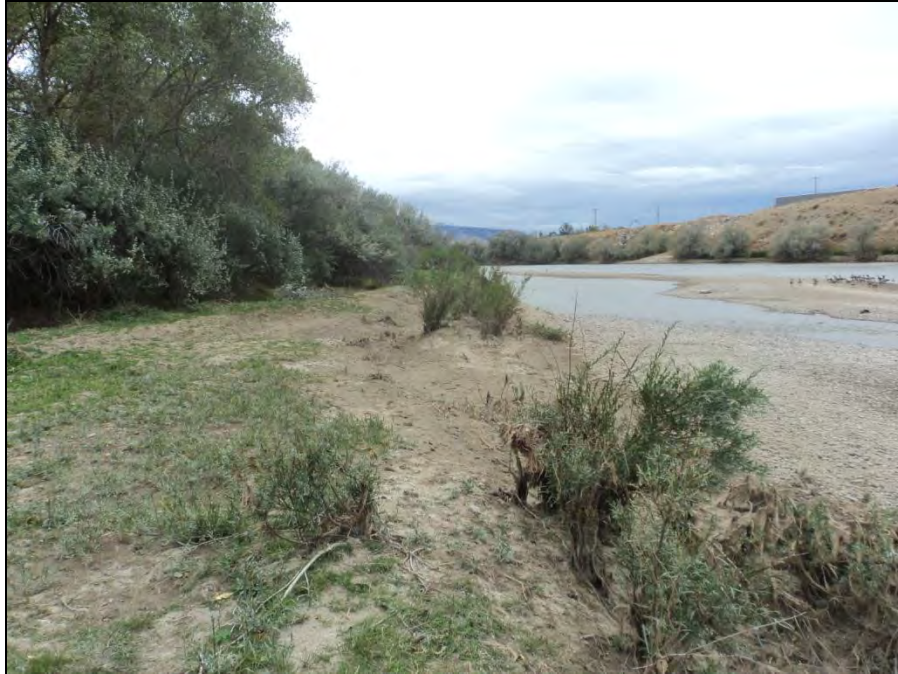
This site is located on Izaak Walton League of America property that includes a portion of riverfront along the North Platte River (Figure A10). This area is divided by a human-constructed levee that separates the upper terrace zone from the lower terrace zone and sandbar zones. The upper terrace zone is a mature, open understory cottonwood gallery with very little understory vegetation. The lower terrace zone supports a dense cover of Russian olive (planted as a windbreak) (Photopoint 12). The sandbar zone is frequently flooded and recently scoured, with portions entirely devoid of vegetation. Sandbar willow and reed canarygrass are well-established throughout these zones. Other species observed at this site included eastern cottonwood, hawthorn, cheatgrass, sandbar willow, plains cottonwood, Kentucky bluegrass, narrowleaf cottonwood, prairie rose, western snowberry, and downy hawthorn.

This portion of the riverfront is part of the Izaak Walton League Nature Trail and is not associated with the North Platte River trail corridor. Public access is limited and the aesthetic benefits from any restoration may not be recognized by the public. However, the Russian olive stands are a potential seed source for future downstream establishment and are located away from a stabilized riverbank. Removal of Russian olive would potentially eliminate an upstream seed source.

Photopoint 12. Well established Russian olive stand and seedlings along the lower terrace zone at Site 10.
