**North Platte River Restoration
Project – First Street Reach**

Stream Quantification Tool (SQT)
Monitoring Report

December 20, 2022

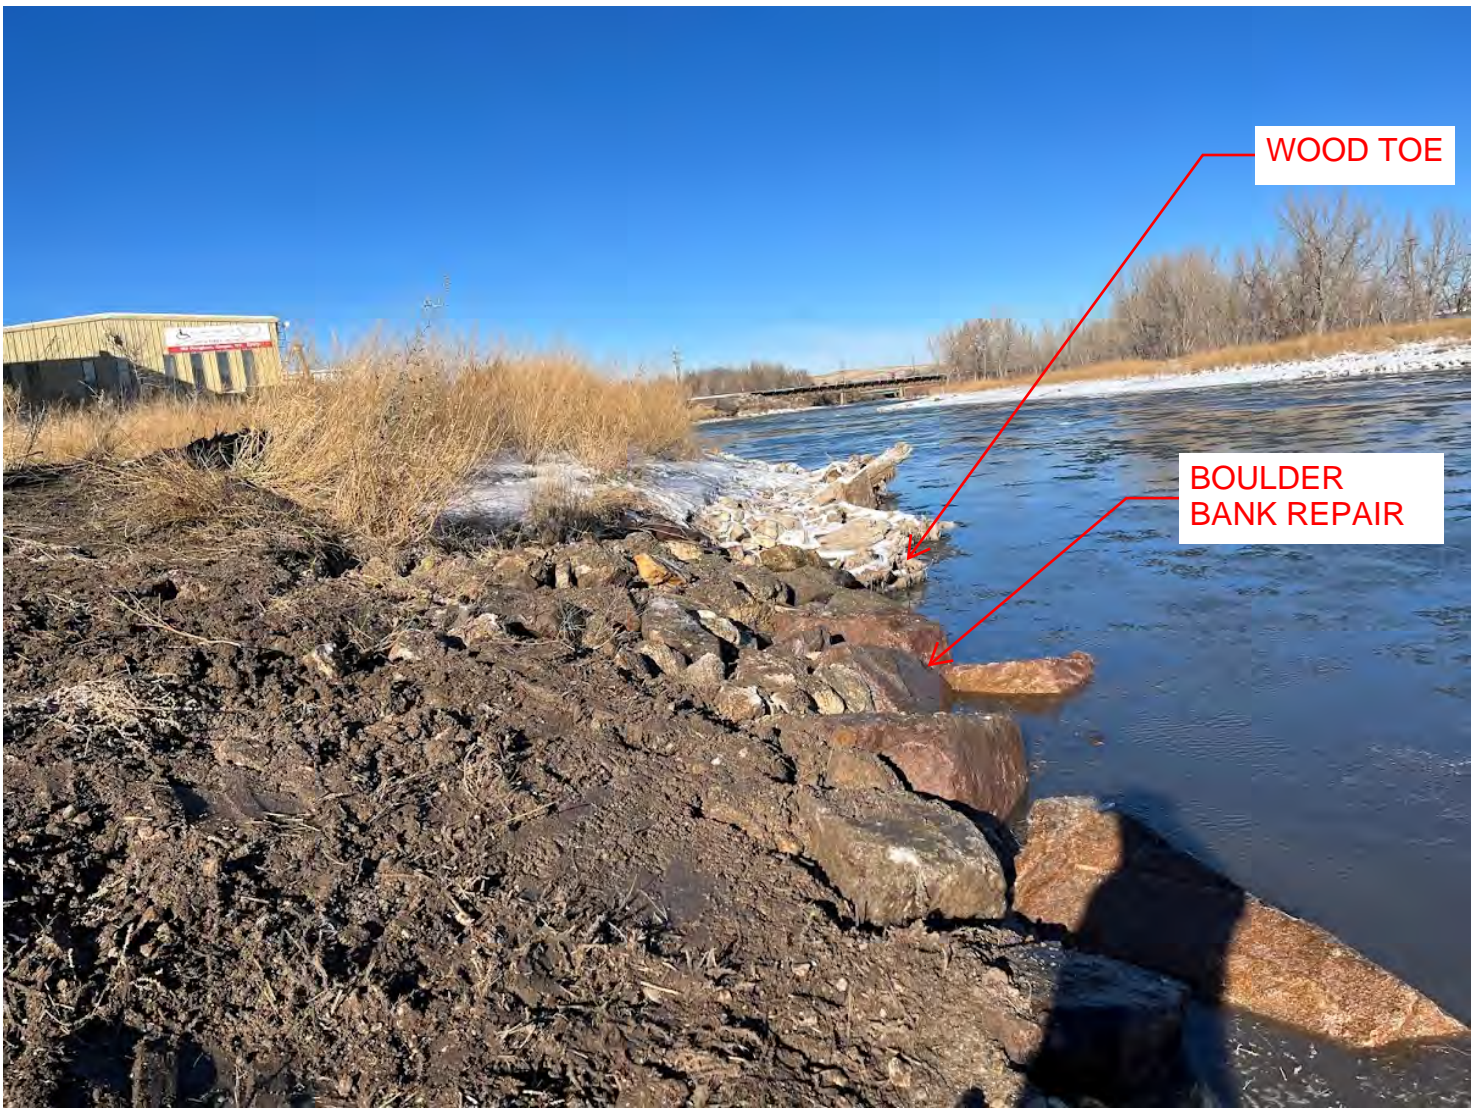
WOOD TOE

BOULDER
BANK REPAIR
