## North Platte River Environmental Restoration Master Plan – Phase I

City of Casper Public Services Department  
Casper, Wyoming

Stantec Consulting Services, Inc.  
2950 East Harmony Road, Suite 290  
Fort Collins, Colorado 80528

May 21, 2012

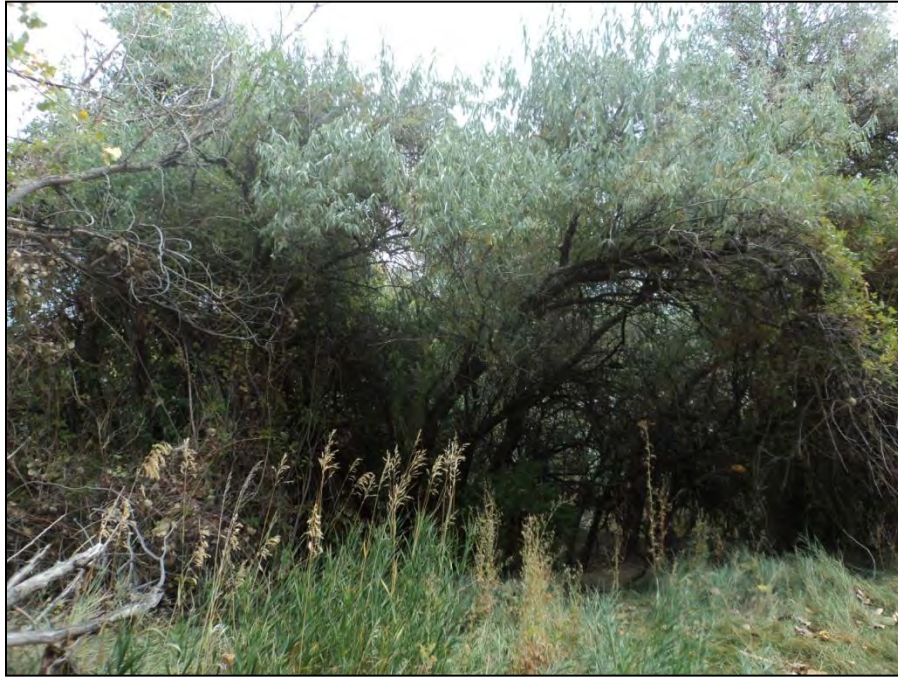
This site is located in the North Platte River Park vegetation restoration priority area (Figure A8). Russian olive is well-established in mature stands along the riverbank (Photopoint 3). A variety of reclamation seed mix grasses, such as western wheatgrass and crested wheatgrass, are common in the understory. The density of Russian olive is high, with dominant canopy cover near the riverbank. This site is a potential seed source for Russian olive spread to nearby Lansing Park, which has very low Russian olive densities. Although there are mature eastern cottonwoods in the area, there are no occurrences of seedlings or saplings observed. Some cottonwoods have visible beaver (*Castor canadensis*) damage and at least one cottonwood tree was felled. Sandbar willows are well established along the riverbank where Russian olive is not present. Other species observed included eastern cottonwood, plains cottonwood, narrowleaf cottonwood, box elder, curlycup gumweed, kochia, cheatgrass, tall wheatgrass, reed canary, western snowberry, and green rabbitbrush.

Russian olive removal would be difficult and costly due to density and age of the stand; however, the potential seed source of Russian olive from this site and proximity of healthy riparian habitats downstream increases the appeal of treatment at this site. Cutting of Russian olive with concurrent and recurrent stump applications of herbicide would allow the root system to maintain bank stability while willow plantings establish.

Photopoint 3. Dense stand of mature Russian olive on riverbank at Site 8.

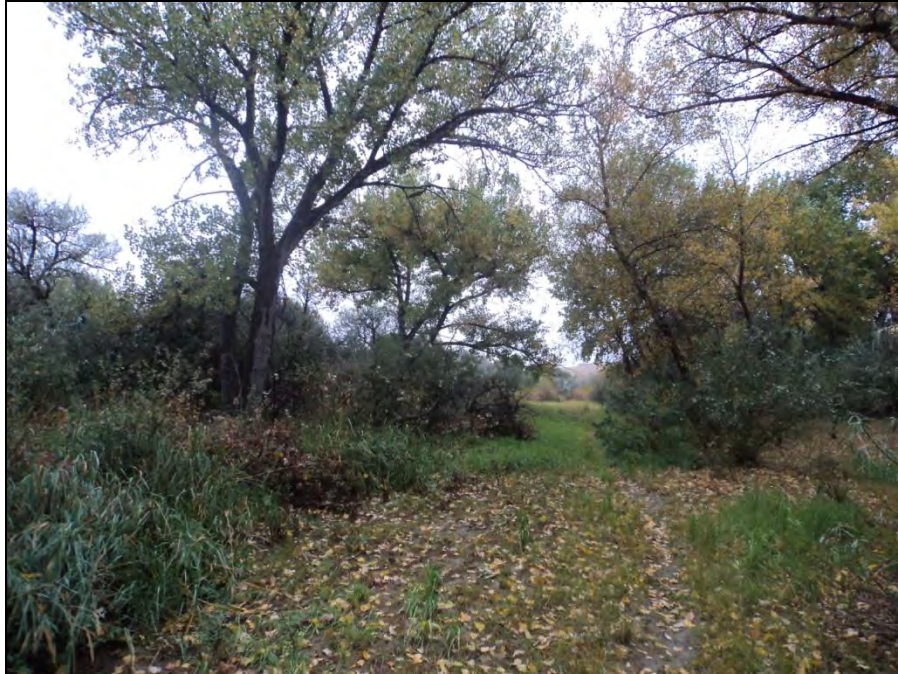
This site is located in the North Platte River Park vegetation restoration priority area (Figure A5). This area is entirely within the lower terrace zone and downstream of high priority site 6. Russian olive is established in this area, but is mostly mature stands along the riverbank (Photopoint 7). Russian olive saplings are established along the many frequently flooded swale wetlands that were naturally blocked-off side channels. There are several mature cottonwoods interspersed throughout the grassy upper terrace zone, where cheatgrass is typically the dominant cover. Additional species observed at this site included eastern cottonwood, western wheatgrass, crested wheatgrass, reed canarygrass, scratchgrass, western snowberry, narrowleaf cottonwood, Kentucky bluegrass, alkali sacaton, and sandbar willow.

Russian olive saplings could potentially be eradicated from the swale wetland areas and further wetland development could occur at this site. Russian olive removal along the riverbank could be labor intensive with potential bank stabilization issues.

Photopoint 7. Russian olive interspersed under a cottonwood gallery at Site 5.

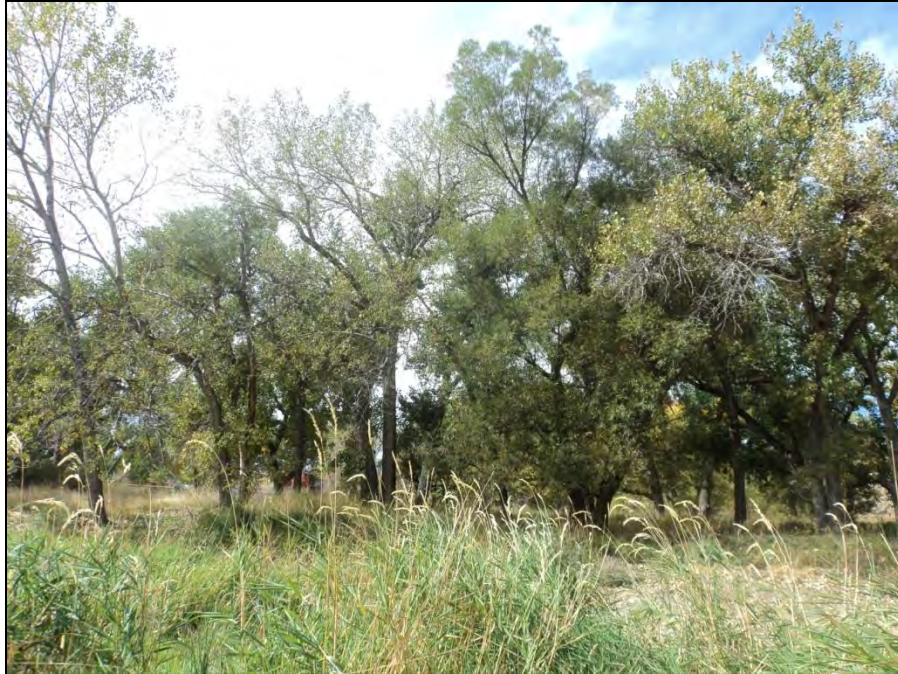
This site is located in the North Platte River Park vegetation restoration priority area (Figure A7). This area is immediately downstream from Site 8, which supports a high density of Russian olive and a potentially large seed source. Mature cottonwoods are well established with a native grass understory (Photopoint 10). The lower terrace zone is well vegetated but contains very few shrub and/or tree species. Cheatgrass is beginning to gain dominance in sparsely covered areas. This upper terrace zone is heavily used recreationally which may facilitate the additional spread of invasive species. Established cottonwood and willow saplings were not observed in high densities. Additional species observed at this site included reed canarygrass, western wheatgrass, cheatgrass, crested wheatgrass, plains cottonwood, eastern cottonwood, crack willow, Kentucky bluegrass, narrowleaf cottonwood, kochia, black willow common reed, and timothy.

Russian olive densities are low at this site; however, this area has high invasibility potential based on its proximity and downstream location to Site 8 that has high Russian olive densities. Cheatgrass may potentially be controlled in the upper terrace with spot treatments, recreation use control, and overseeding of native grass species. Riverbank enhancements and the reestablishment of local hydrological patterns may increase sandbar willow and cottonwood establishment, further reducing the likelihood of Russian olive establishment and spread.

Photopoint 10. Mature cottonwoods with native grass understory at Site 7.

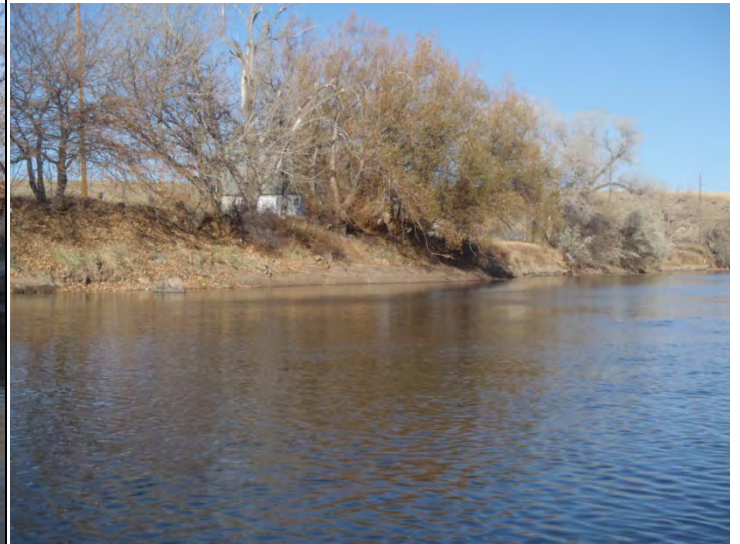
**Rock Toe-Stairs Map-1-011**

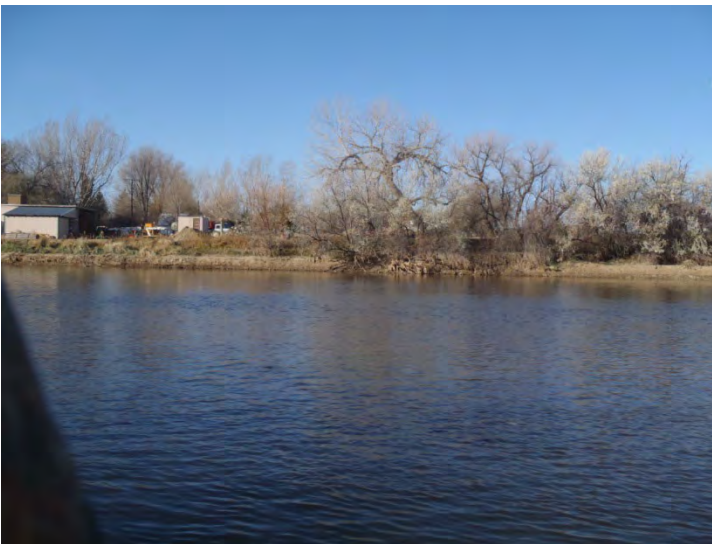
**Rock Toe-Dock Map-1-009**

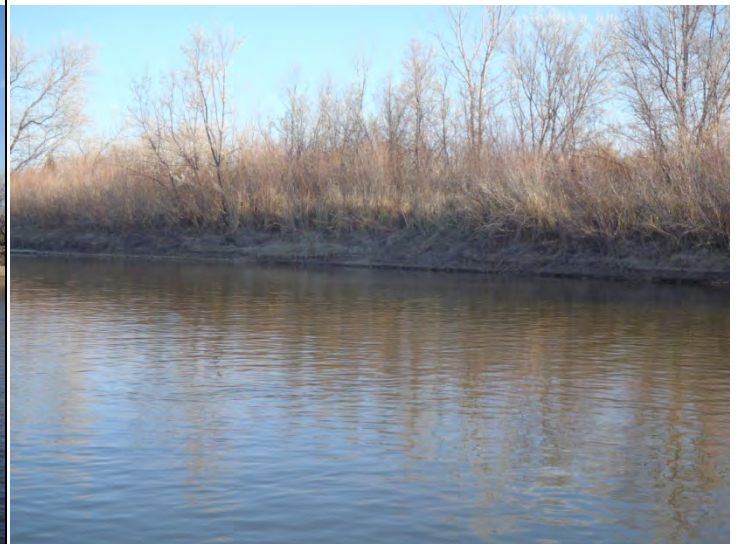
**Rock Toe Map-2-012**

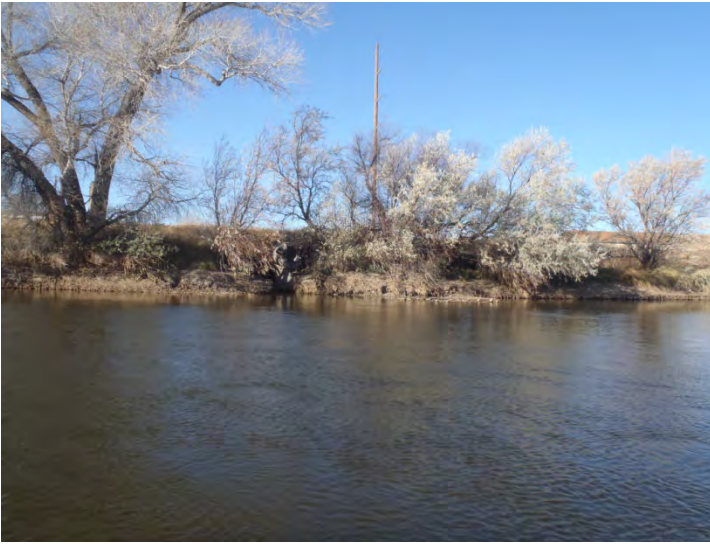
**Rock Toe-Dock Map-2-013**

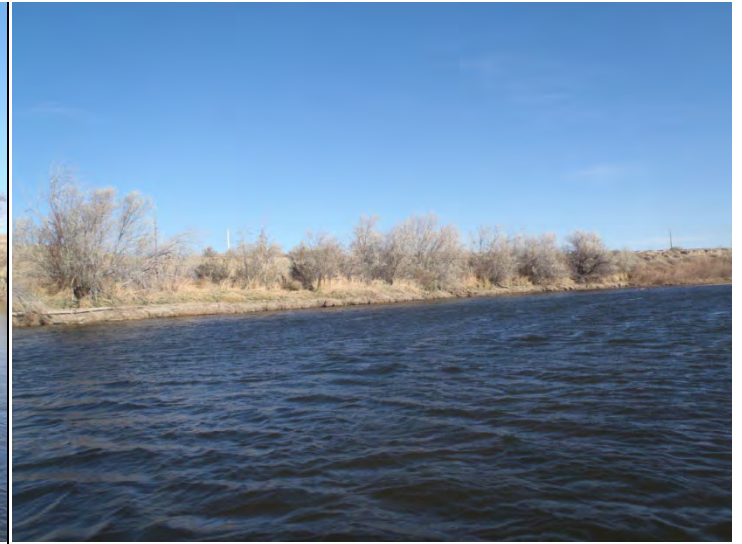
**Rock Toe-Dock Map-2-016**

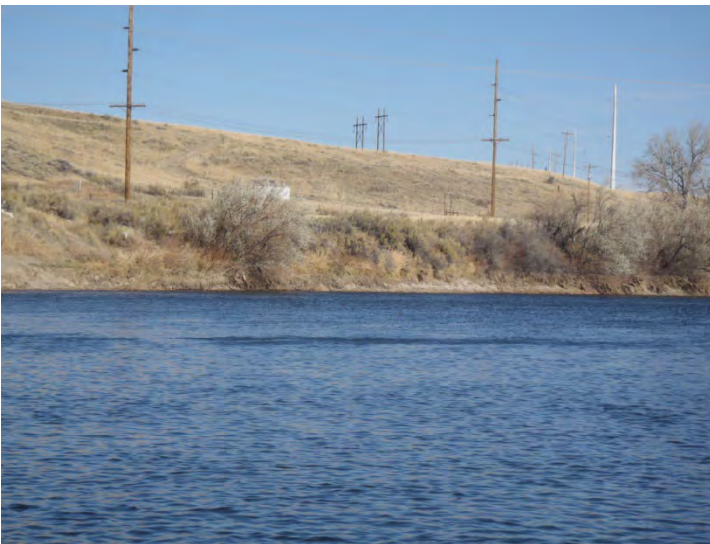
**Rock Toe-Dock Map-2-014**

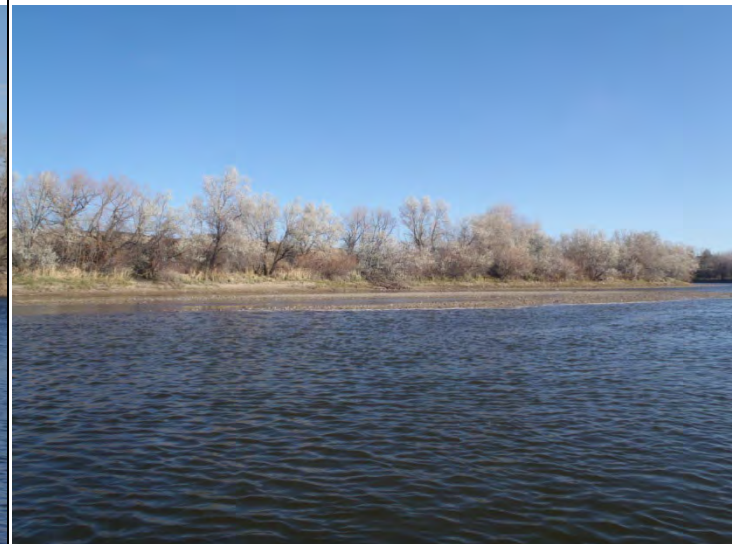
**Rip-Rap Map-2-017**

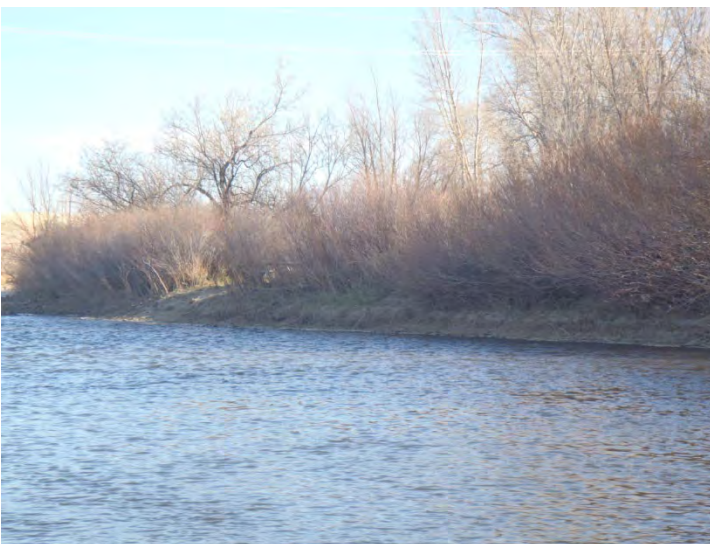
**Stairs Map-2-015**

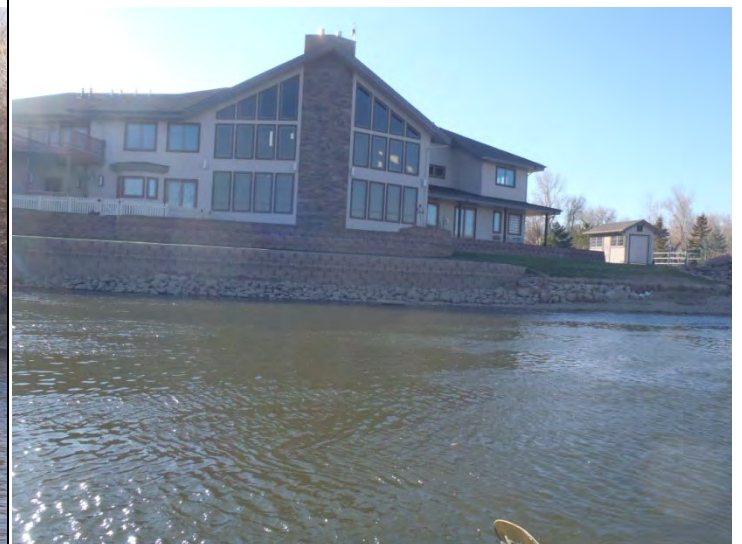
**Retaining Wall-Dock Map-2-018**

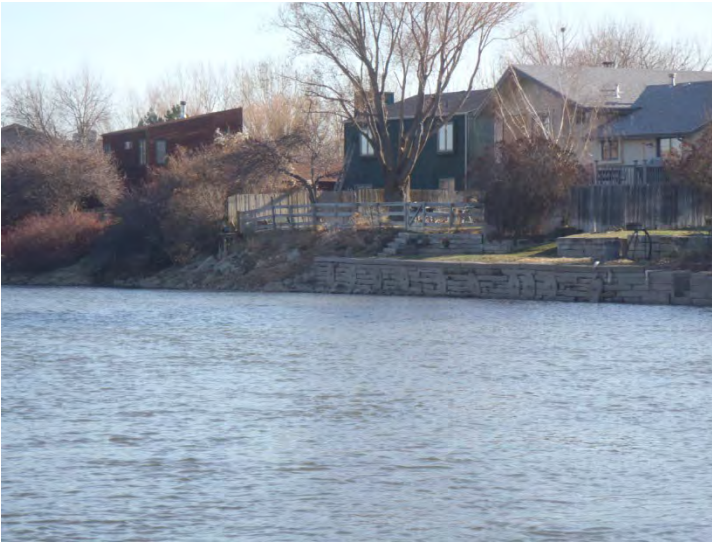
**Stairs-Dock Map-2-019**

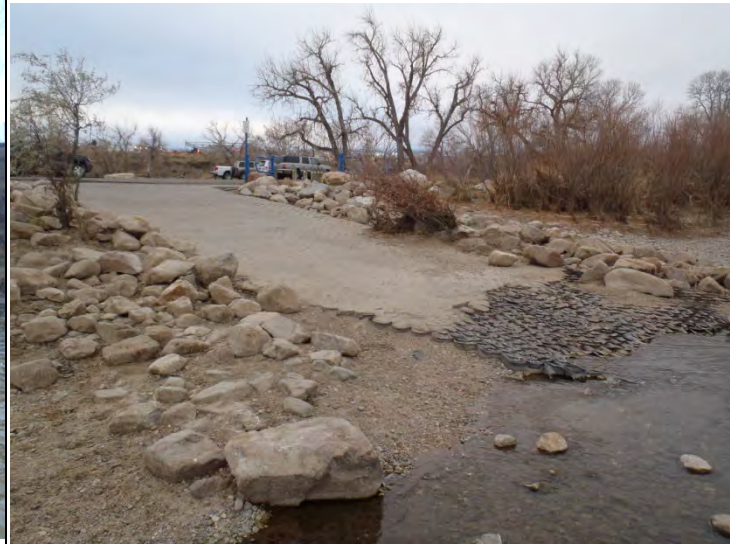
**Boat Ramp Map-2-023**

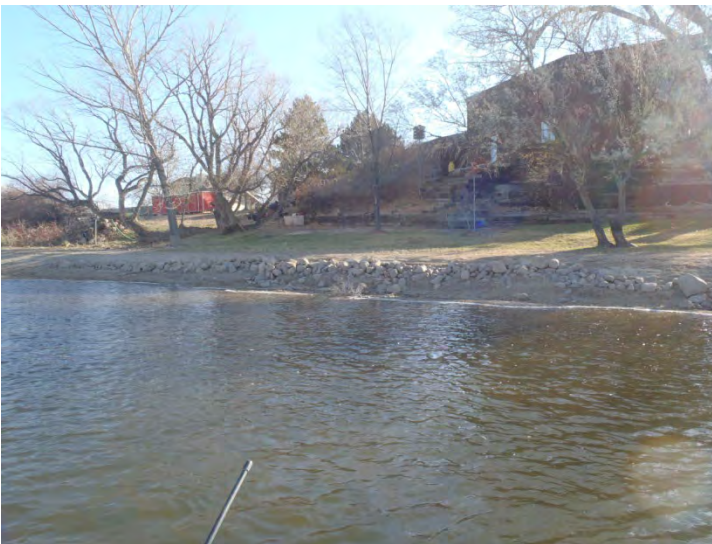
**Rip-Rap-Rock Toe Map-2-021**

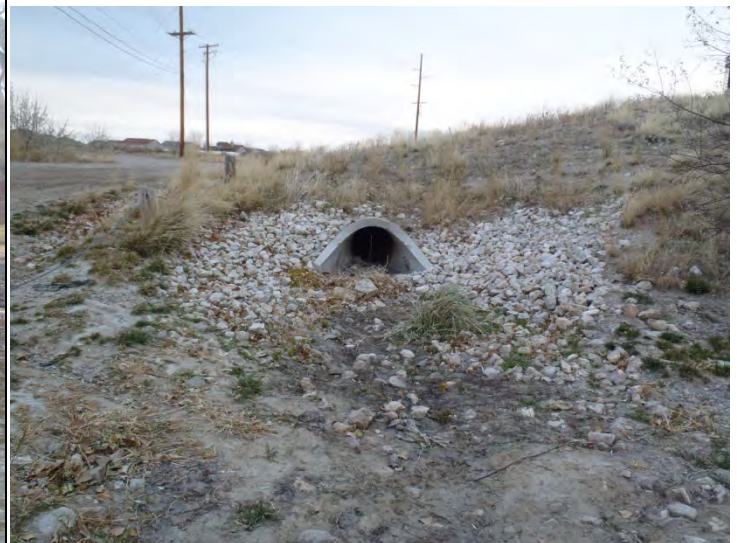
**36 IN Invert Pipe Map-2-024**

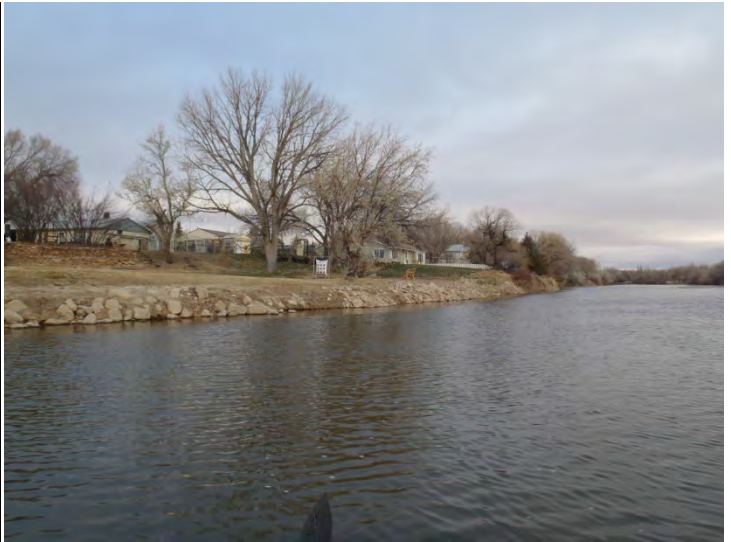
**Rock Toe Map-2-028**

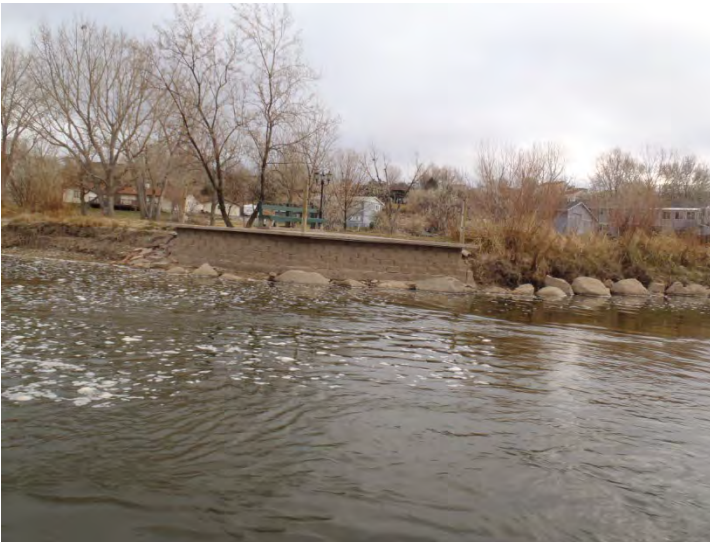
**Retaining Wall Map-2-026**

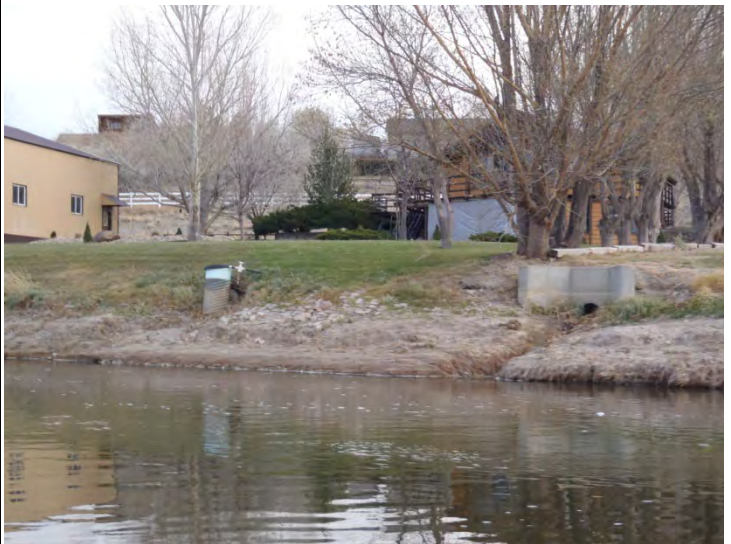
**36-18 IN Invert Pipes Map-2-029**

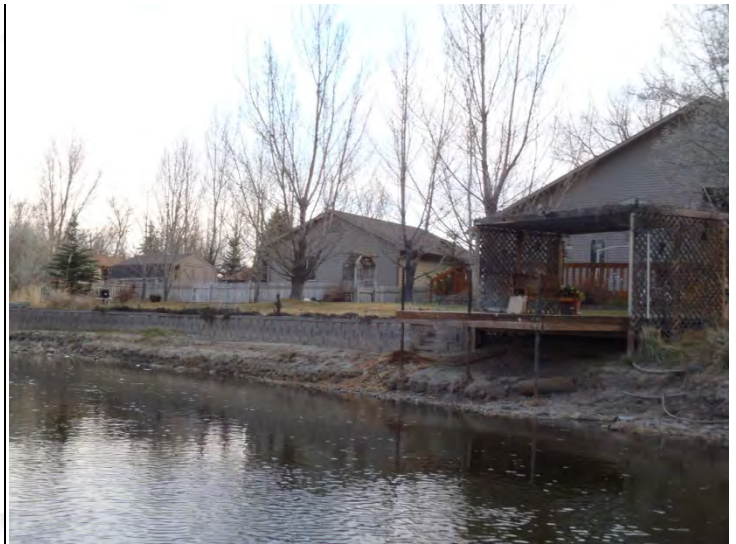
**Dock-Retaining Wall Map-3-034**

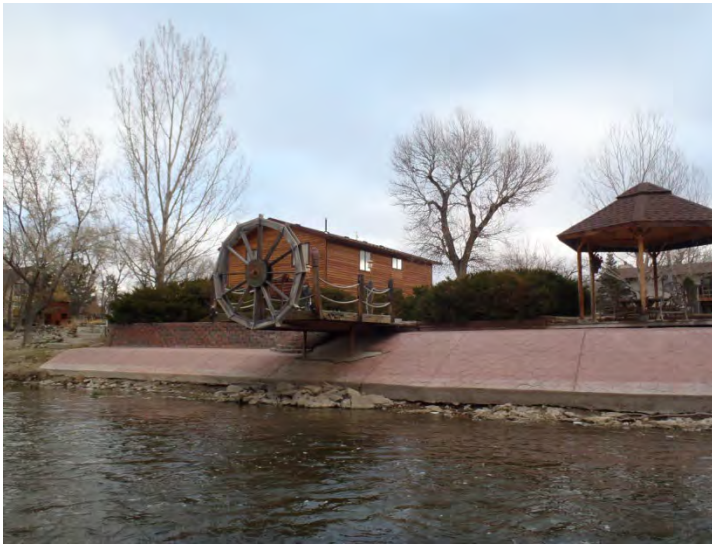
**Dock-Retaining Wall Map-3-032**

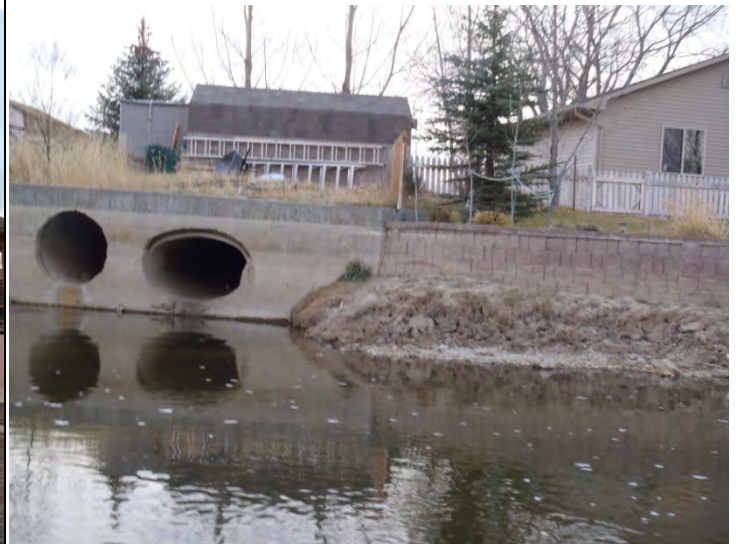
**42X66-48 Pipe Inv-Retain Wall-Map-3-035**

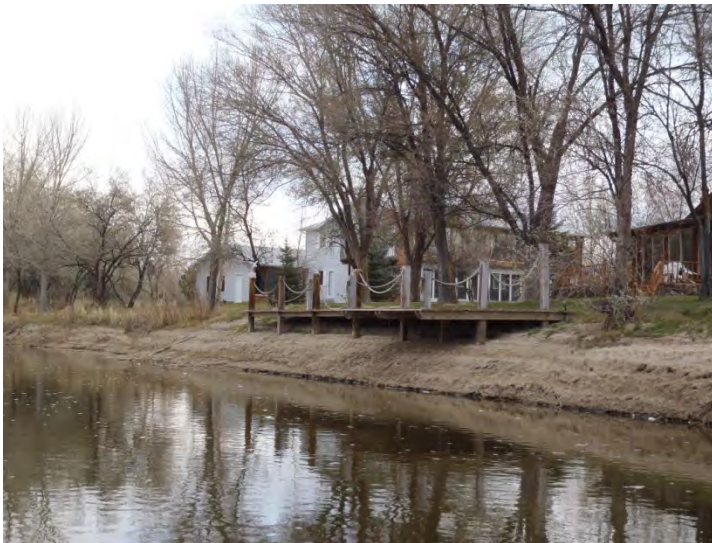
**Dock Map-3-033**

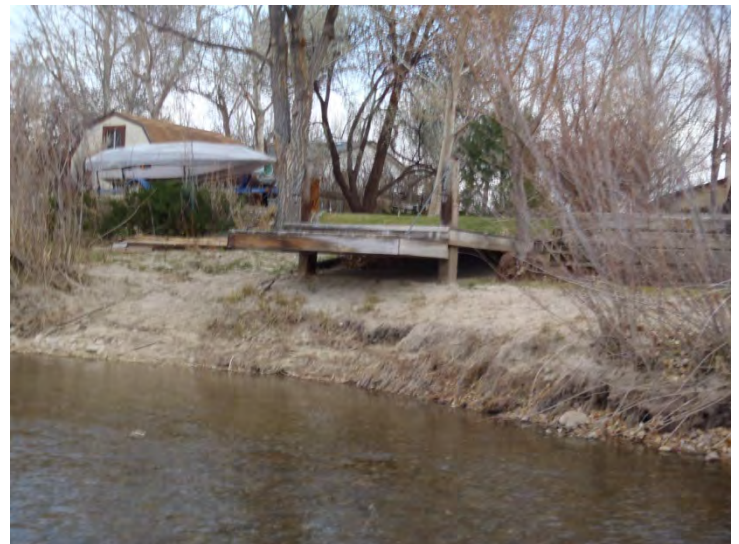
**Dock Map-3-036**

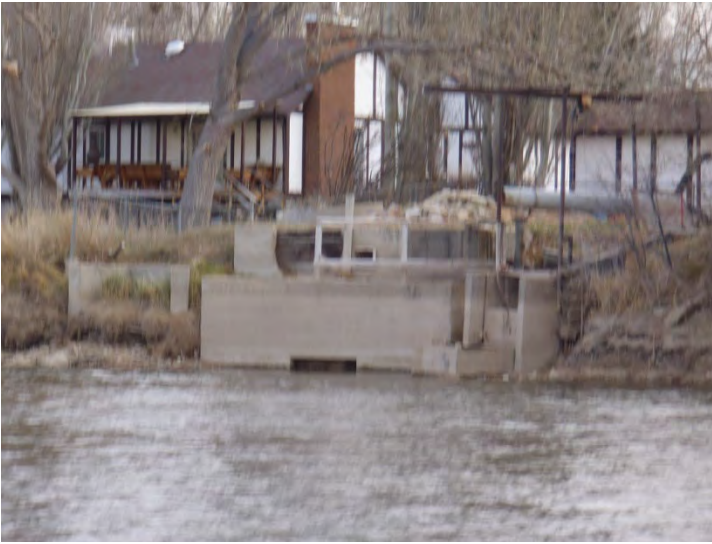
**Dock Map-4-037**

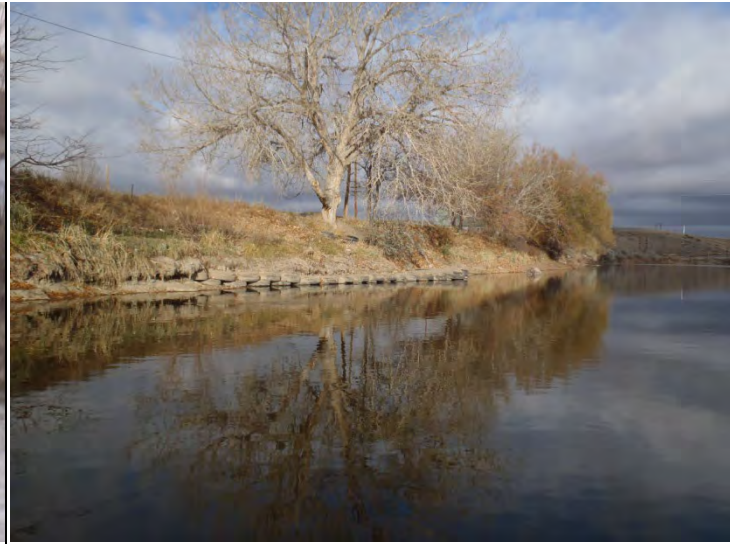
**Tire Toe Map-4-040**

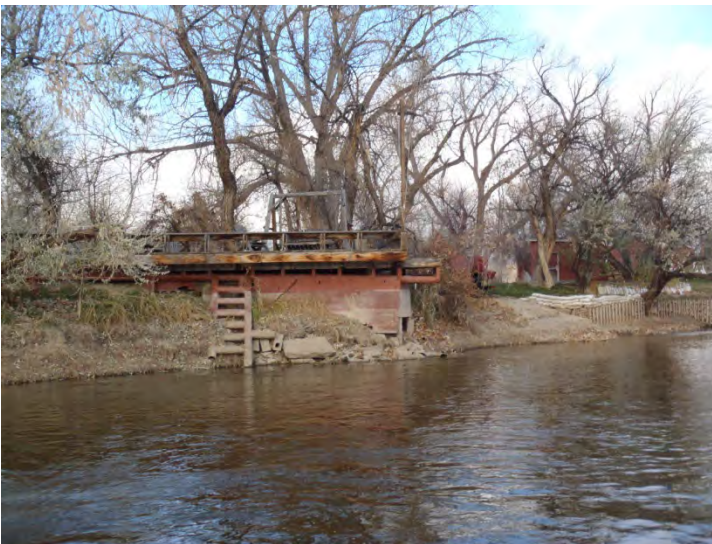
**Dock Map-4-038**

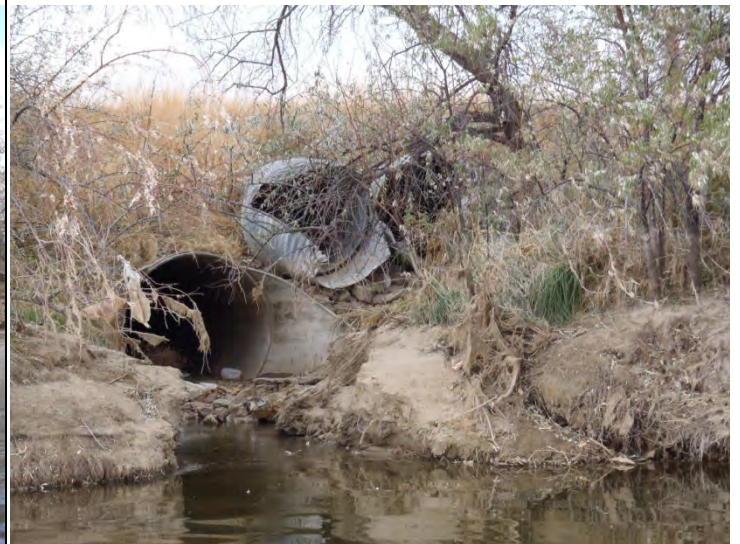
**48-60 IN Pipe Invert Map-4-041**

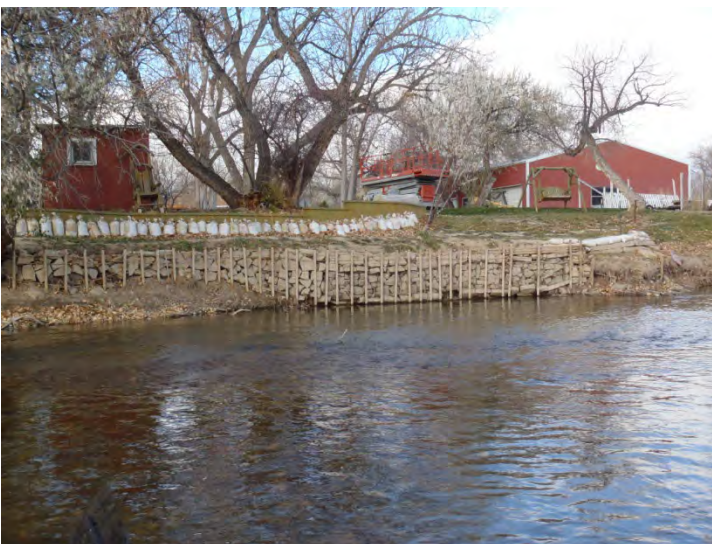
**Retaining Wall Map-4-039**

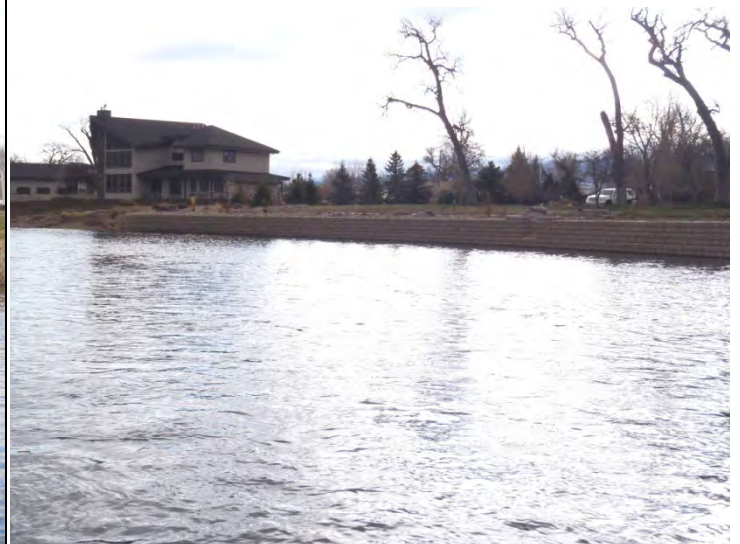
**Retaining Wall Map-5-042**

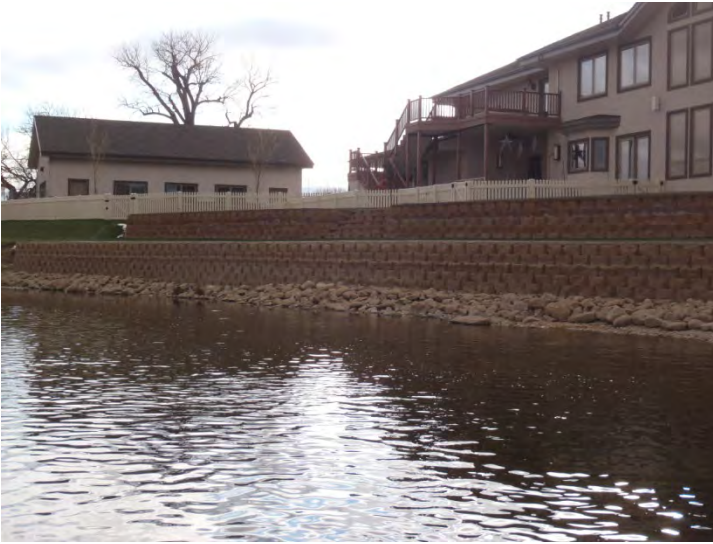
**Retaining Wall Map-5-043**
